Hawaii National Marine Renewable Energy Center (HINMREC)

OTEC Heat Exchanger Program: 2015 Ultrasonic Scanning for Corrosion Monitoring Progress Reports

Prepared by:
Makai Ocean Engineering

STATUS REPORT 1

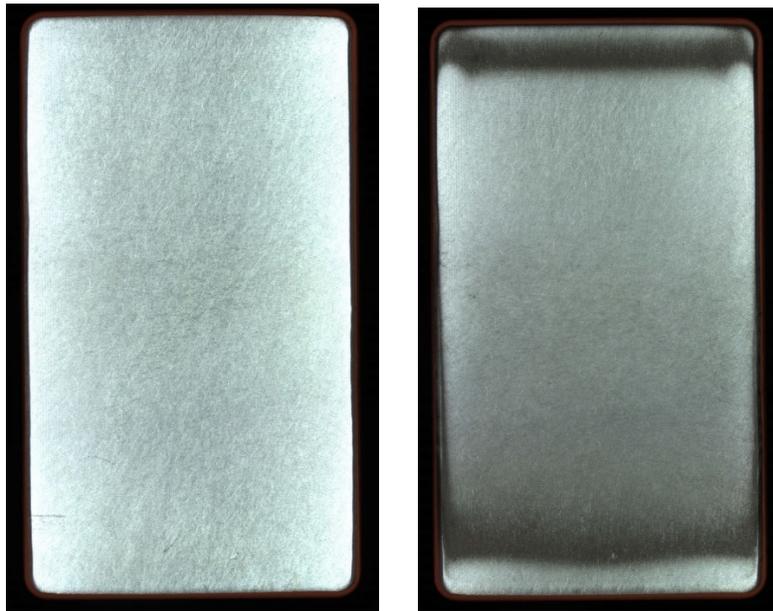
6 samples of three different aluminum alloys have been exposed to seawater for two weeks and some are already showing corrosion. We are able to detect pit depths in the ultrasonic scans for a couple of the samples. All samples are showing color changes to their surfaces (e.g. Figure 1). Non-uniformity of the darkening could be attributed to uneven flow characteristics since the samples are slightly recessed.

Figure 1: An Al 6061 sample exposed to flowing seawater at 1 day (left) and 15 days (right) showing surface color changes.

Neither 6061 sample has shown any corrosion, but their surfaces have darkened (Figure 1). As anticipated, the Al 2024 samples are corroding quickly and allowing us to confirm our experimental strategy (Figure 2 and Figure 3).

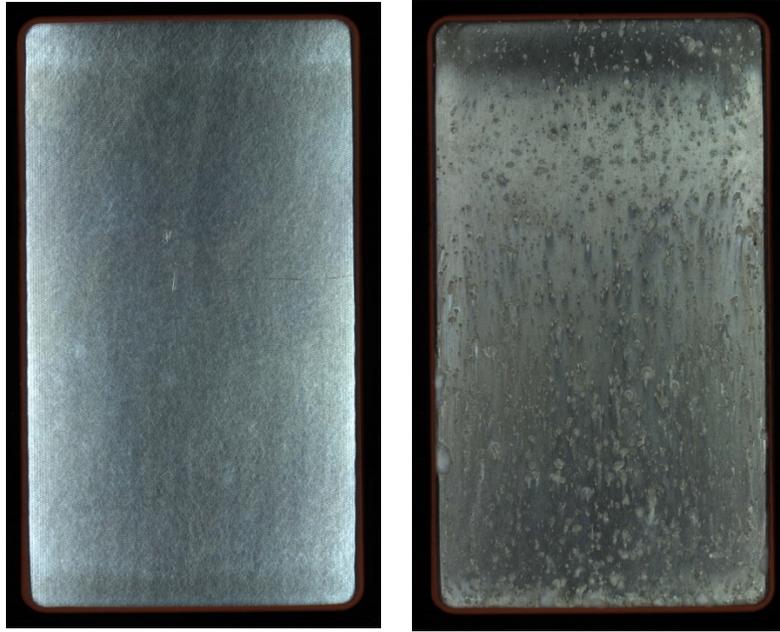
Figure 2: Corrosion development in Al 2024 sample in flowing water at 1 day and 15 days exposure.

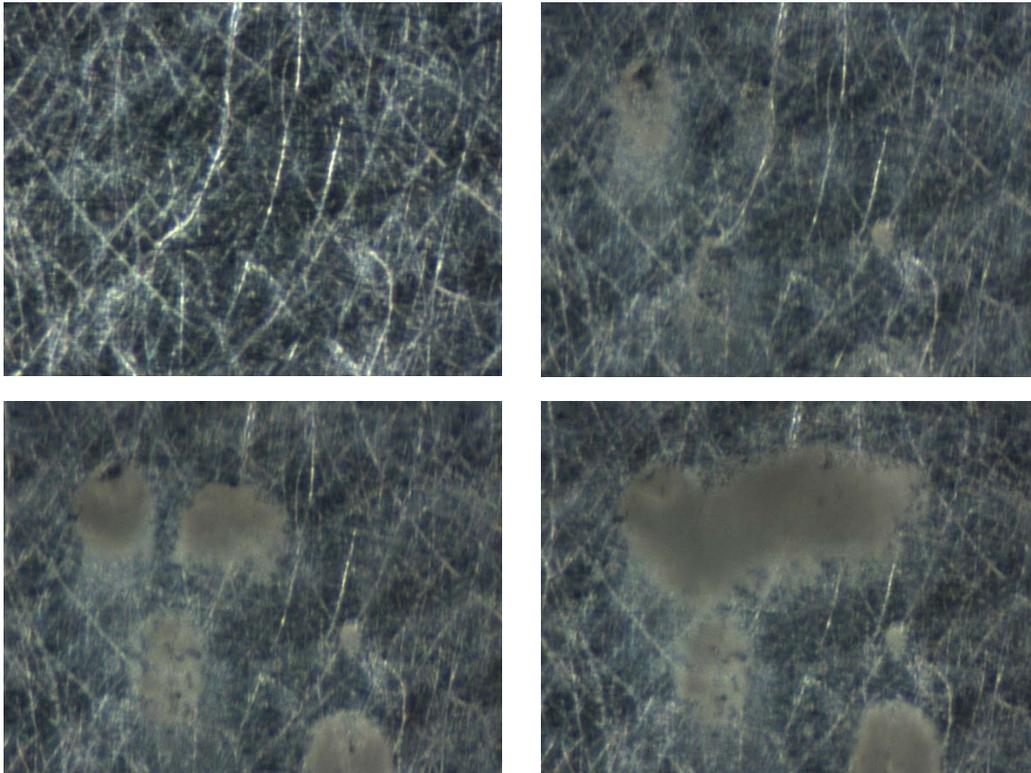
Figure 3: High magnification images (0.04" field of view) of corrosion product accumulation in Al 2024 sample in flowing water at 1, 2, 3 and 4 days exposure.

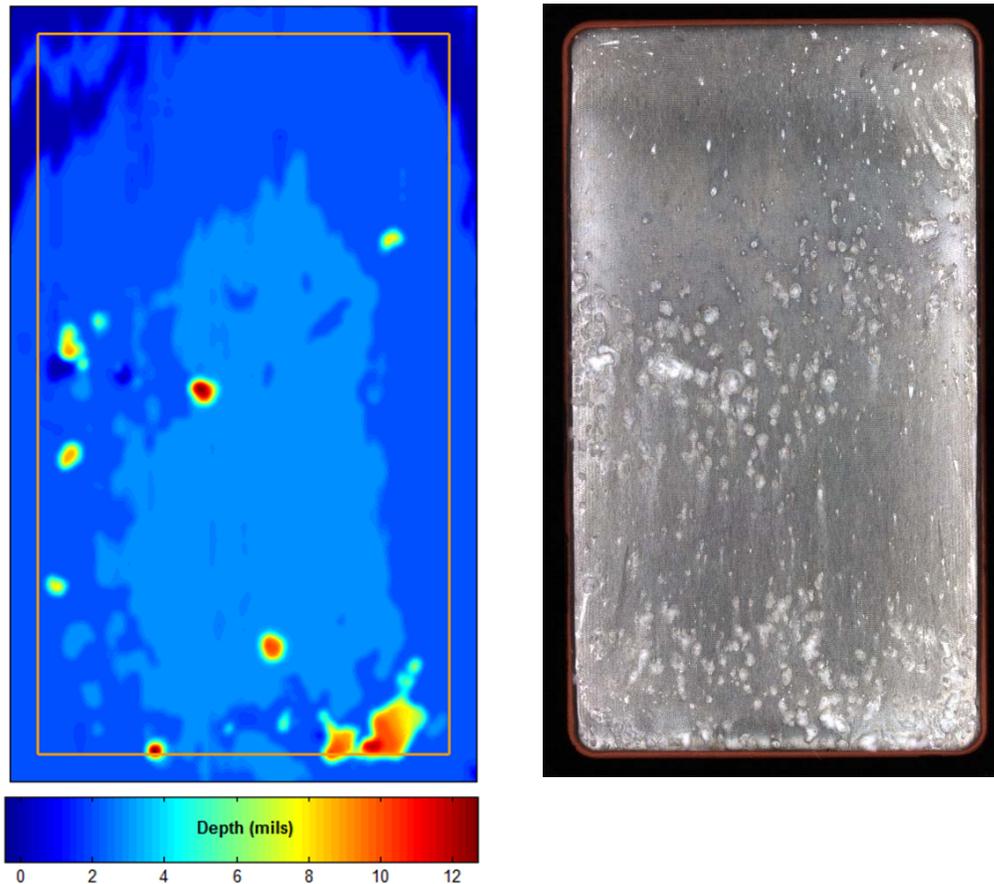
So far water flow velocity is not making a noticeable difference in the Al 2024 samples' development. We are able to detect multiple pits with the ultrasonic scanner on the Al 2024 samples with depths up to 0.013 inches (Figure 4). Most, but not all, of the pits correlate to regions of visible corrosion product build up on the sample's surface.

Figure 4: Ultrasonic measurements of sample thickness change (pit depth) and the surface image of the Al 2024 sample in stagnant seawater after 15 days exposure.

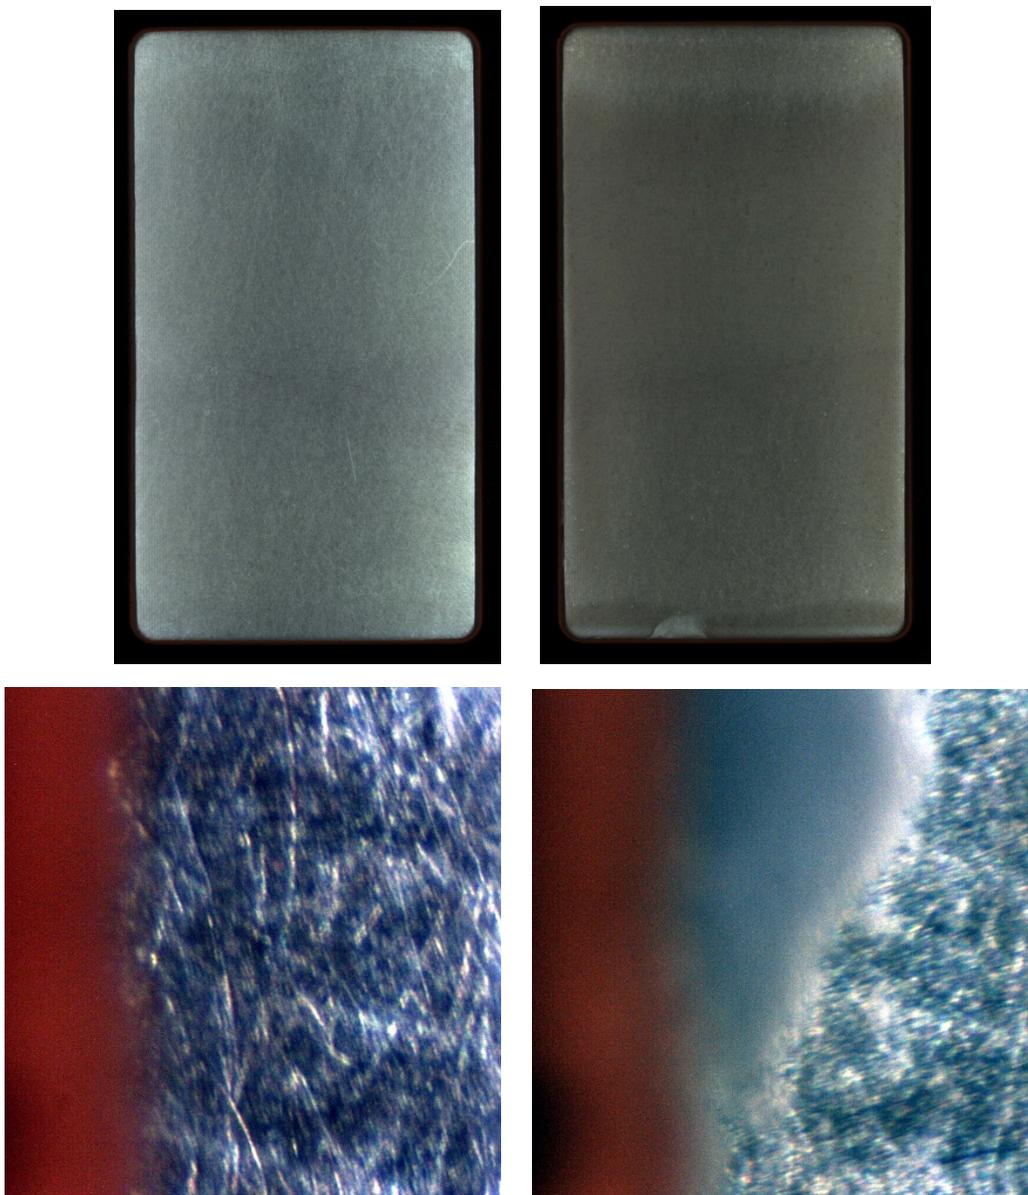
The Al 5052 samples are developing differently in the two flow regimes, with crevice corrosion developing on the near stagnant sample (Figure 5) and none yet appearing on the sample in flowing water. In our previous corrosion experiments we noticed that Al 5000 series is more susceptible to crevice corrosion than Al 6000 series. Ultrasonic scanning has yet to detect any pits forming under the corrosion product. Open circuit potential (OCP) measurements show that the stagnant sample has changed from about -950mV to -750mV, while the non-corroding sample has remained constant at about -950 mV. We have observed this change in OCP correlating to pit appearance in our previous studies.

Figure 5: Crevice corrosion development on Al 5082 sample in near stagnant cold seawater. Top – sample at 1 day and 15 days, bottom -- high magnification images of gasket edge at 1 and 8 days exposure. At eight days tool marks on the surface of the sample have diminished.

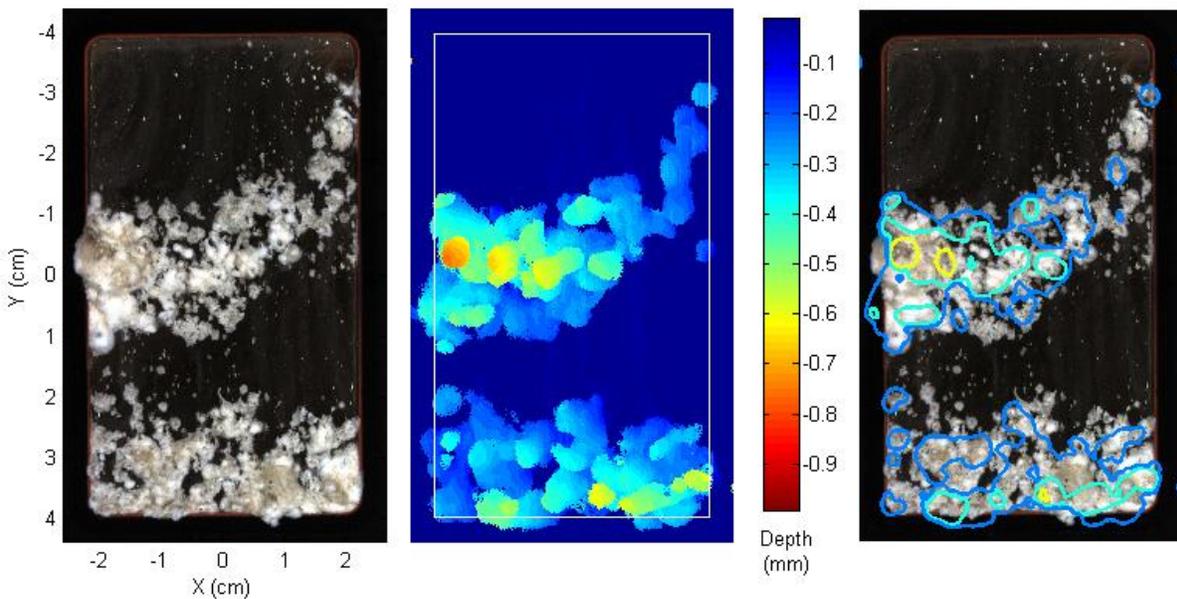
The accumulation of corrosion product on the Al 2024 and AL 6061 samples continues, though at a slower rate than it initially progressed. Corrosion appears worse at the gaskets in the Al 2024 samples, while on the Al 6061 samples it appears as discreet sites distributed across the surface. The near stagnant Al 5086 sample has developed corrosion product at one of the gasket edges, while in flowing water no corrosion has been detected. Figures 1 – 6 show the latest imaging and ultrasonically measured depths for the 6 samples being tested. There is good correlation between areas covered in corrosion product and the corrosion location detected ultrasonically. The ultrasonic scanner's beam width (~4 mm) makes the pits appear wider in the scans relative to the images, but the corrosion depths measured are accurate to 0.03 mm.

Figure 1: Al 2024 sample in near-stagnant deep seawater at 4.5 months. Left - imaging, center – ultrasonically determined depths, right – overlay of the two images.

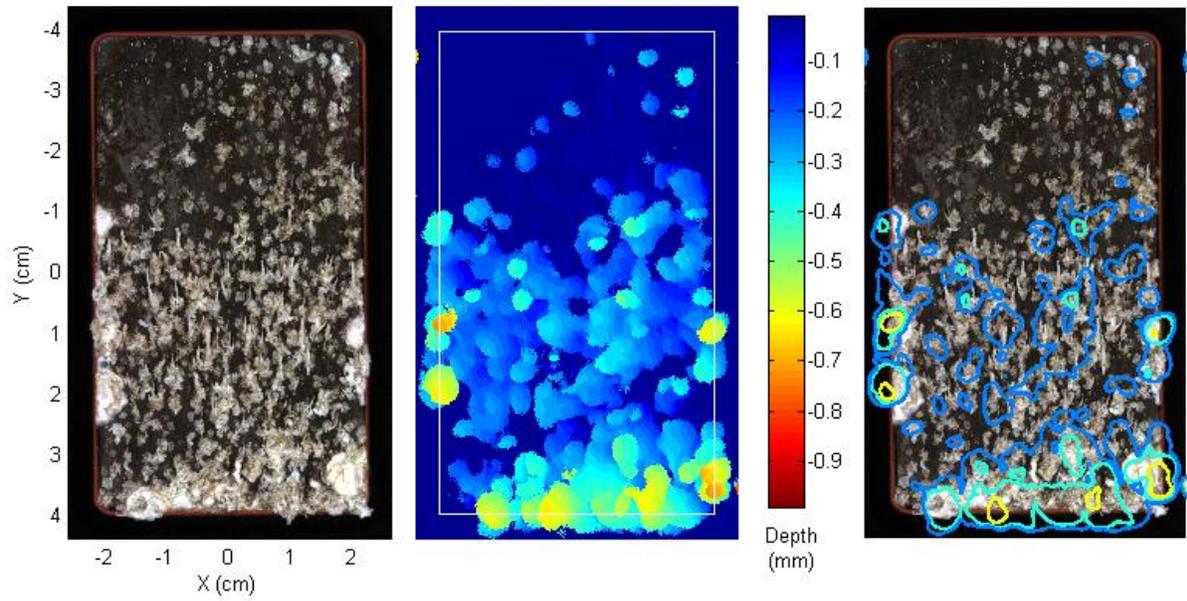
Figure 2: AI 2024 sample in 1 m/s flowing deep seawater at 4.5 months. Left - imaging, center – ultrasonically determined depths, right – overlay of the two images.

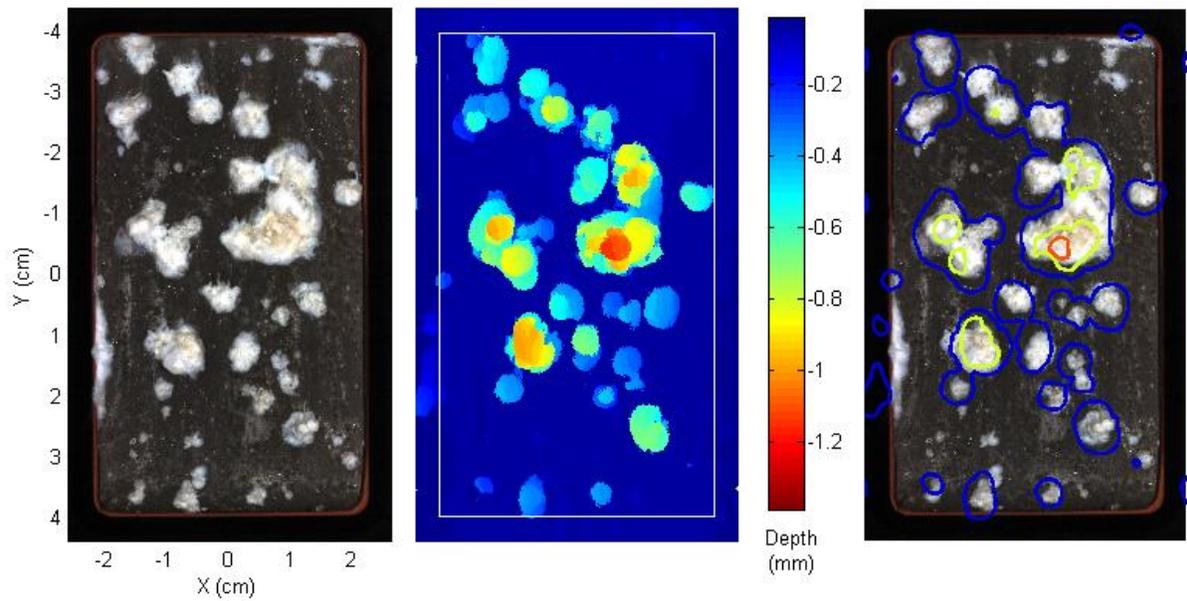
Figure 3: AI 6061 sample in near-stagnant deep seawater at 4.5 months. Left - imaging, center – ultrasonically determined depths, right – overlay of the two images.

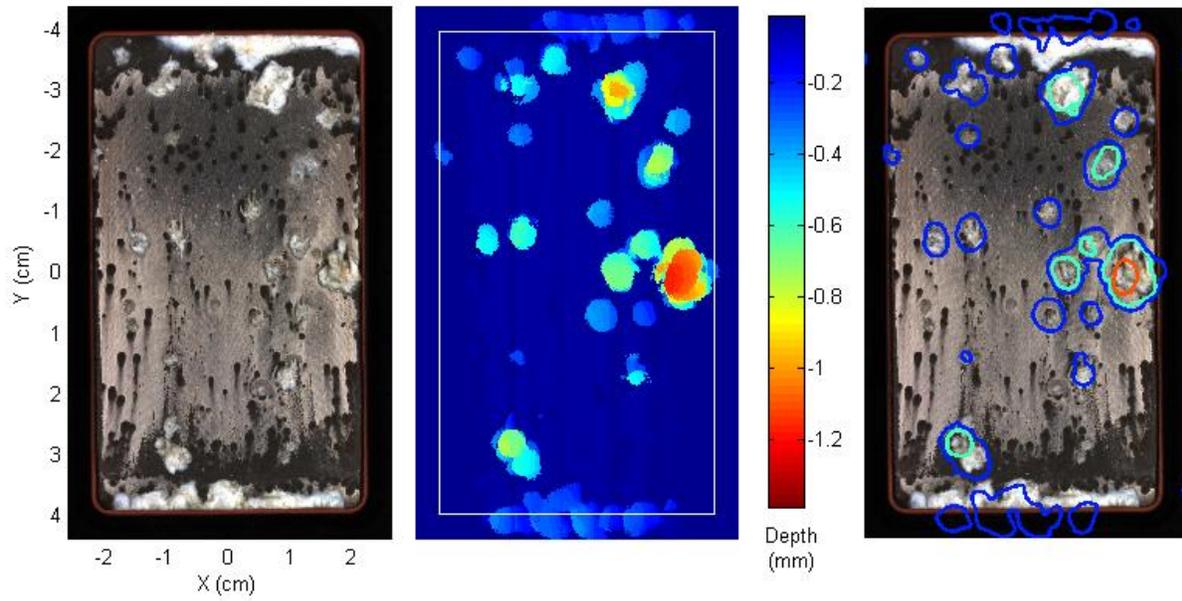
Figure 4: Al 6061 sample in 1 m/s flowing deep seawater at 4.5 months. Left - imaging, center – ultrasonically determined depths, right – overlay of the two images.

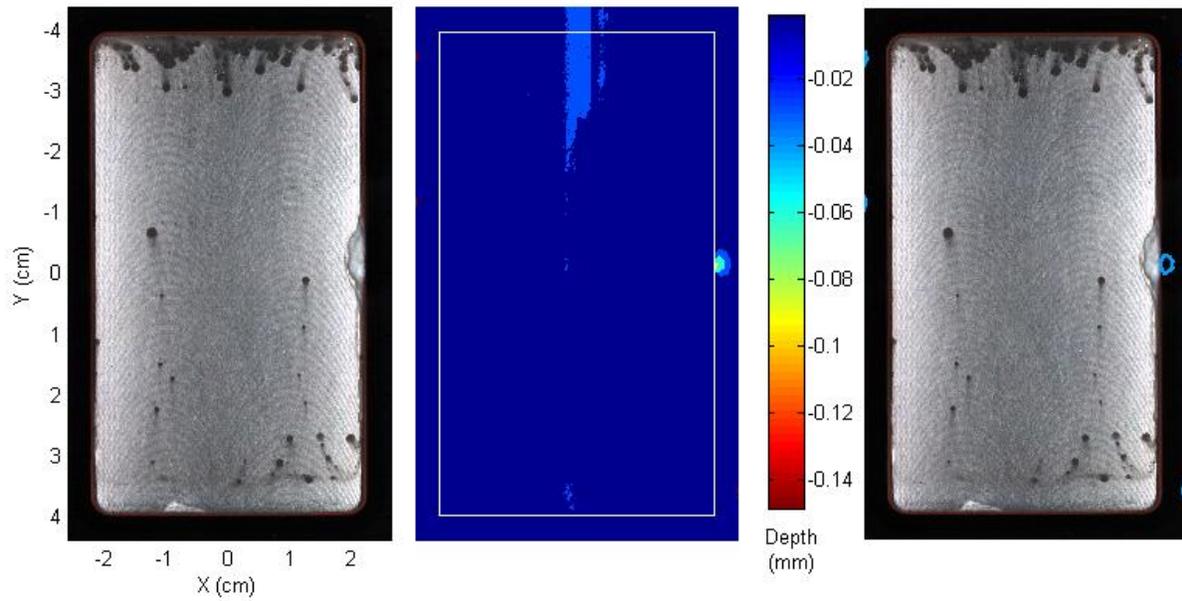
Figure 5: Al 5086 sample in near-stagnant deep seawater at 4.5 months. Left - imaging, center – ultrasonically determined depths, right – overlay of the two images.

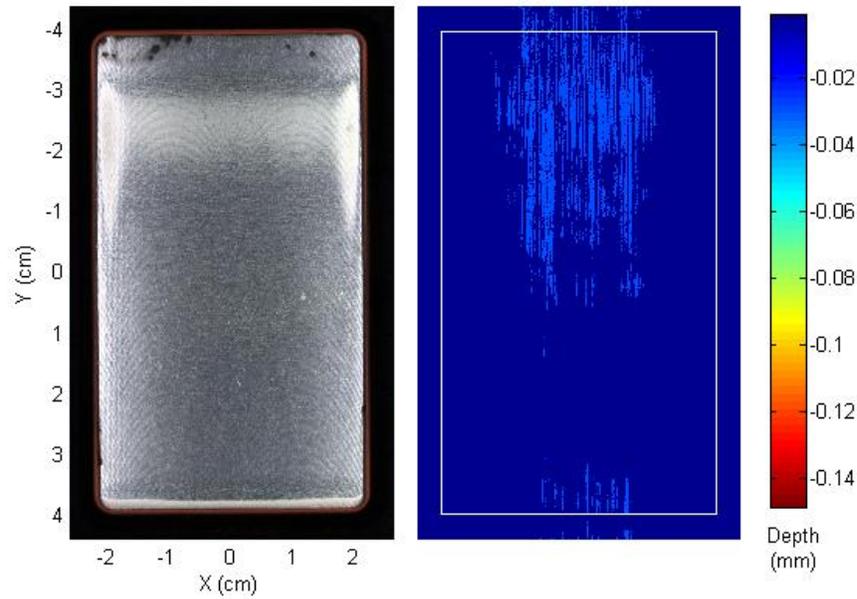
Figure 6: Al 5086 sample in 1 m/s flowing deep seawater at 4.5 months. Left - imaging, center – ultrasonically determined depths, right – overlay of the two images (not shown).

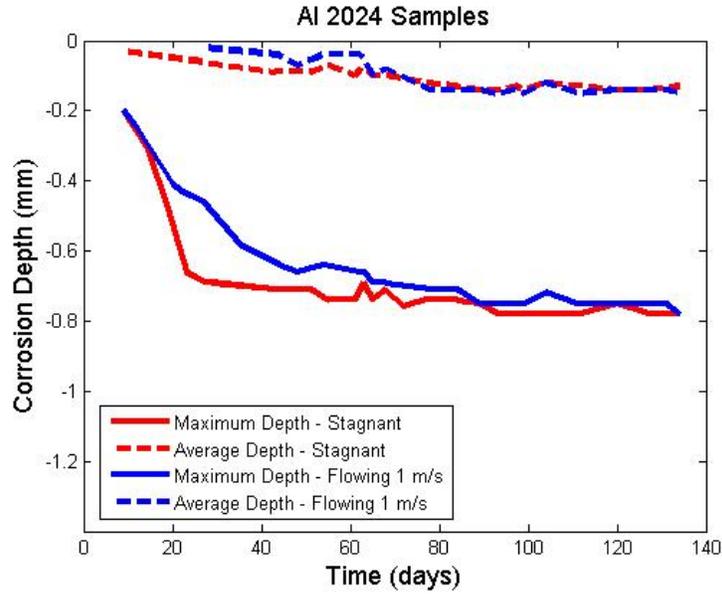
After a few weeks of rapid growth, the maximum corrosion depths in the Al 2024 samples have leveled off at ~0.8 mm. While the maximum corrosion depth is not increasing, the overall amount of corroded volume (indicated by measuring the average depth over the entire surface) is increasing nearly linearly (Figure 7). The Al 6061 samples' corrosion depths and volume are still increasing linearly and currently have maximum depths of 1.2 mm (Figure 8). We have recently detected a small amount of under-gasket corrosion in the near-stagnant Al 5086 sample which is currently 0.1 mm deep.

Figure 7: Maximum and surface-averaged corrosion depths measured ultrasonically in the Al 2024 samples.

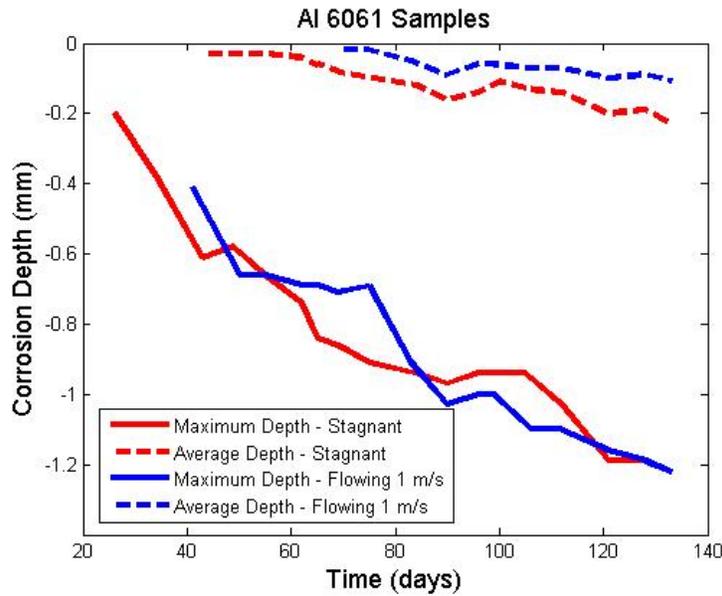
Figure 8: Maximum and surface-averaged corrosion depths measured ultrasonically in the Al 6061 samples.

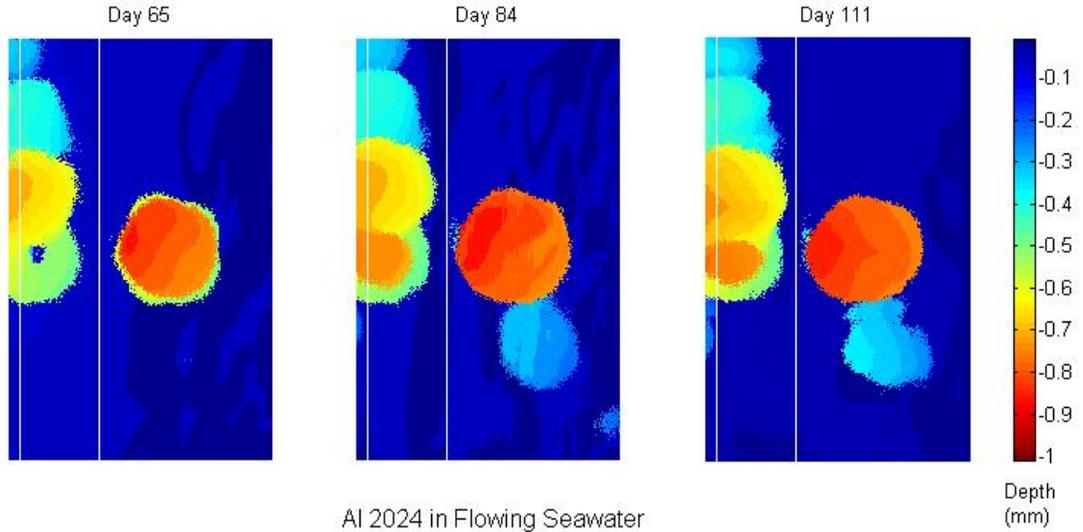
The ultrasonic scanner is detecting corrosion penetration underneath the samples' gaskets. Figure 9 shows an extreme example of this penetration in the Al 2024 near-stagnant sample. The white lines indicate the location of the gasket edges, with seawater flow on the left

and air on the right of the gasket. The prominent red pit seen in all frames is a pre-drilled reference hole that is used to align the images and ultrasonic scans. After day 65 another pit started growing near this hole. This may be corrosion that has penetrated all the way underneath the gasket. However no leaks have been observed in the sample. Table 1 shows the extent of under-gasket corrosion penetration for the samples.

Figure 9: Corrosion appearing outside the gasket in the Al 2024 sample in flowing seawater. White lines are the edges of the gasket, water flows on its left and air to its right. The prominent red pit outside the gasket at day 65 is a predrilled reference hole. After day 65 another pit has been growing.

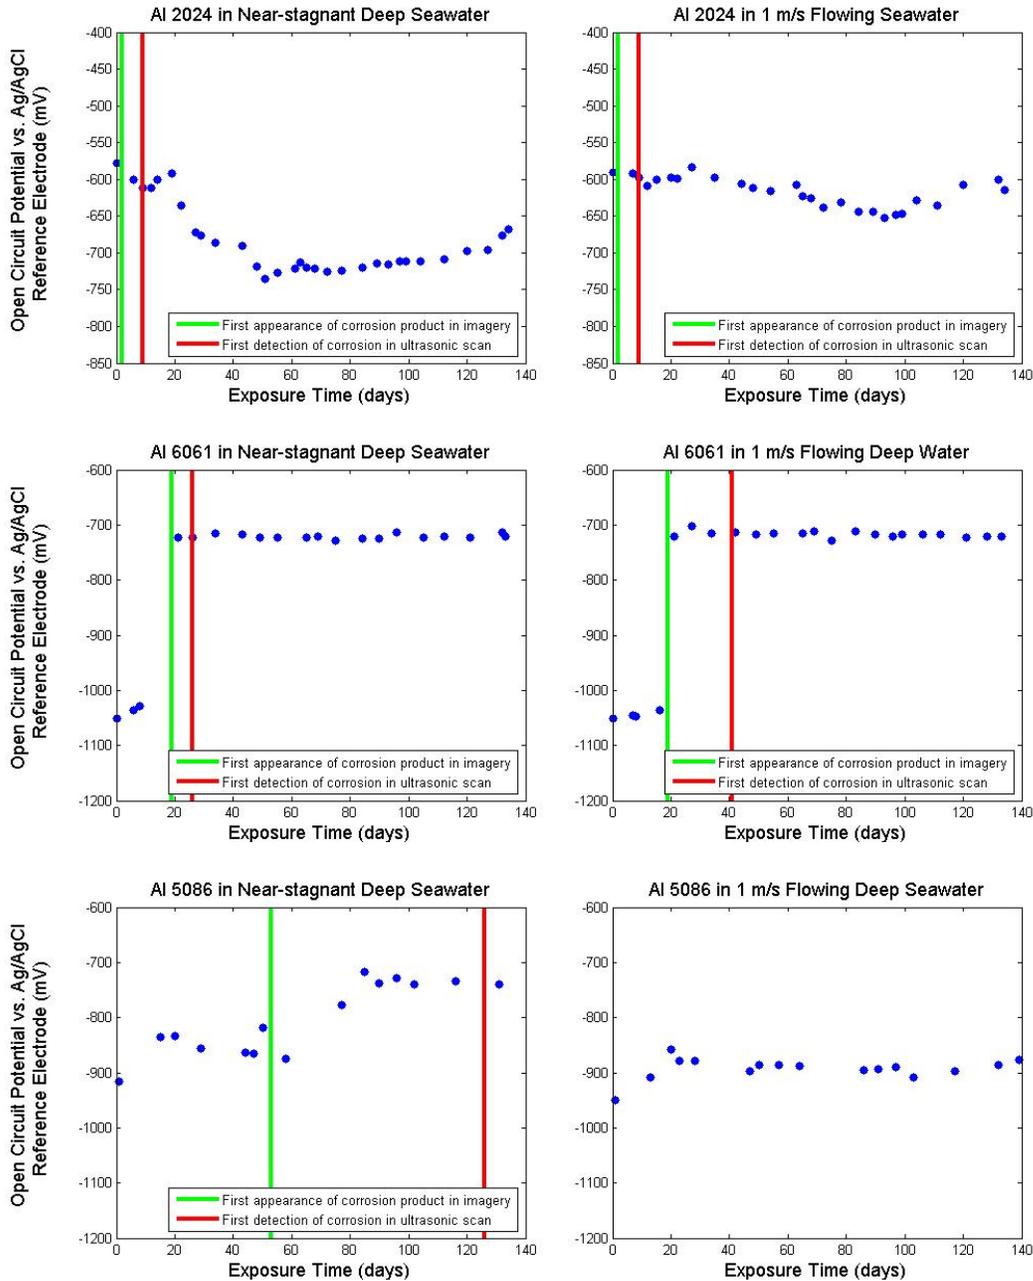
The most recent open-circuit potential (OCP) of the samples against an Ag/AgCl reference electrode are shown in Figure 10. As noted before, the Al 6061 samples show a dramatic change in OCP when corrosion product is first observed, rising abruptly from approximately -1050 mV to approximately -700 mV. The Al 2024 samples show no such dramatic change to their OCP upon the appearance of corrosion, but are continuing to change over time. The OCP of the two Al 5086 samples are currently different by about 150 mV. It is still too early to confirm, but this may be due to the fact that one sample shows corrosion and the other does not.

Figure 10: Open-circuit potential measurements against an Ag/AgCl reference electrode.
