4.5 Energy Test Platforms: Crissy Field Center Wind Power Study: Wind Turbine Commissioning and Interconnection

**Prepared by:
Golden Gate National Parks Conservancy**

Wind Turbine Commissioning and Interconnection

Crissy Field Center Wind Power Study

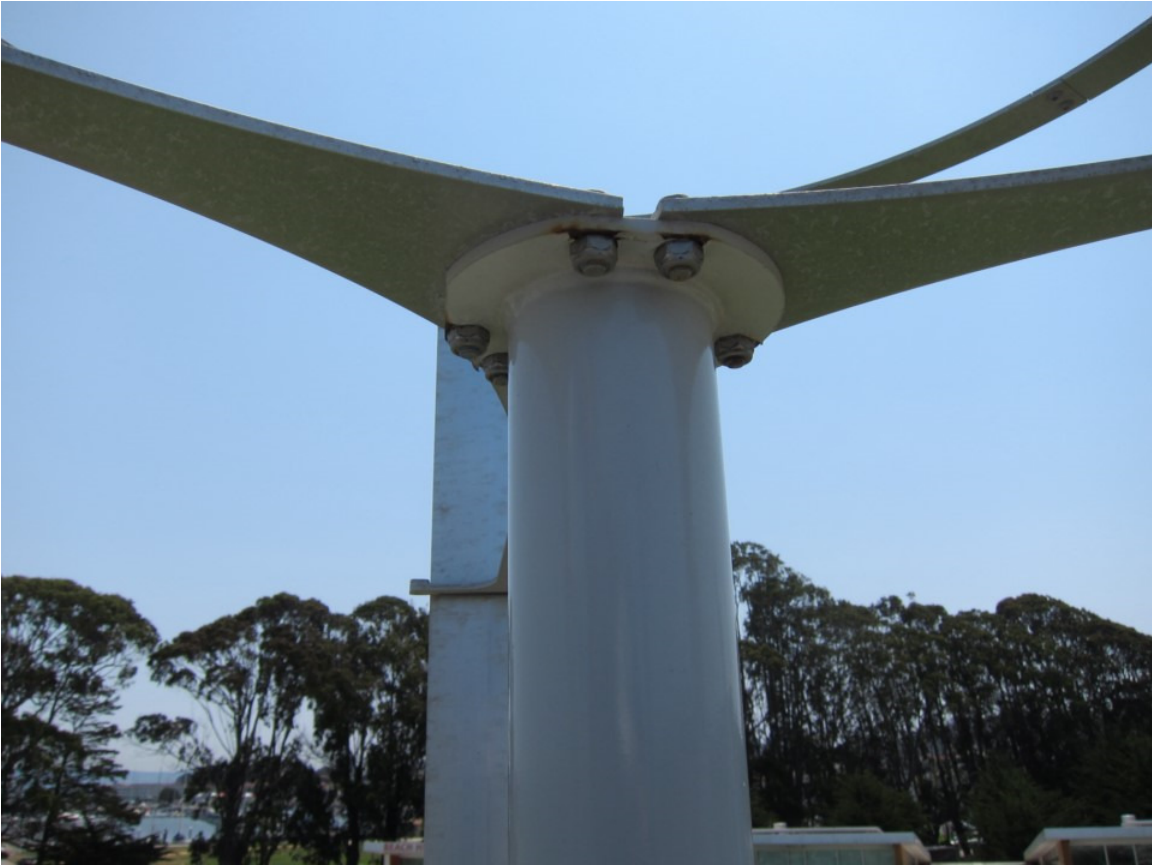
Figure 1. Northern Windspire. Rust is occurring at bolted flange connections on the rotor. Cold galvanizing compound was applied.

Recommendations: The rust is likely to become worse over time. The CFC may opt to sand and paint the rusty areas if desired. Future maintenance should be scheduled to continually apply cold galvanizing compound or replace rusty fasteners.

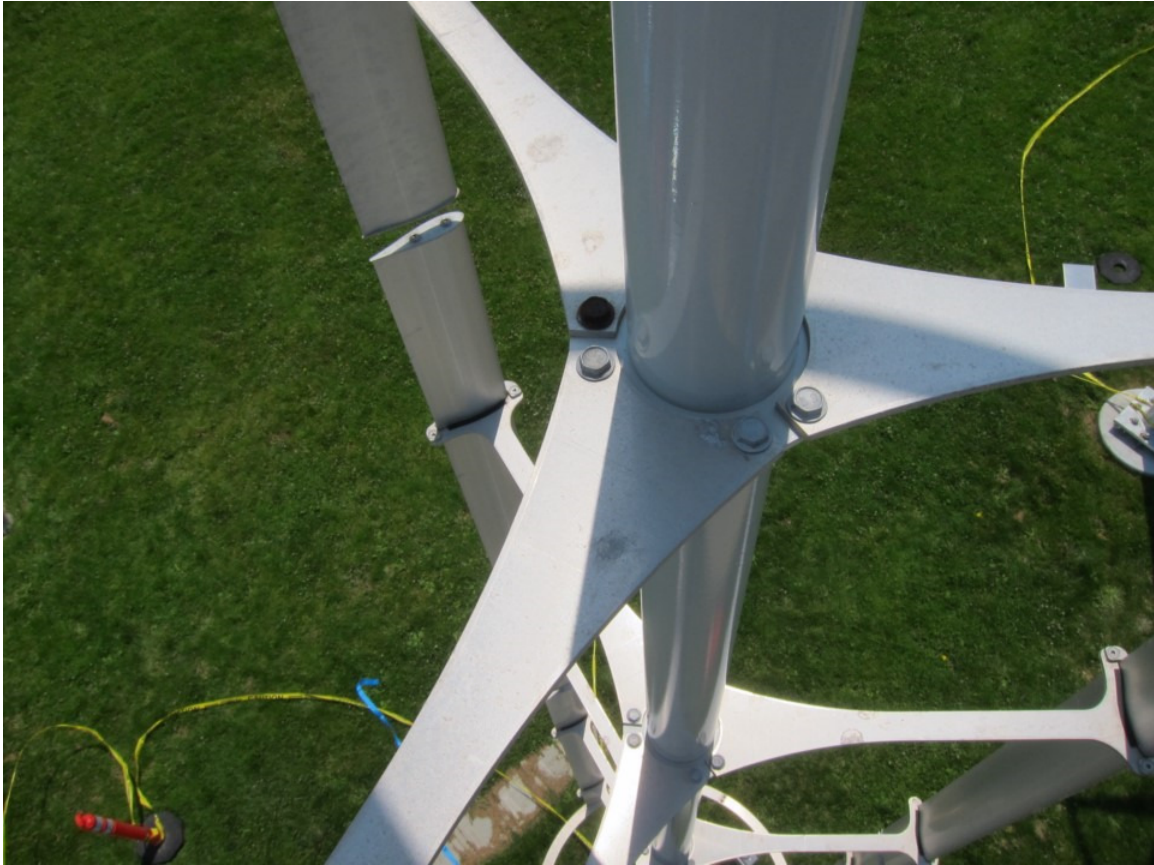
Figure 2. Northern Windspire. Some galvanized bolts were starting to rust on rotor flange connections. Cold galvanizing compound was applied.

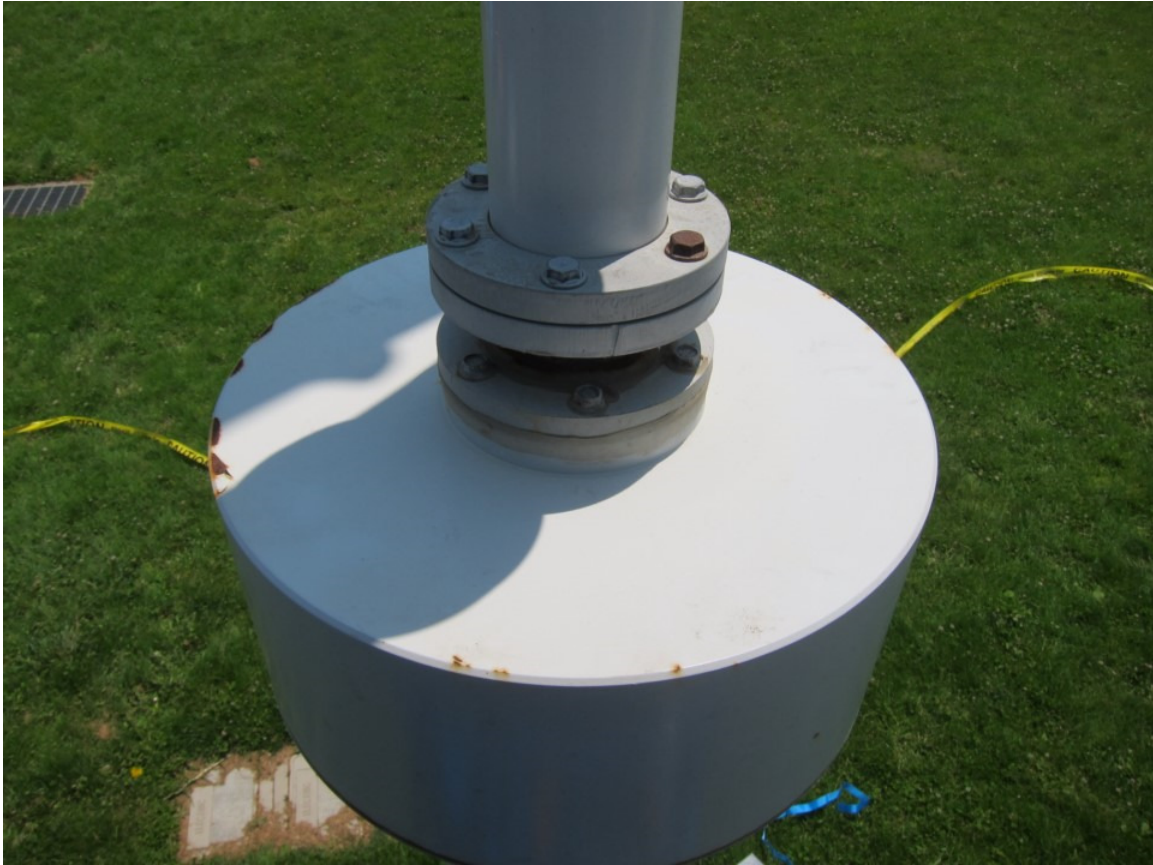
Figure 3. Northern Windspire. Rust present on inverter housing. Some cold galvanizing compound was applied but the rust will likely become worse.

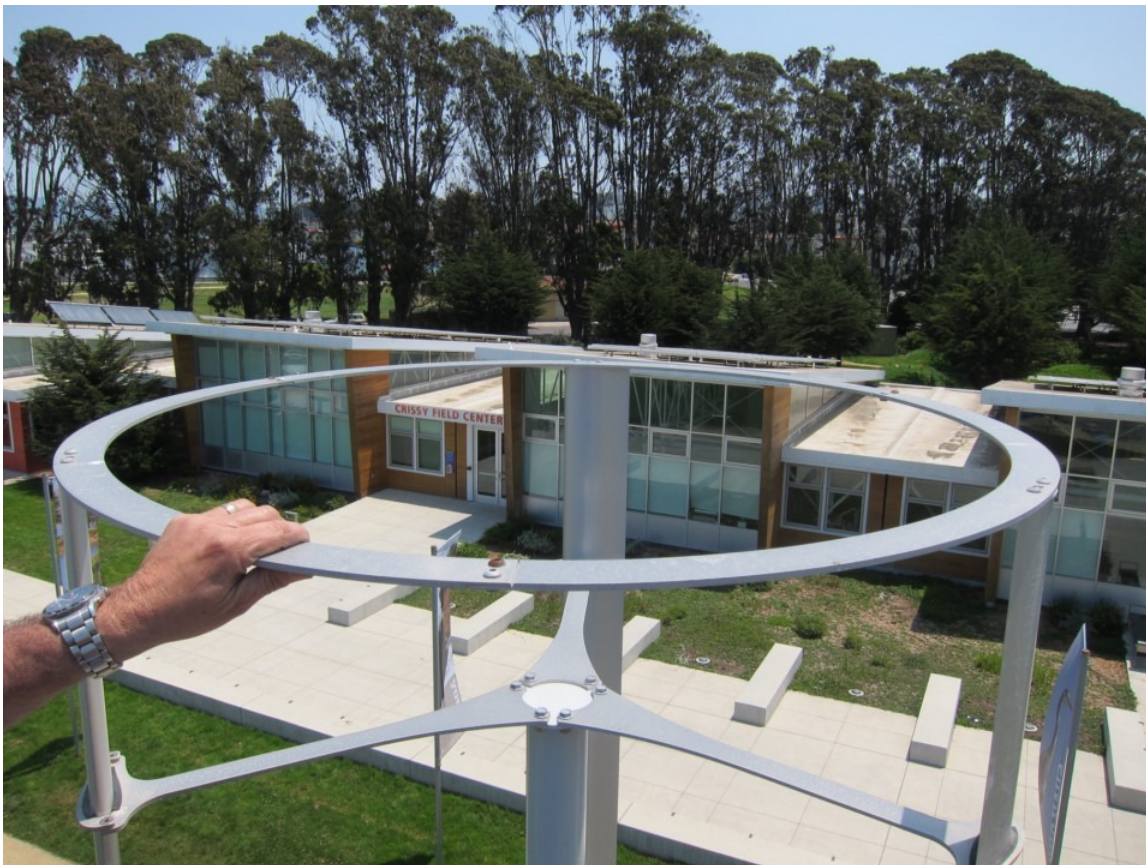
Figure 4. Southern Windspire. Rotor disc hardware rust. Cold galvanizing compound applied.

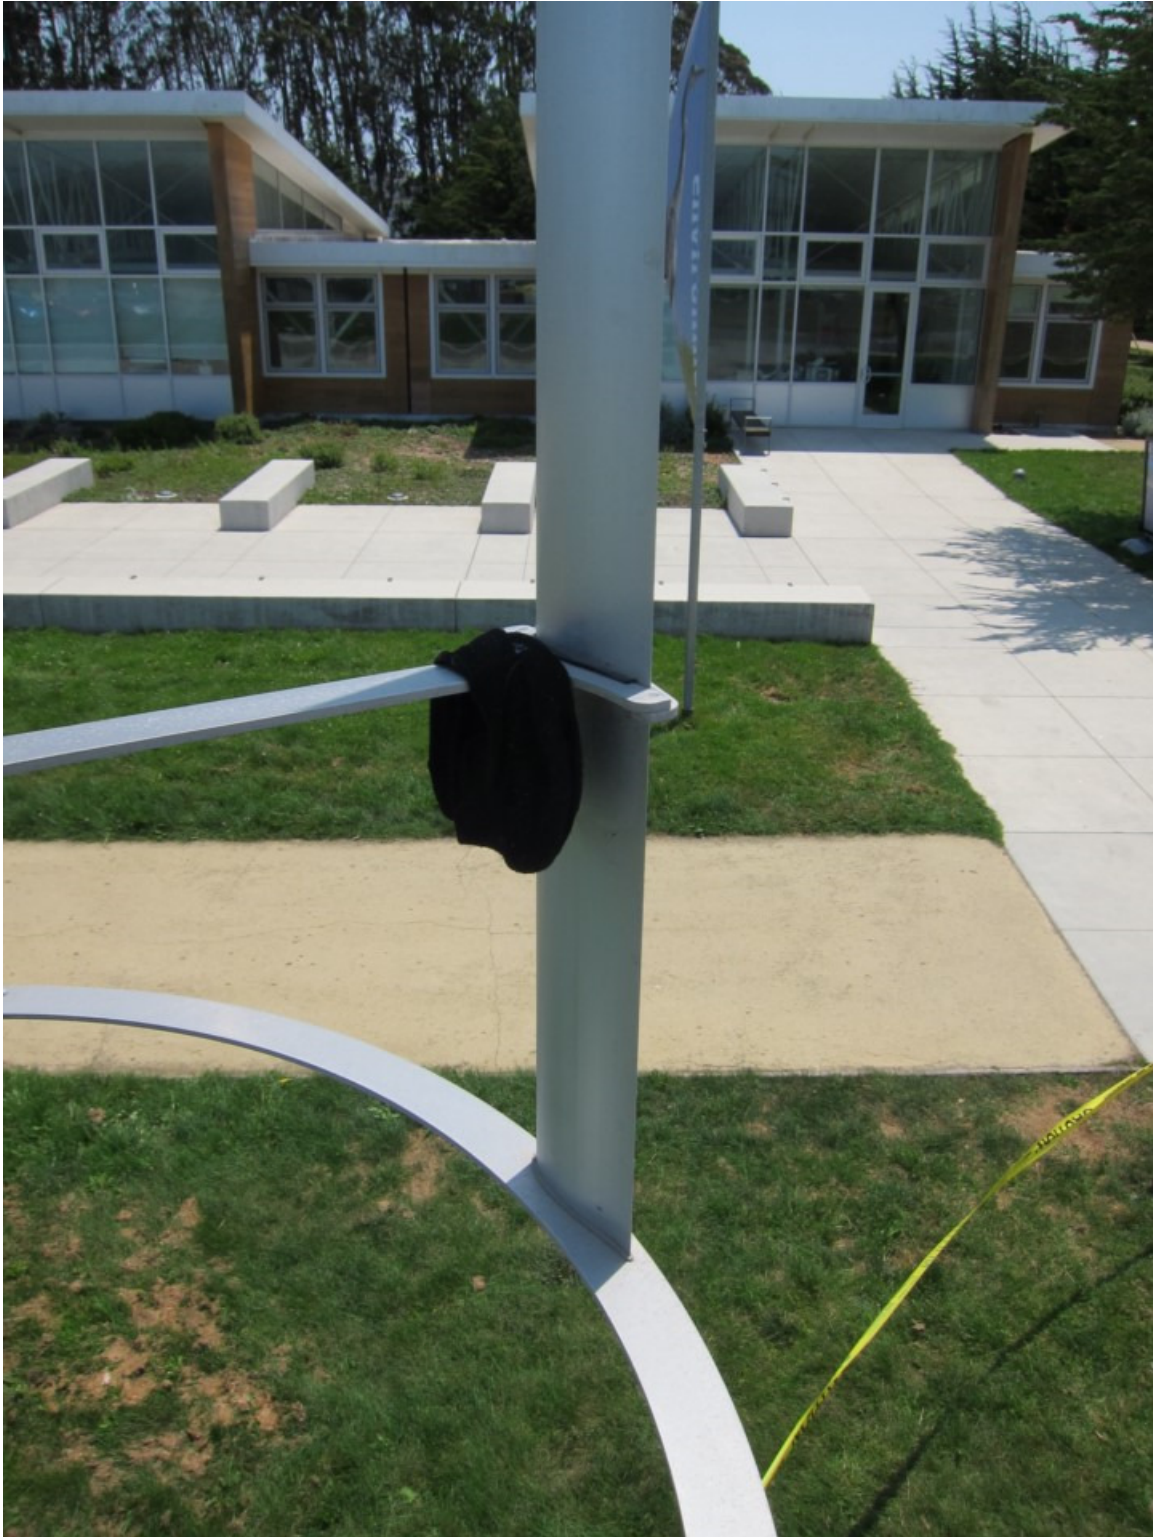
Figure 5. Southern Windspire. Sock found and removed.

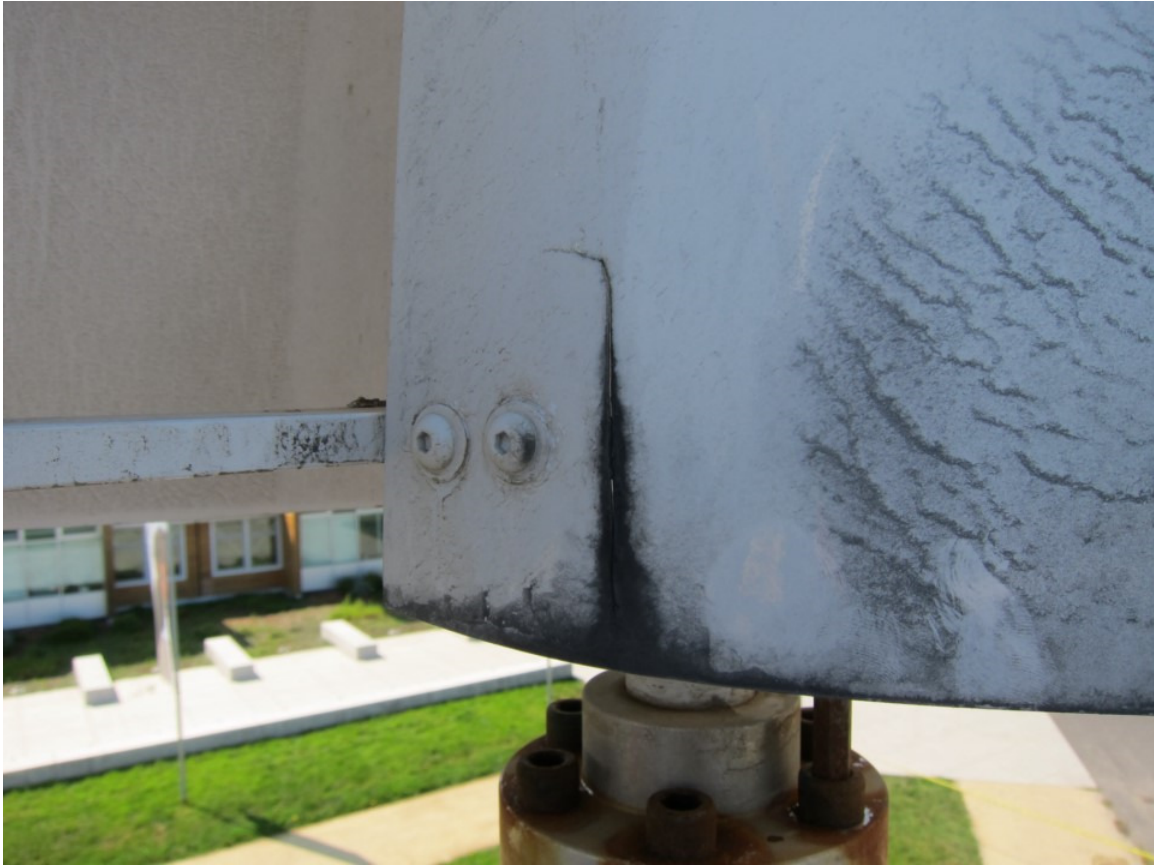
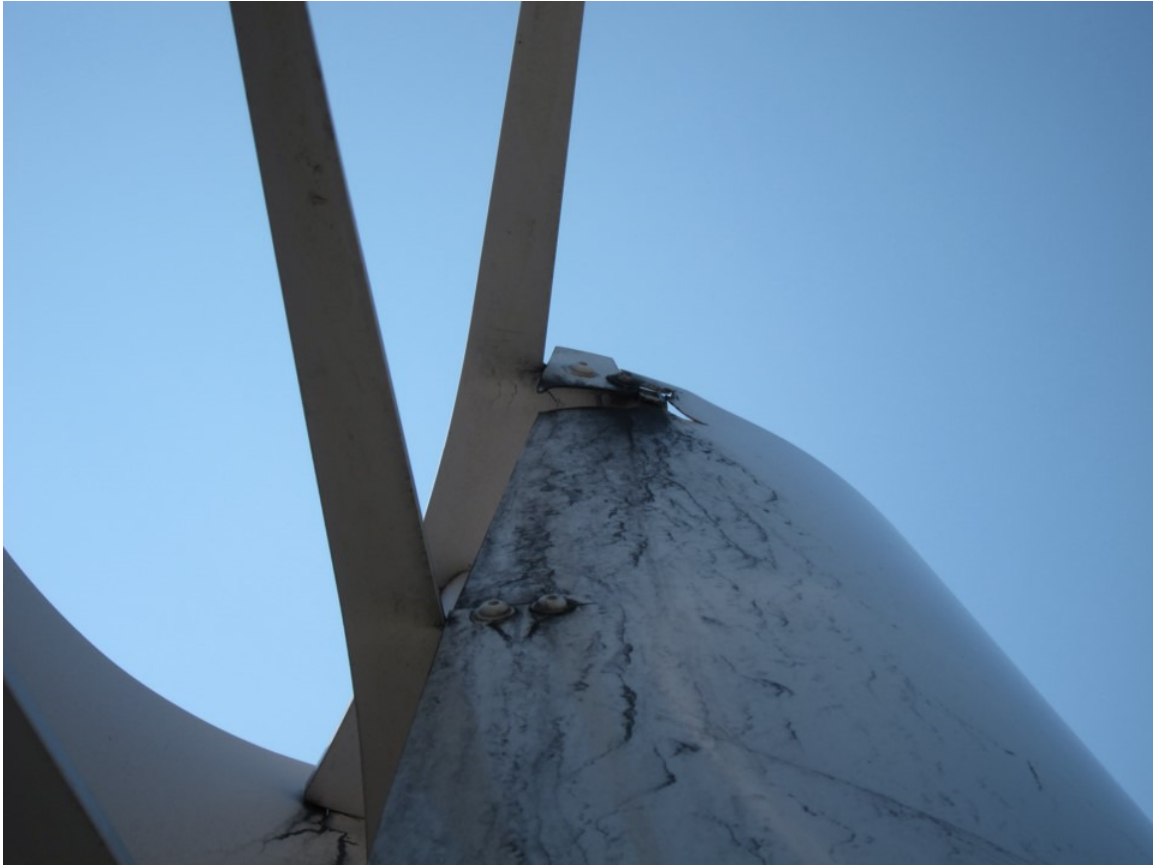
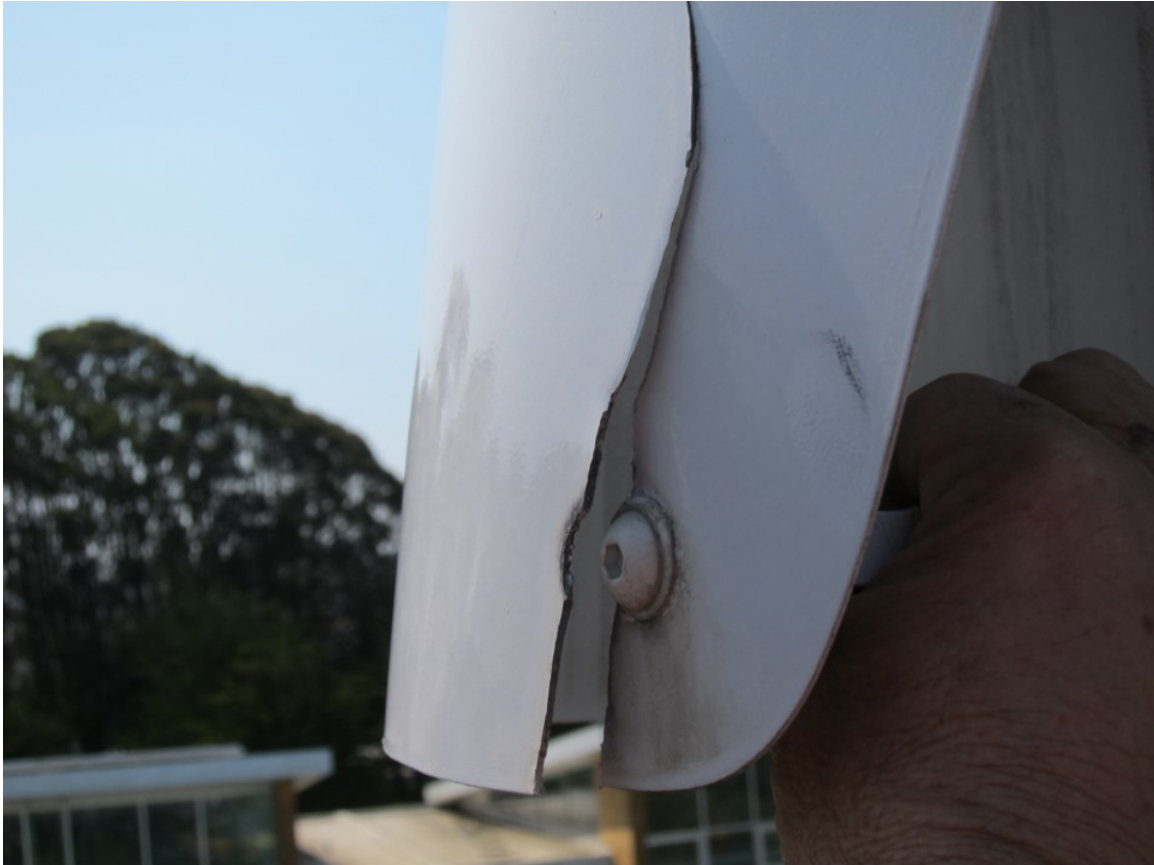
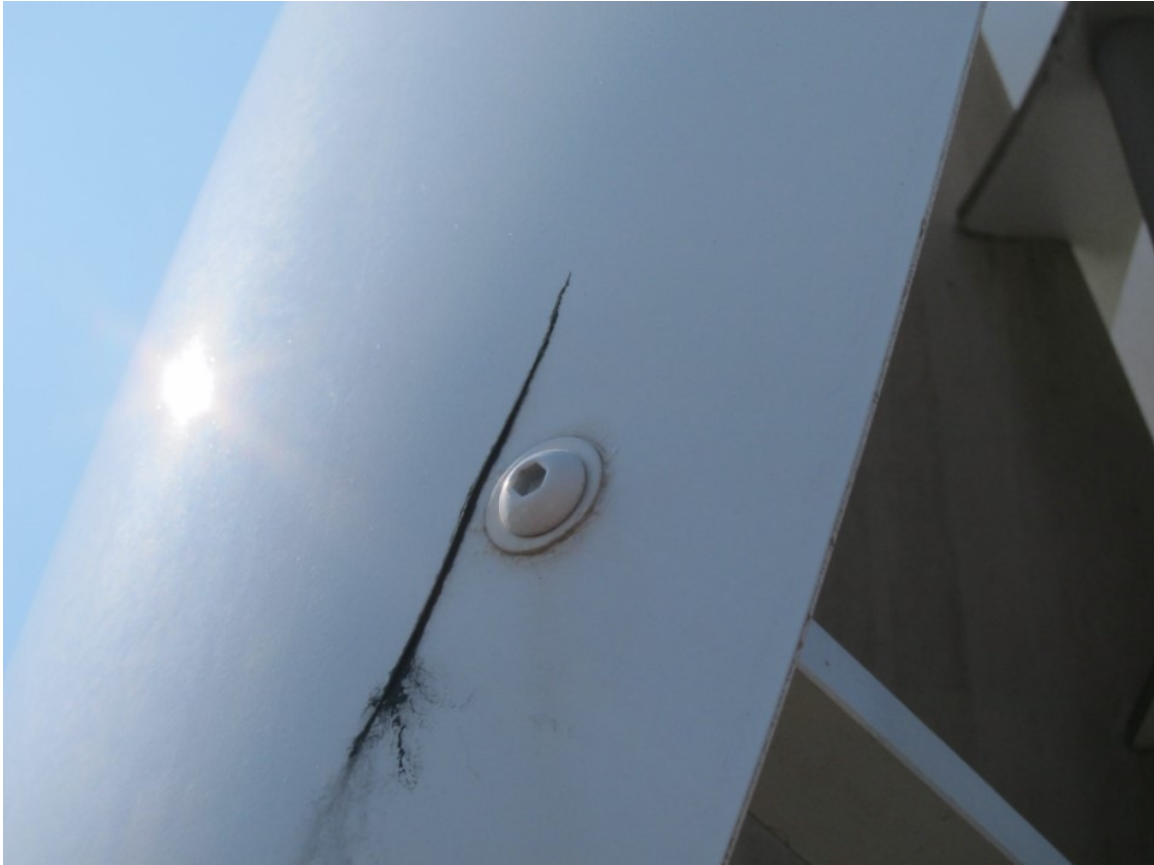
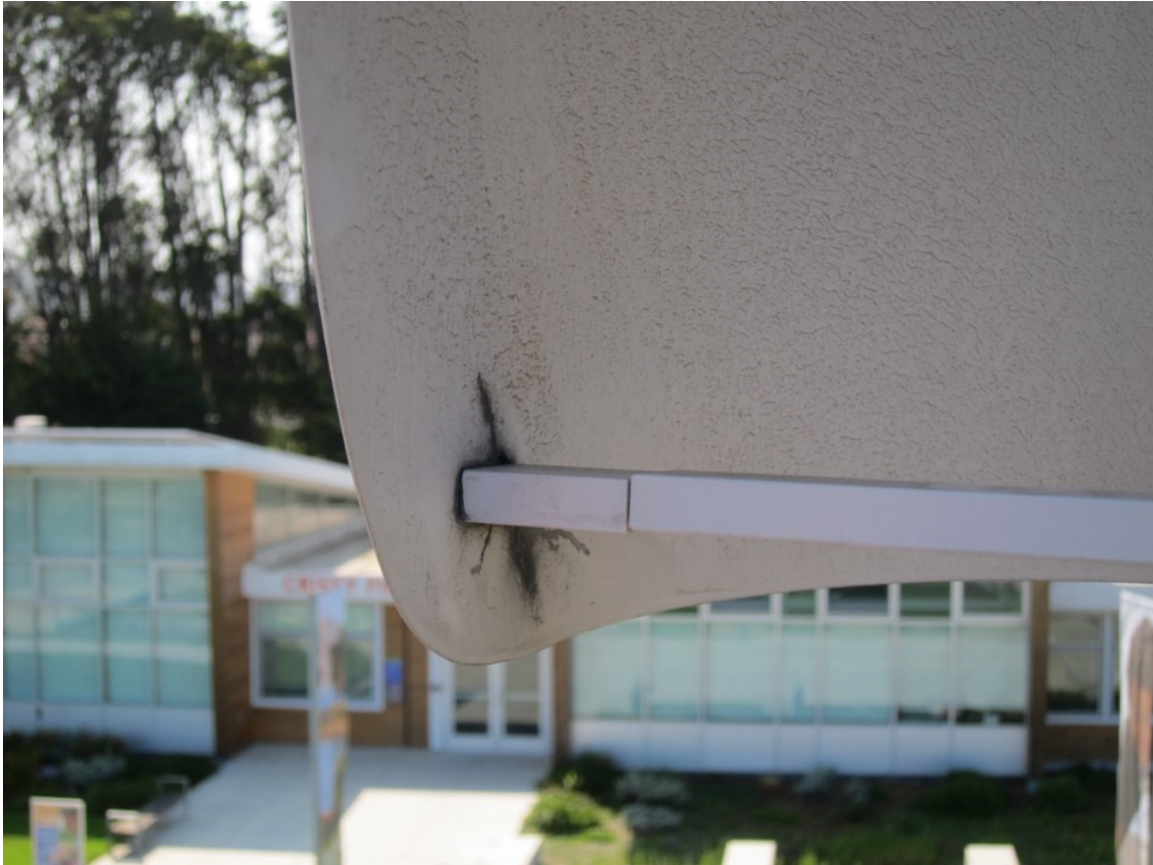
The aluminum blades are severely cracked at the strut locations. Two blade areas have completely severed from the struts. Refer to Figures 6 – 10.

The reason for the failure is unknown but is likely due to inherent design flaws.

Figure 6. Tangarie. Lower blade crack.

Figure 7. Tangarie. Upper portion of blade cracked and severed from strut.

Figure 8. Tangarie. Lower blade crack.

Figure 9. Tangarie. Blade crack.

Figure 10. Tangarie. Blade crack.

This unit needs to be completely be replaced. Luminalt does not recommend replacing it with another of the same design unless the manufacturer can prove that the design flaws have been repaired. The cracking in the blades could result in catastrophic failure where the blades come off possibly causing injury or death.

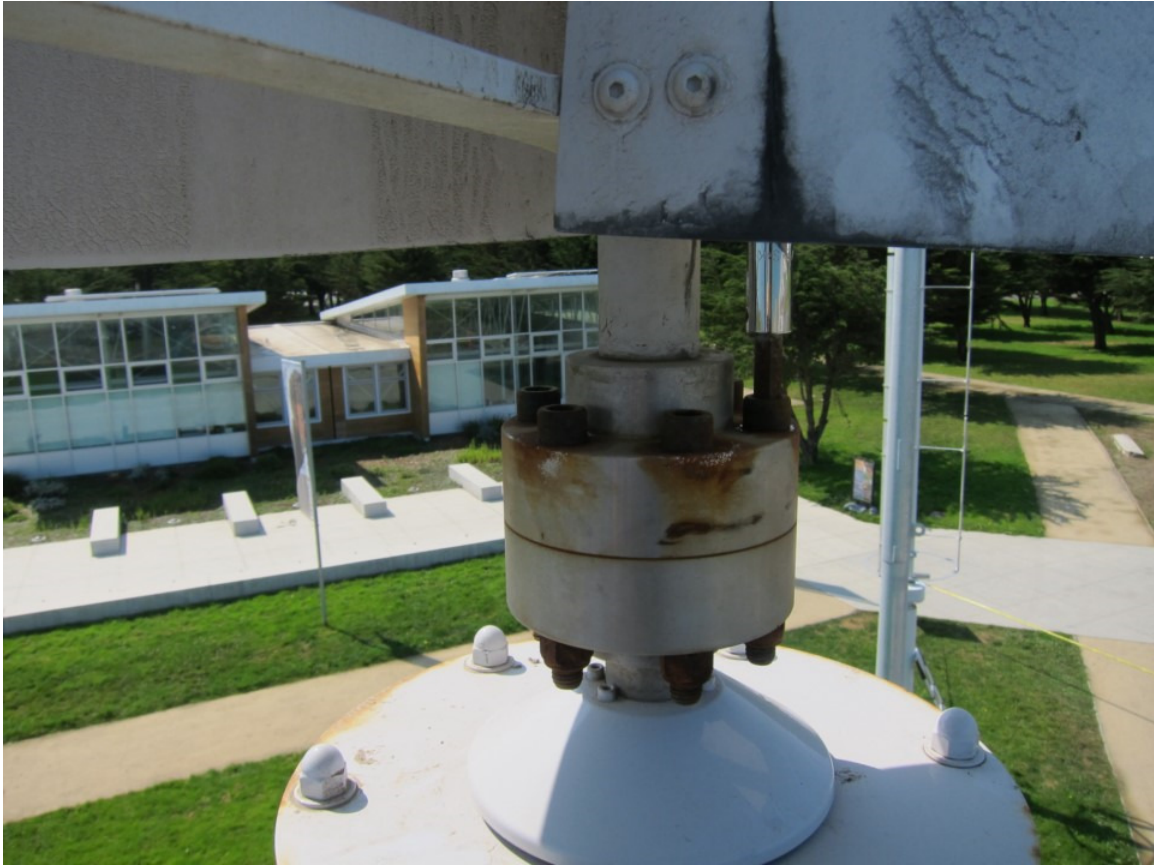
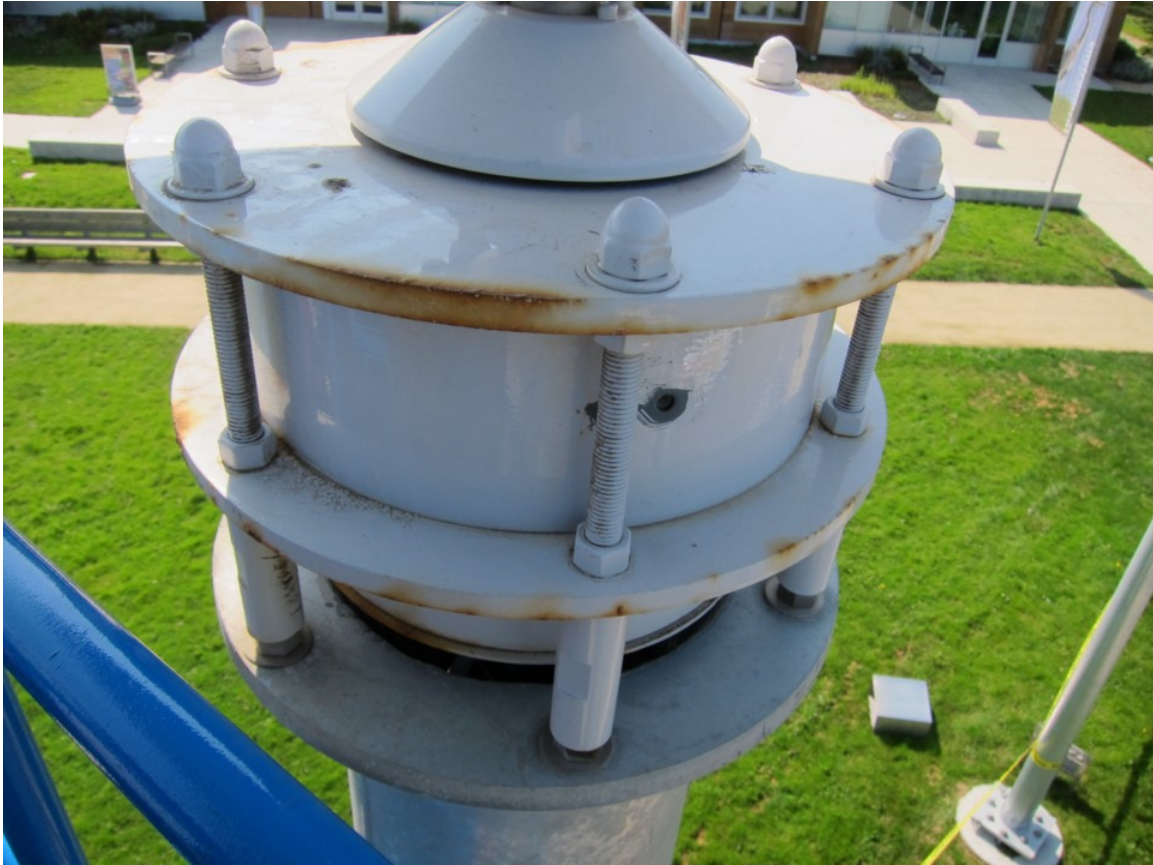
Rust is present on several areas of the generator housing. Refer to Figures 11 – 12.

Figure 11. Tangarie. Shaft bolt rust.

Figure 12. Generator housing rust.

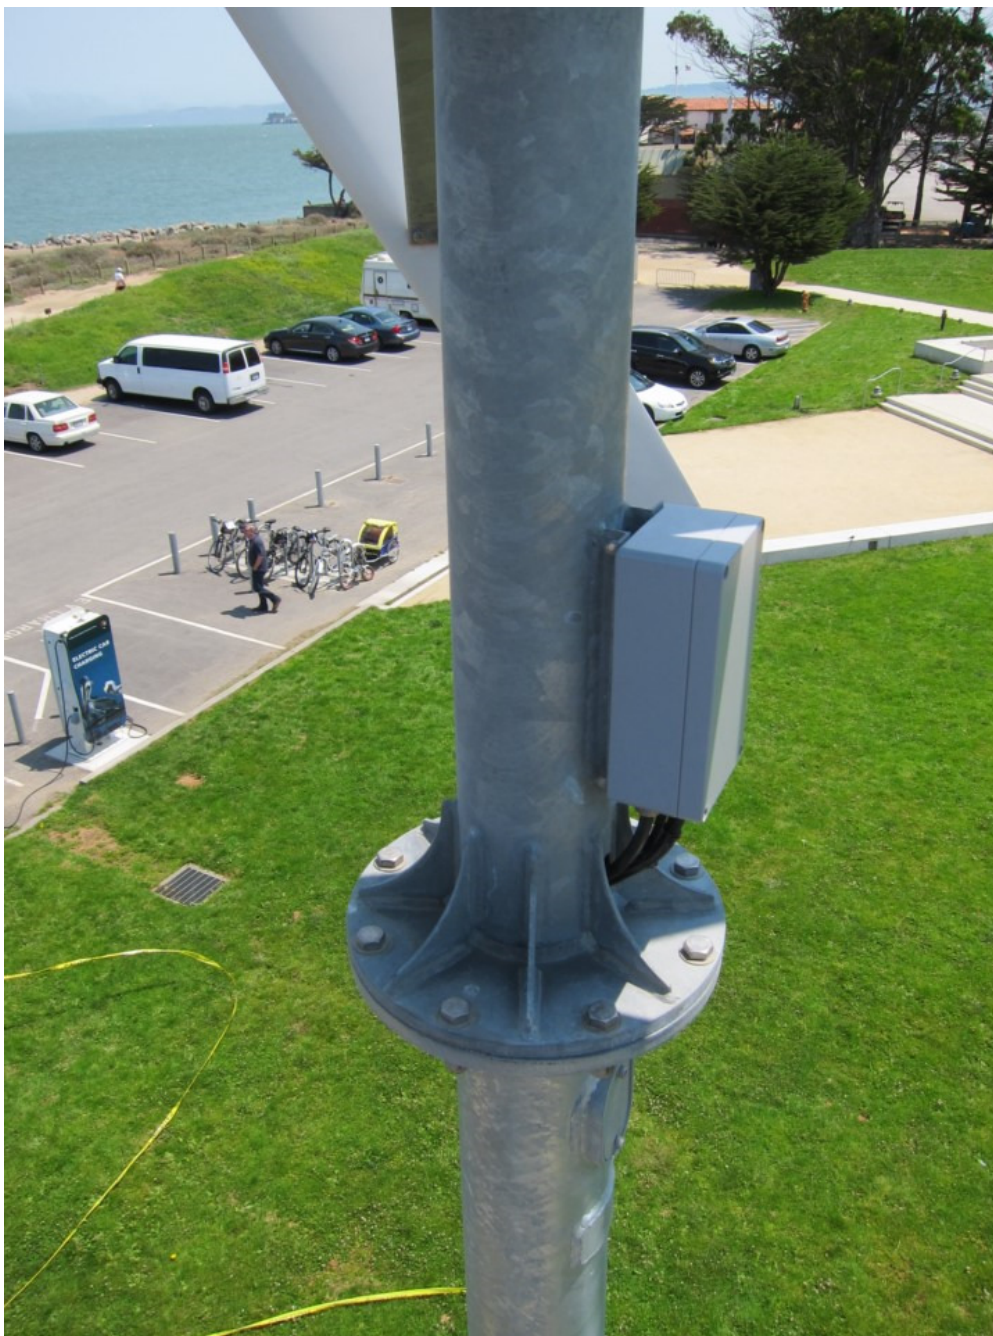
Figure 13. Northern Venco. Tower flange connection in good condition.

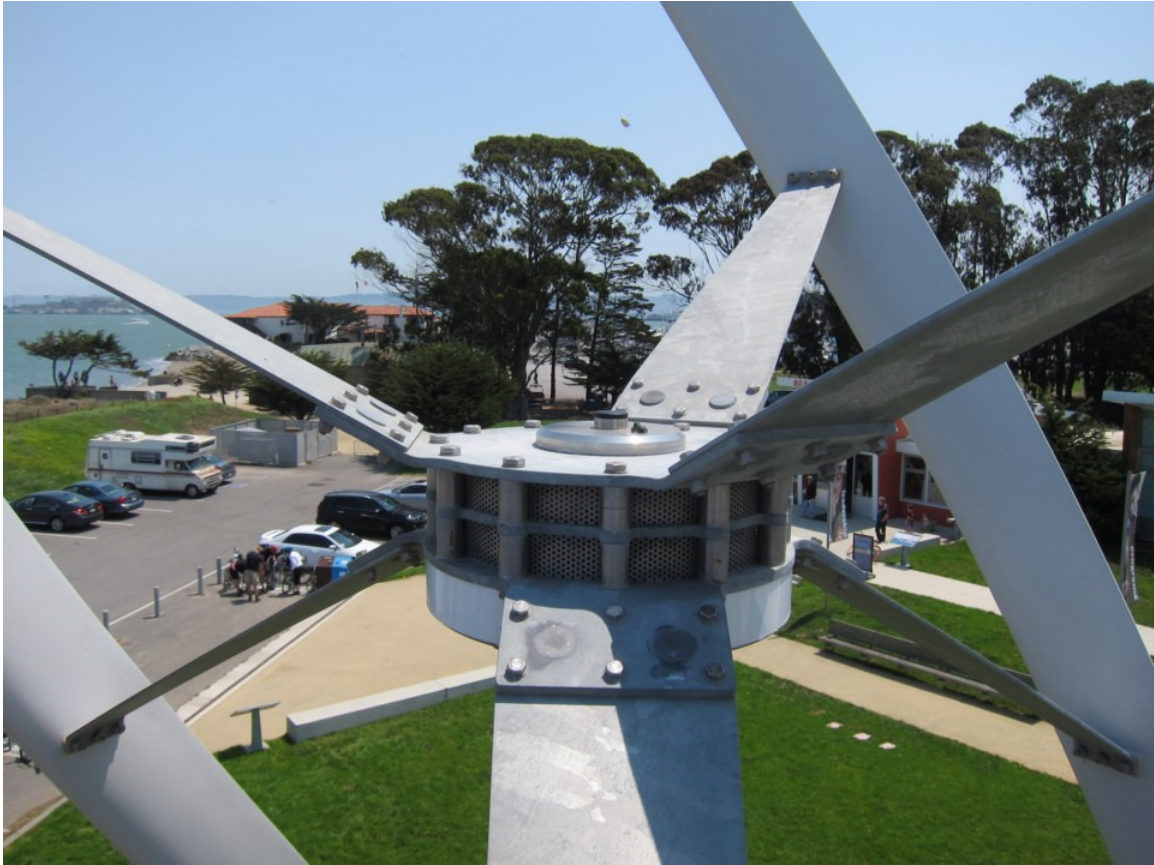
Figure 14. Southern Venco. Alternator housing and struts in good condition.

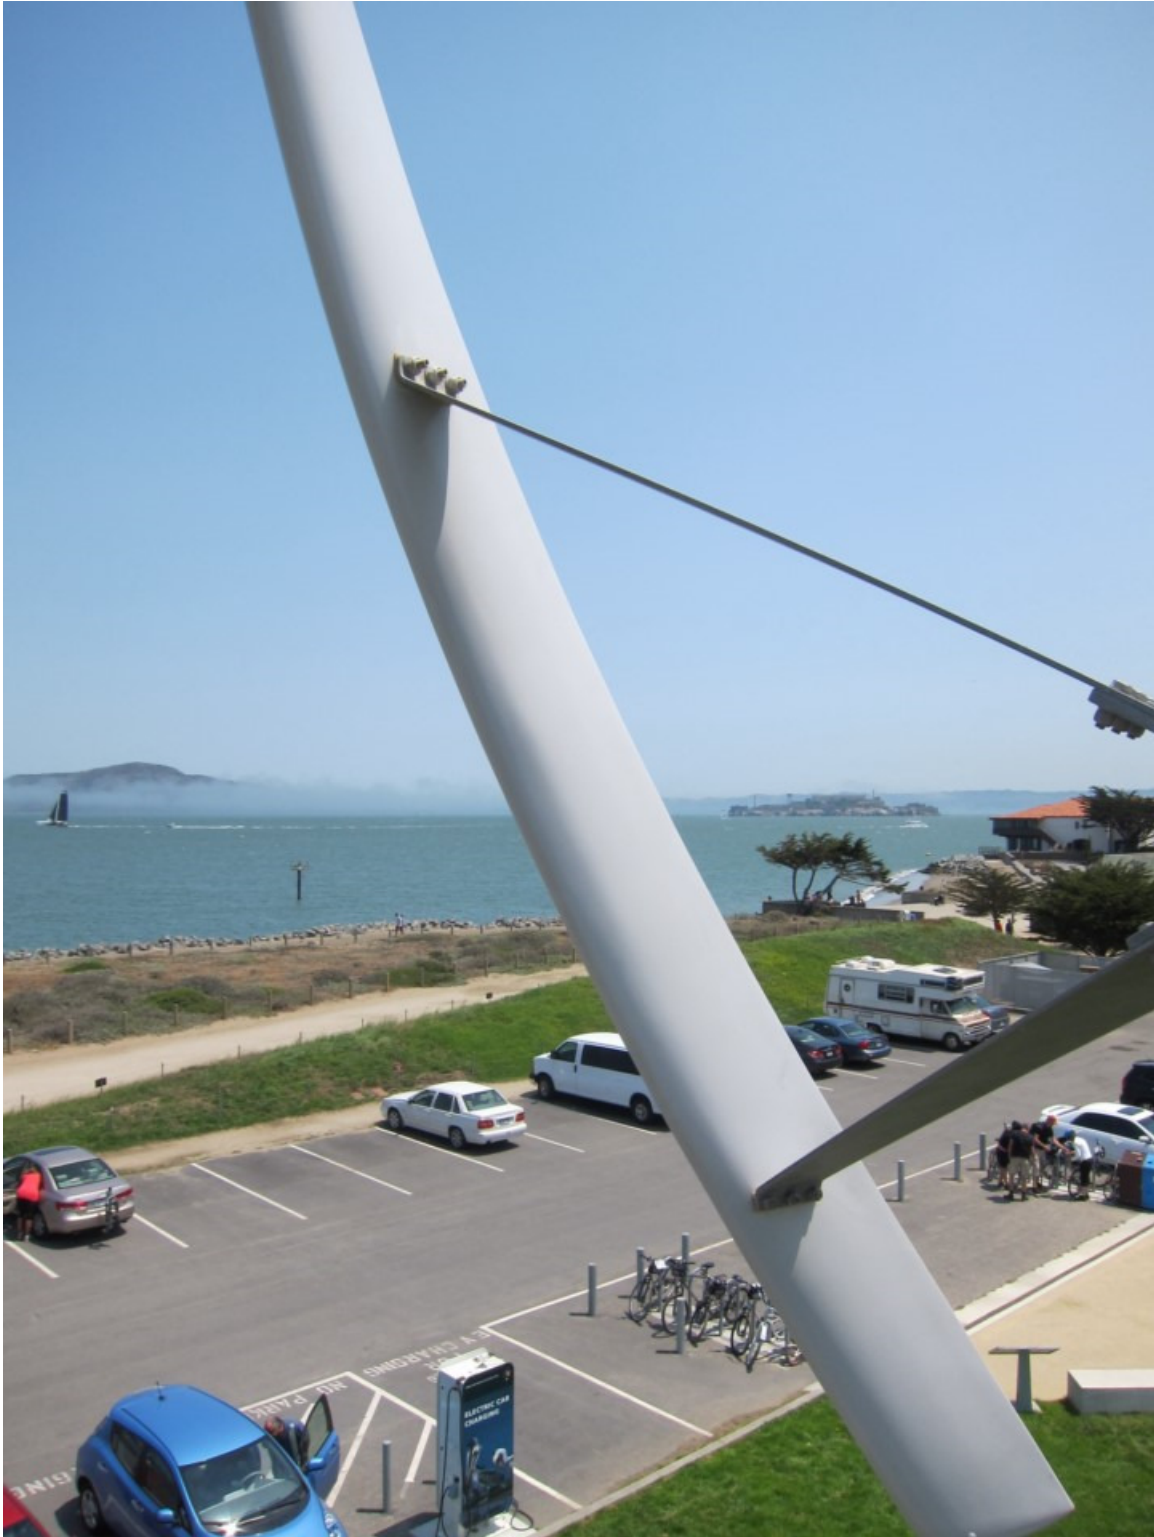
Figure 15. Northern Venco. Blades and strut connection in good condition.

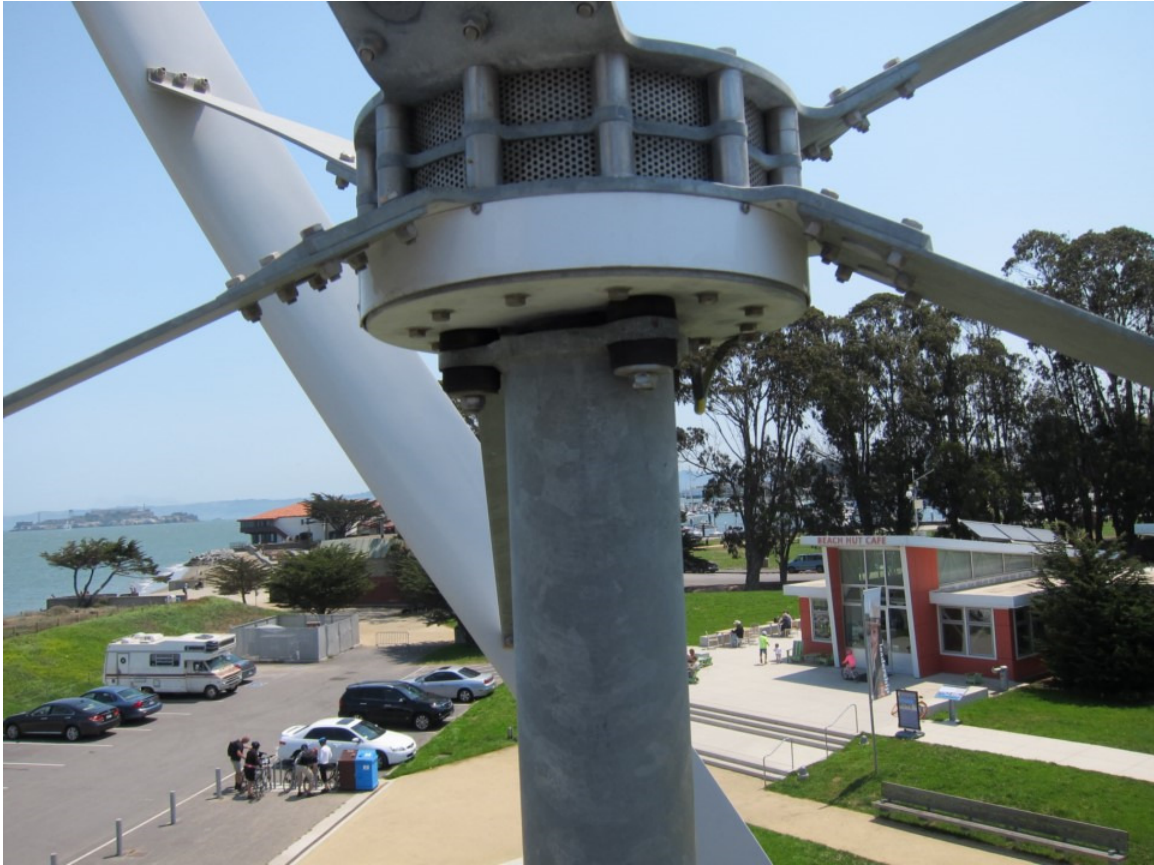
Figure 16. Southern Venco. Alternator housing and vibration dampers in good condition.

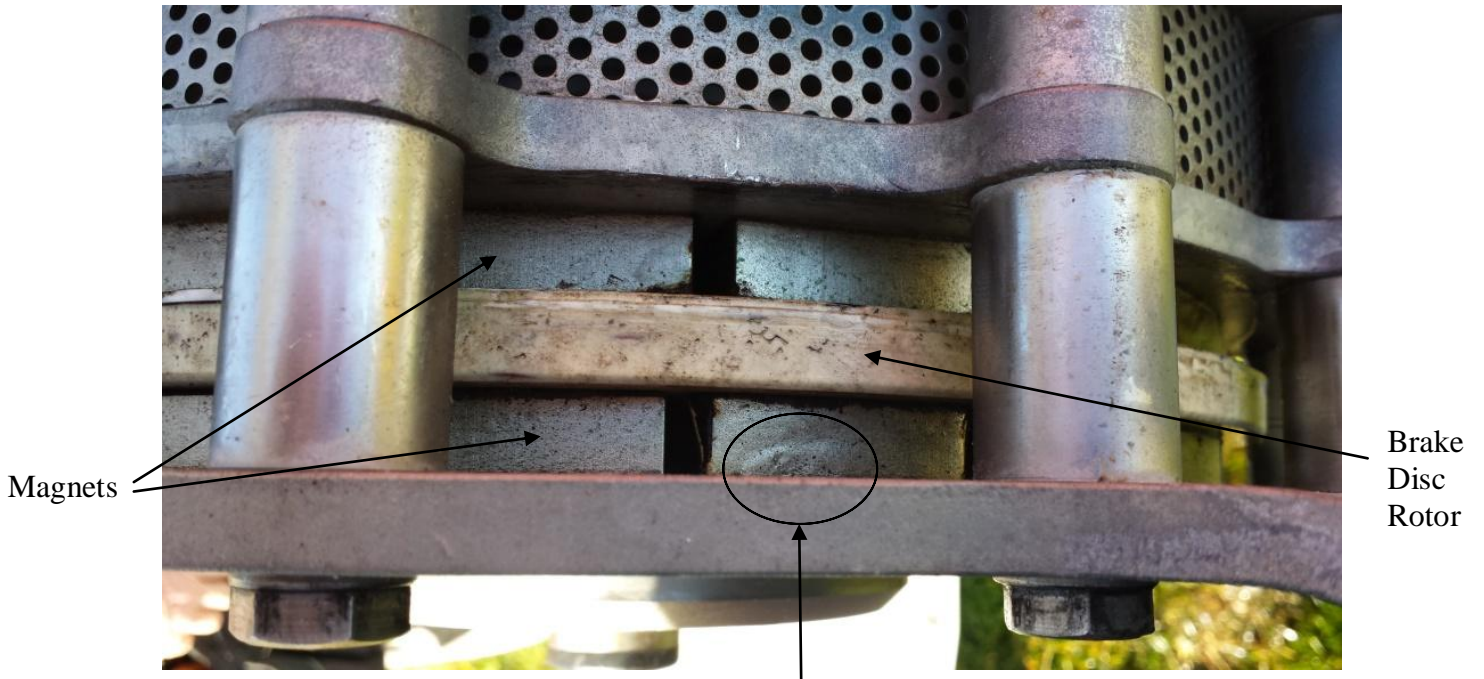
General notes: Both Venco units were not spinning, even in significant wind. Both units were seized and required a reasonable amount of force to "crack" the units loose. The bearings in both units are in good condition and do not need replacement at this time. We ran electrical tests to assure that the electric brakes were not engaged. Further inspection revealed that the components of the braking mechanism are beginning to fail. The brake magnets seem to be made from cast-iron which has a metal plating. The plating is blistering on the magnets and is beginning to dislodge and restrict the movement of the turbine by wedging between the magnets and the brake disc rotor. Refer to Figure 1.

Figure 1: Plating Blistering on the Magnet

Recommendations: Our initial recommendation is to request the manufacturer replace the units. If that is not an option, our recommendation would be to remove the units, open them and remove the plating, sand the magnets and recoat them with an epoxy-like coating.

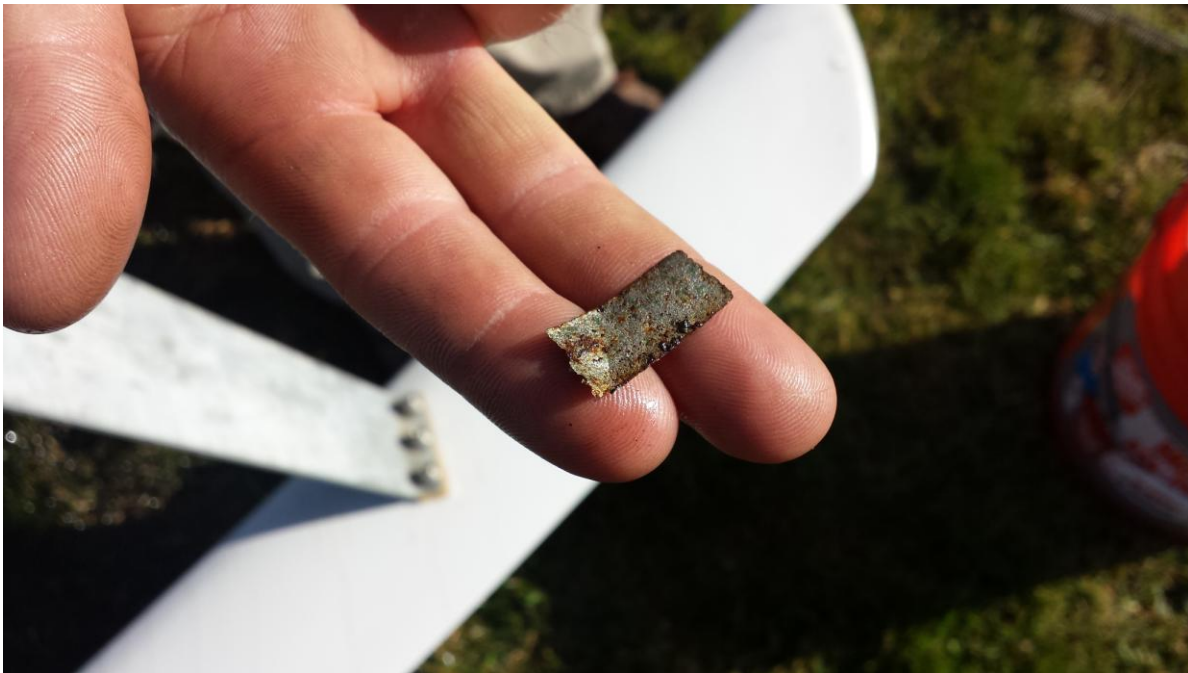
Figure 2: An example of the plating that has detached from the magnet

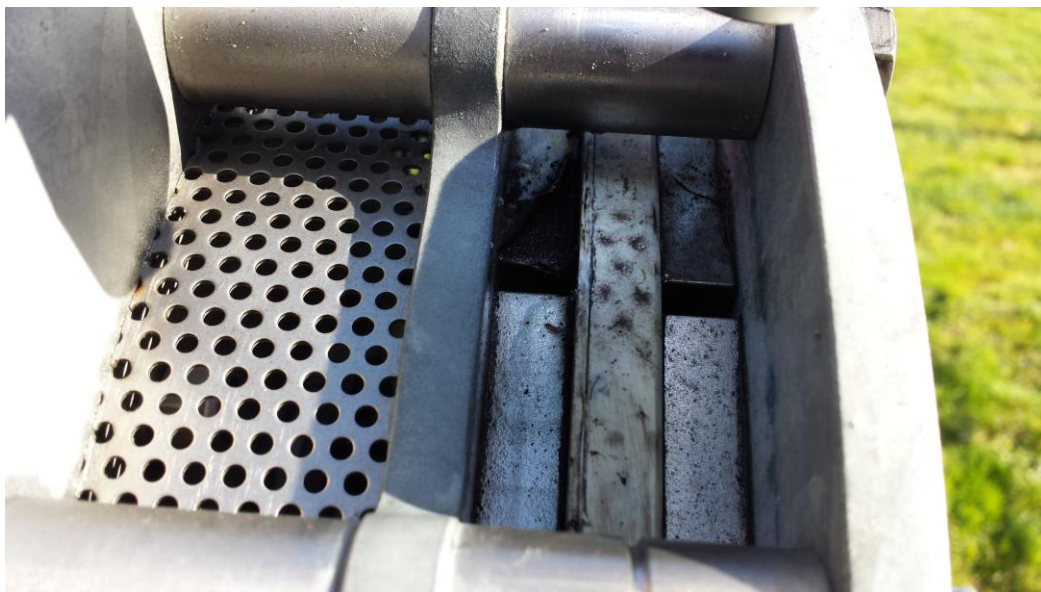
Figure 3: The plastic coating on the disc is becoming dislodged

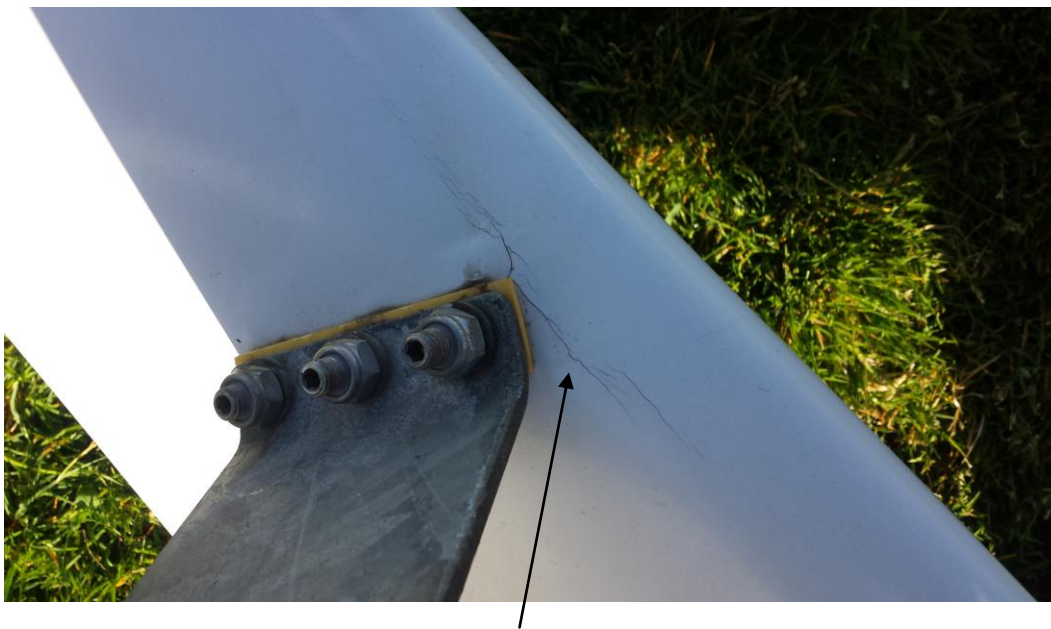
There are stress cracks on one of the blades on the South turbine. Refer to Figure 4.

Figure 4: Stress cracks on one of the blades of the South turbine

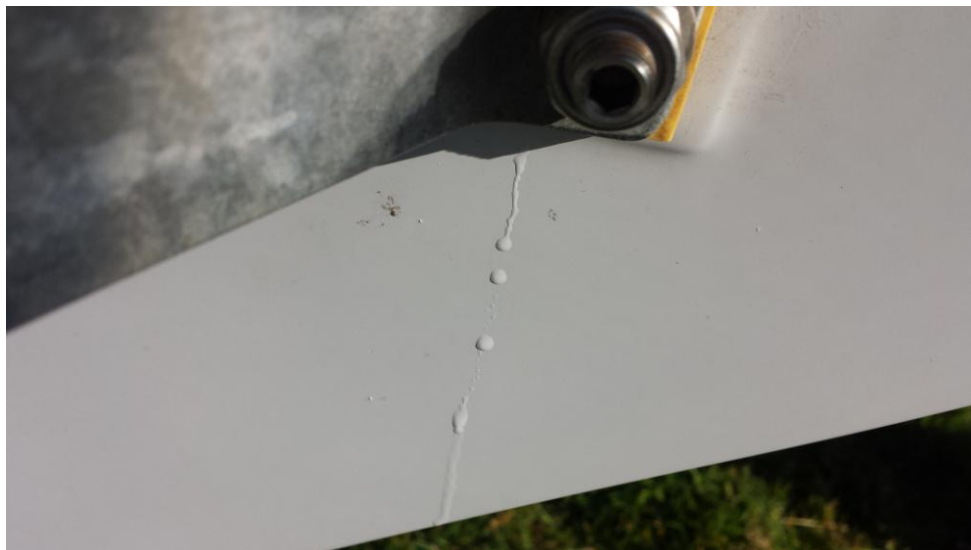
There is water inside the blades on the South turbine. The weep holes on the bottom of the blade are clear and without blockage. Refer to Figure 5.

Figure 5: Water is lodged inside the blades on the South turbine even though weep holes on the bottom of the blade are clear.
