Maintenance Report MCBH Hydrogen Filling Station

**Prepared for HNEI
By
Dr. Guenter Randolph**

Grandalytics

30 June 2017

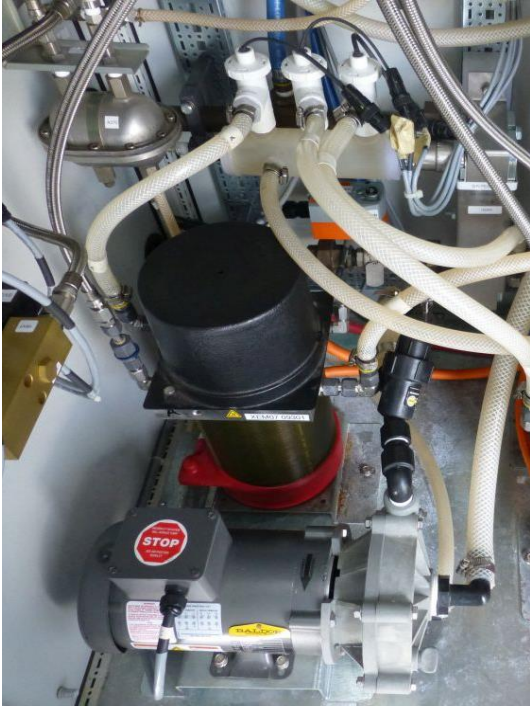
The Hydrogen filling station at the Marine Corps Base Hawaii has not been in use for approximately 2 years, since August 2015 when the GM Equinox fuel cell electric vehicle project was completed. Systems were periodically operated afterwards, but after failure of a pilot valve on the 700bar compressor in September 2015, no 700 bar compression could be performed pending replacement of the valve. Coolers and the electrolyser were exercised and in April 2016, the electrolyser was upgraded with a dew point sensor to meet Toyota technical requirements for fueling the Mirai fuel cell electric vehicle. In August 2016, 4 of the 9 electrolyser's power supply failed and no hydrogen was produced thereafter. About once a month, the electrolyzer was switched on to circulate fresh deionized water through the fuel cell stacks in order to preserve the Proton-Exchange-Membrane (PEM) stacks by keeping them hydrated. Progressive corrosion could be observed as illustrated in Figures 1 to 3. In 2017 a major effort to refurbish the electrolyzer was started.

Fig 1: Fluid compartment, May 2014

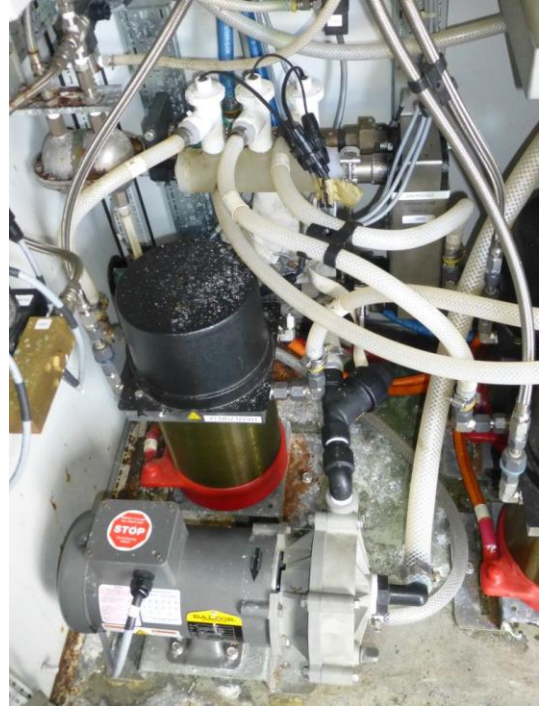
Fig 2: Fluid compartment, Aug 2016

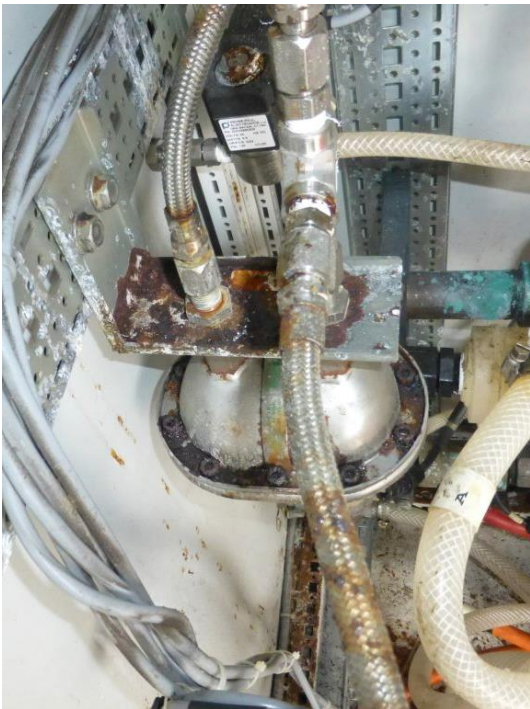
Fig 3: Fluid compartment, May 2017

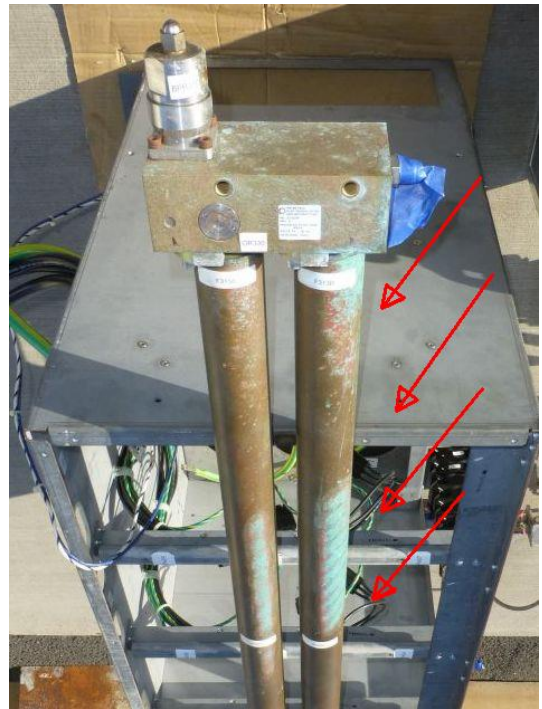
The high salt concentration in the ambient air is a major concern at MCBH. The electrolyser uses a fan to maintain a positive pressure inside the fluid compartment and dilute any hydrogen leaks that may occur to ensure low concentrations of hydrogen in the enclosure, hence, there is a high volume of air throughput. The corrosion pattern highlighted in picture 4 shows exactly the effects of the airflow from the blower over the brass columns of the hydrogen dryer.

Fig 4: Corrosion by salt air flow

- Design the system to meet the challenges of the environmental conditions at the site and consider ample ventilation and filtration of salty or dusty air.

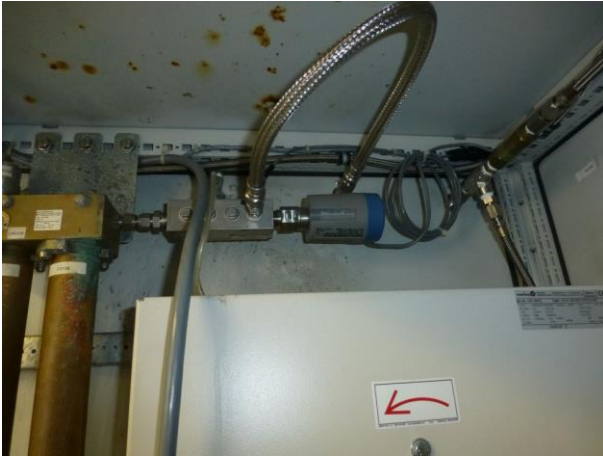
At times when the electrolyser is not running at high power and generating heat, the electrolyzer chiller cools the inside of fluid and electrical compartments below ambient temperature. Due to the high humidity, this leads to condensation of water and droplet formation on metal surfaces. The airflow enriches the water with salt and the metal surface corrodes rapidly as can be seen in figures 5 to 7.

Fig 5: Electrolyser ceiling, April 2016

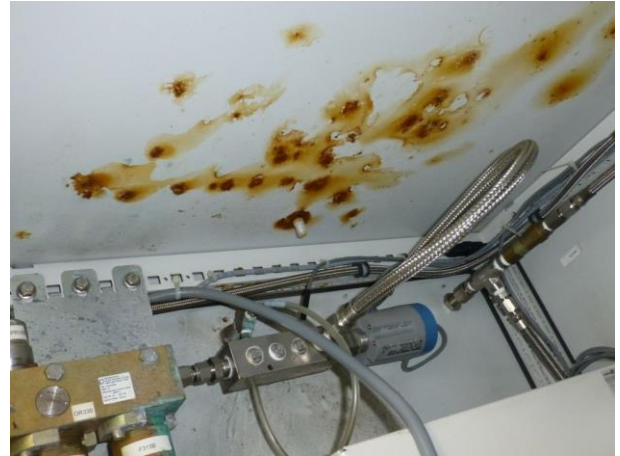
Fig 6: Electrolyser ceiling, August 2016

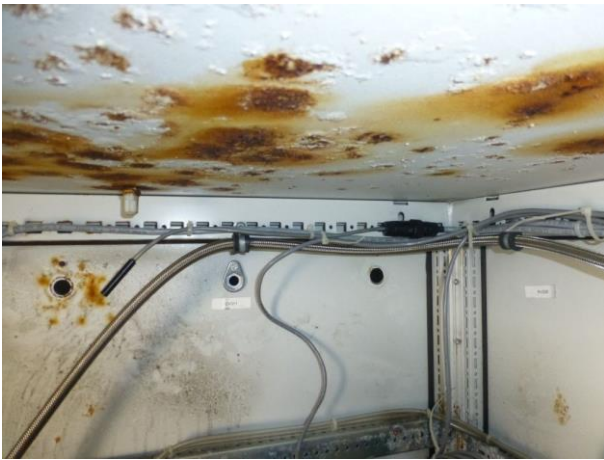
Fig. 7: Electrolyser ceiling, May 2017

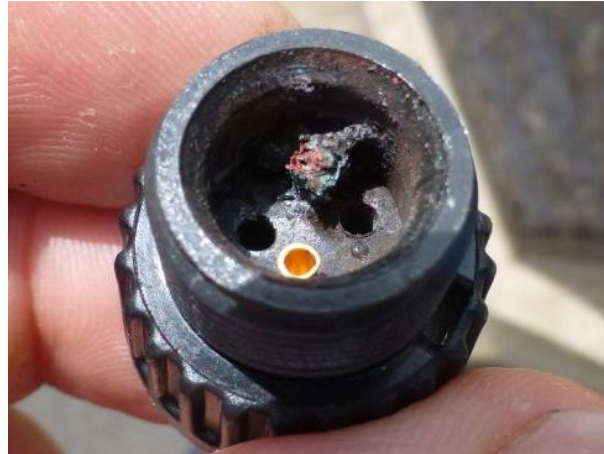
However, only moulded assemblies are truly IP67 (flood protected) because the problem on mounted connectors still remaining is the cable input. While we did not observe any problem with the mating contacts, we found internal corrosion through cable grommets that did not seal completely, see Figure 8.

Fig 8: Cable Corrosion

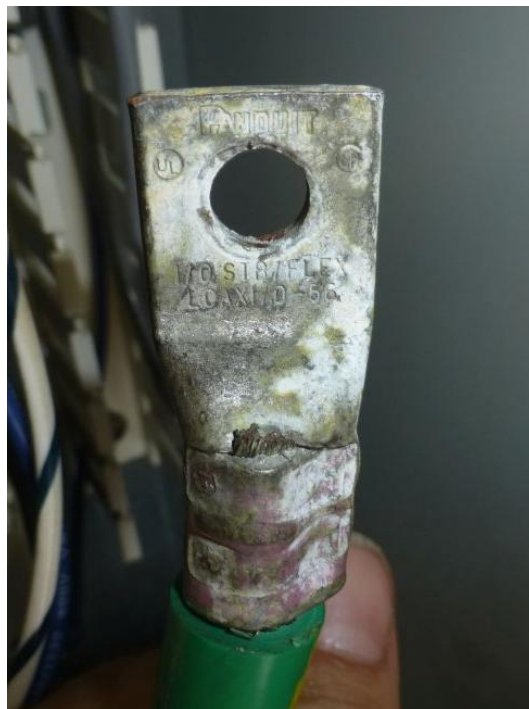
Fig 9 Terminal Corrosion

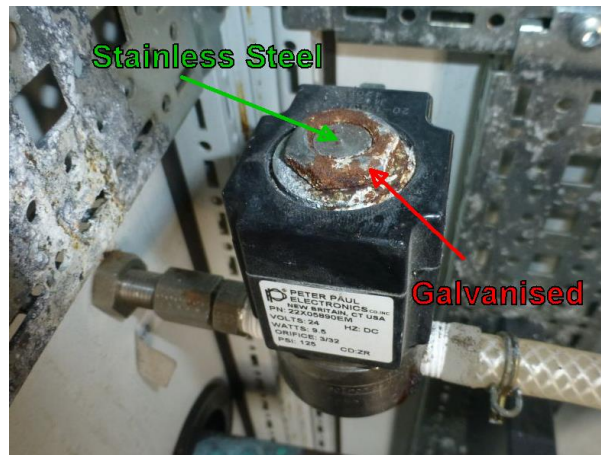
In such environments the use of stainless steel is mandatory. Some assemblies, however, included galvanised or other metallic components which are subject to corrosion, even more as metals with different electro-chemical potential are in contact in the presence of an electrolyte (salty water) which triggers accelerated galvanic corrosion. An example of a valve having a stainless steel body and galvanised nut and washer is shown in Figure 10.

Figure 10: Mixed metals

- Only use high quality stainless steel components. While it increases the initial procurement cost, the reduced maintenance and replacement costs will more than pay back the additional upfront cost.

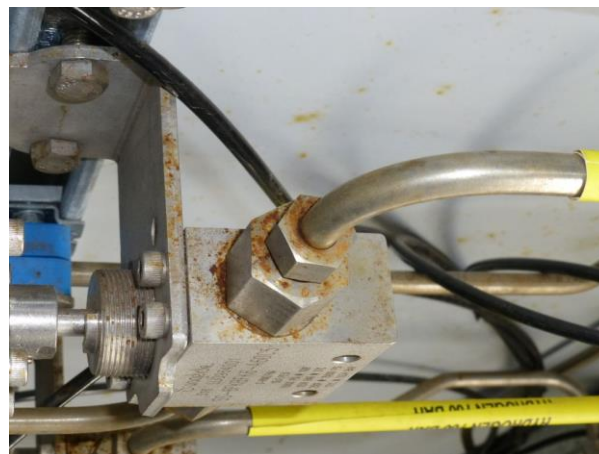
Even stainless steel is not a guarantee for corrosion resistance. First there are many different qualities available (304, 316, 316L, etc.) and it is not always specified for every component. During machining with steel tools, tiny particles can be embedded into the surface of the work piece. Over time those particles can start to rust leaving unsightly stains. Only by special (and expensive) treatment of the surface (pickling) can the tool-steel particles be etched out. This type of corrosion, as shown in Figure 11, however is more a concern for threads and does not severely impact the functionality of the component.

Figure 11: Stainless Steel corrosion

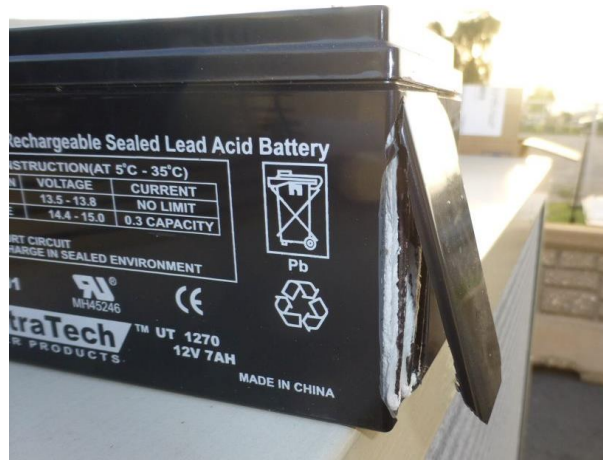
Another problem encountered is related to high ambient temperatures, especially in closed containers. Depending on the hazard zoning of the room (explosive atmosphere always/rarely present, etc.) and type of explosion protection (encapsulation, over pressure, dilution, etc.), the container might or might not have ventilation. Unfortunately, the container with 2 large electrical transformers does not have ventilation and ambient temperatures can exceed 40°C. This caused problem with PLC controllers, repeated PC failures and over-heated lead-acid back up batteries, as shown in Figure 12.

Figure 12: Overheated battery
