Hawaii National Marine Renewable Energy Center (HINMREC)

WETS Deepwater Mooring Inspection

Prepared by:
Sea Engineering, Inc.

March 2017

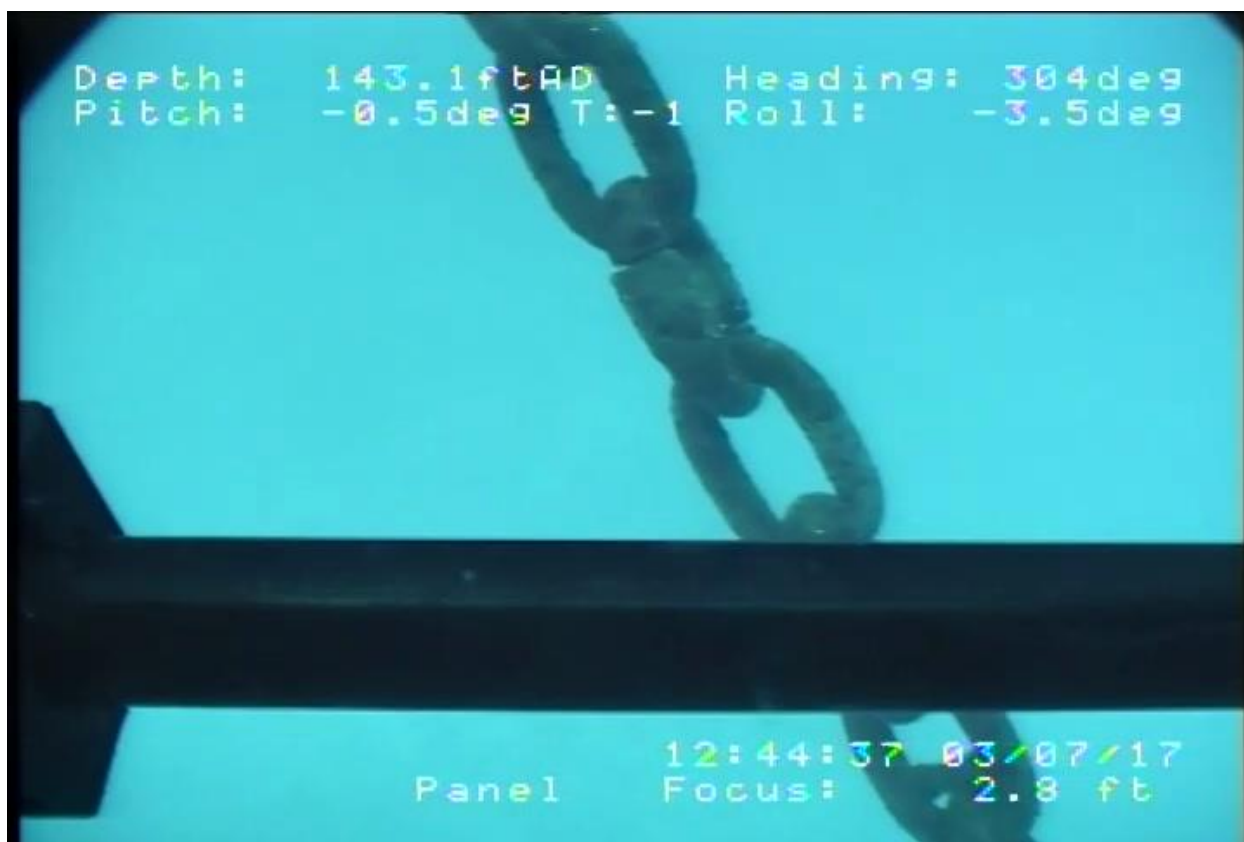
Figure 4-4 A1-ML-4 Kenter Link Gap

The 60m site (A moorings) is currently occupied by the Fred Olsen Lifesaver WEC. Each of the three mooring legs is displacing the sediment in the area where the mooring leg interacts with the seafloor. The displaced sediment forms a trench with the mooring leg in the center (Figure 4-6 and Figure 4-30). The motion of each mooring leg chain has abraded the sinker weights (Figure 4-19 and Figure 4-27). The previous survey (Task 7D) found the fifth sinker weight (SW5) is detached on each of the A mooring legs and the fourth sinker weight (SW4) is detached on the A2 and A3 mooring legs. The present inspection confirmed the detachment of SW4 and SW5 and revealed that the third sinker weight (SW3) is detached on the A2 mooring leg. The sinker weights provide stiffness in the mooring system to reduce the watch circle of the WEC. The A1 mooring chain has a kenter link that is coming apart, a gap has formed between the two halves of the links that is (Figure 4-4).

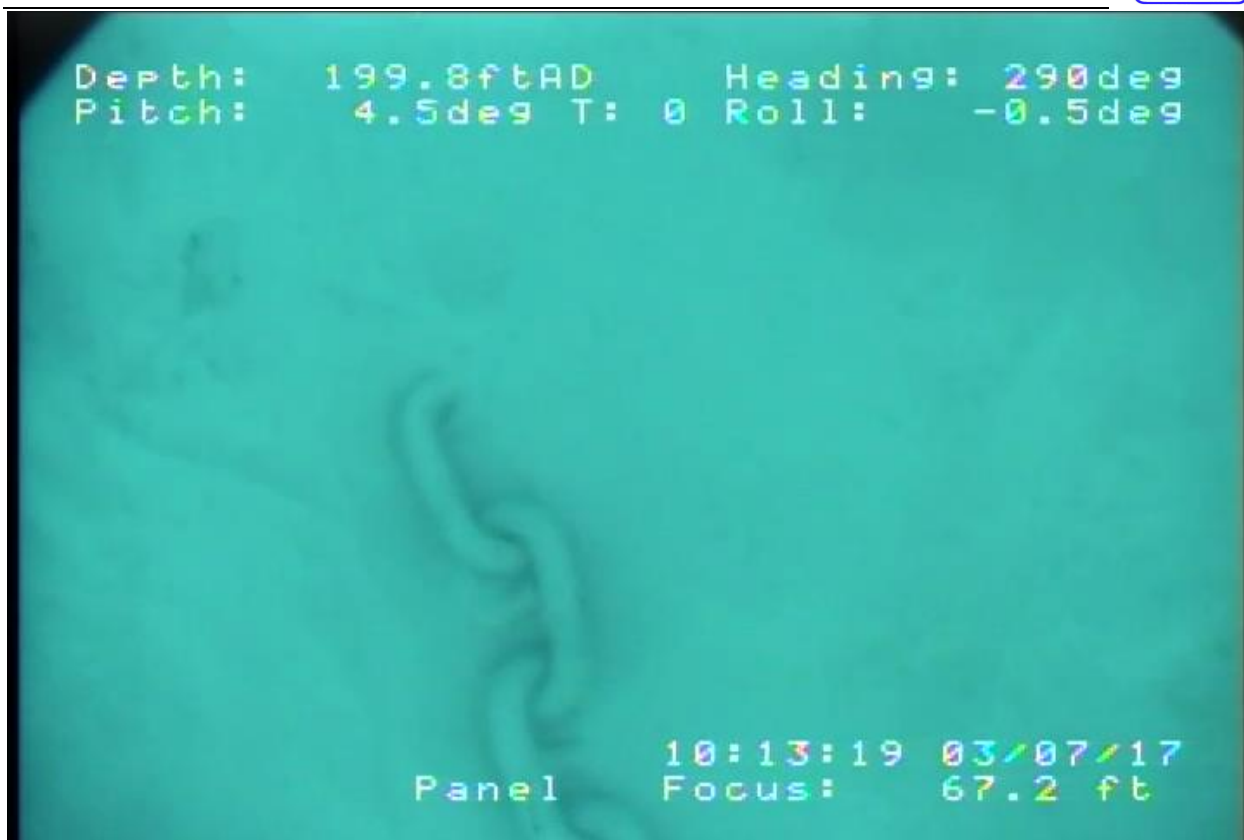
Figure 4-35 B1-ML-4 End of chain attached to surface float

A WEC device has not yet been moored at the 80m site. Each mooring chain hangs vertically under the surface float. There is little to no catenary in the chain. The motion of the B mooring legs displaces the sand and form a hole in the seafloor (Figure 4-37 and Figure 4-53). The B1 mooring chain is broken at the dip section of the chain. The B1 surface float has been temporarily secured to the B3 surface float. The end of the chain attached to the B1 surface float terminates with a link of chain without a stud (Figure 4-35). Also, the end of the chain attached to the B1 anchor also terminates with a link of chain without a stud (Figure 4-36). No remnants of a kenter link were found. A broken kenter link half would likely not have stayed attached to the end of the chain over the distance that the chain was drug to secure it to the B3 surface float. The fifth block on the B1 mooring leg was not found, all other blocks are attached.

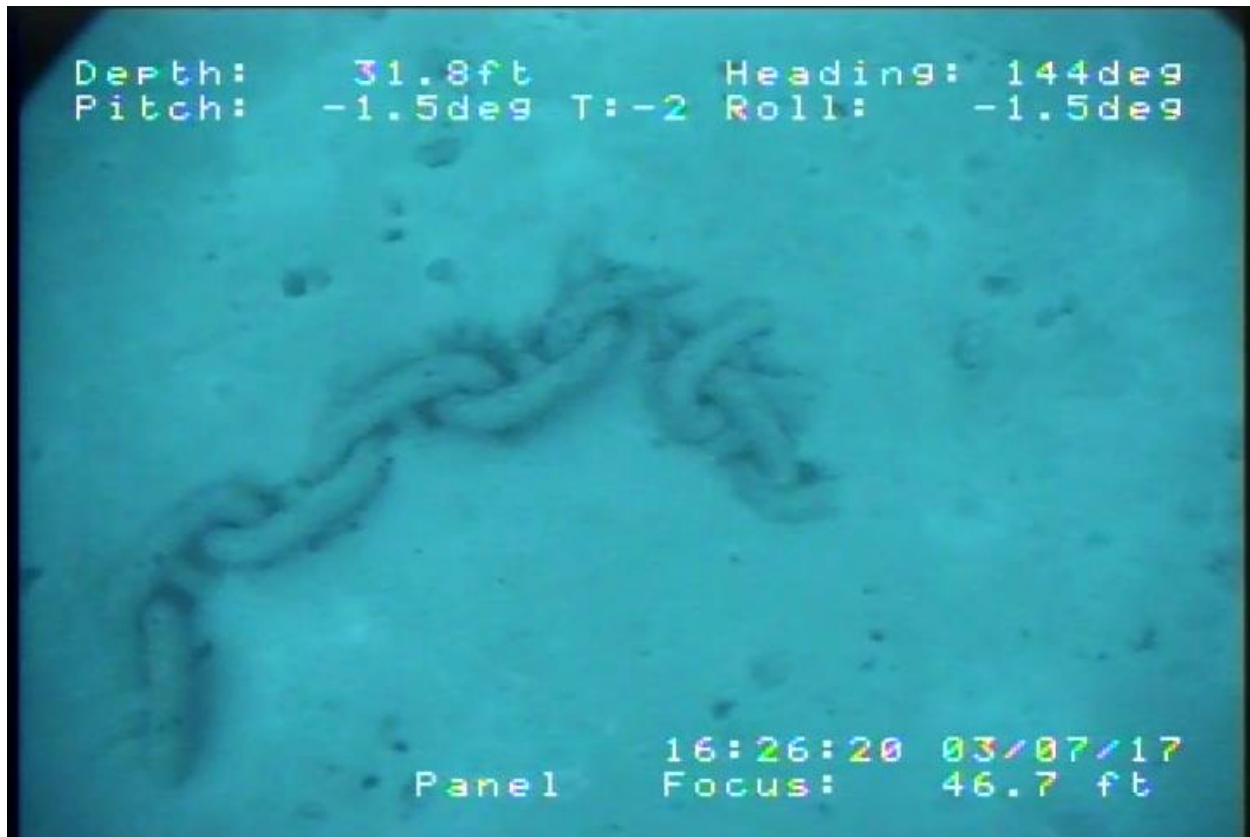
Figure 4-43 B2-ML-4 End of Chain

The failed B2 mooring chain, sinker weights, and anchor (see 11/5/2016 Inspection report) were observed on the seafloor. The surface float was removed by Healy Tibbits. The B3 mooring leg is intact and all sinker weight are still attached.

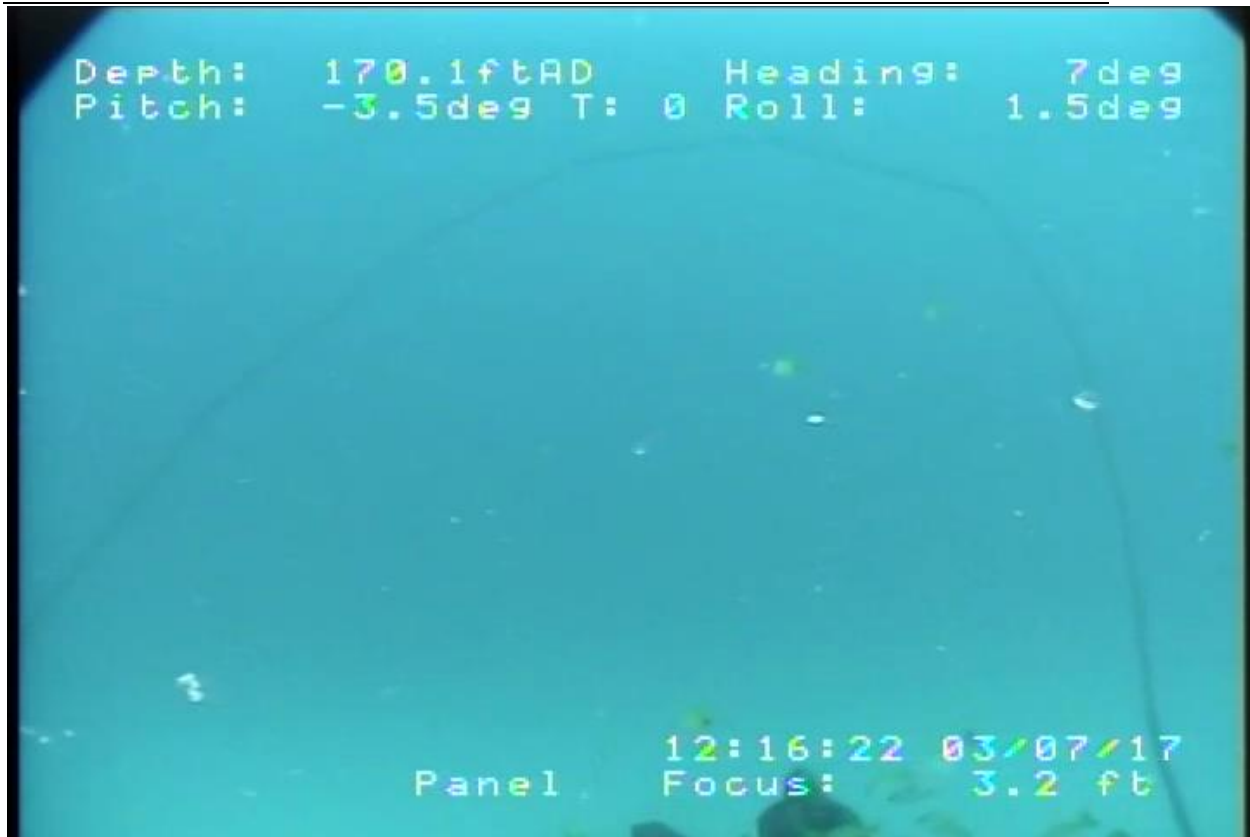
Figure 4-74 PTO3-4 Line Loop

The configuration of the power take off (PTO) chain baskets and bands at the A mooring site is shown in Figure 3-3 and Table 3-3. PTO 1 and PTO 2 were operational during the inspection. The intact components of the PTO 1 and PTO 2 systems are shown in Figure 4-63 through Figure 4-65 and Figure 4-66 through Figure 4-69, respectively. The link of chain attached to the underside of the PTO3 subsurface float failed (see previous Task 6K Report). The two remaining pieces of chain are piled together on the sea floor with the thimble and part of the riser line shown in Figure 4-73. There is a loop in the riser line that is an entanglement hazard to ROV operations shown in Figure 4-74.
