Diagnostic of Li-ion commercial cells, case study

A case study

Commercial LTO//NMC cell

Diagnostics of a LTO//NMC commercial cell

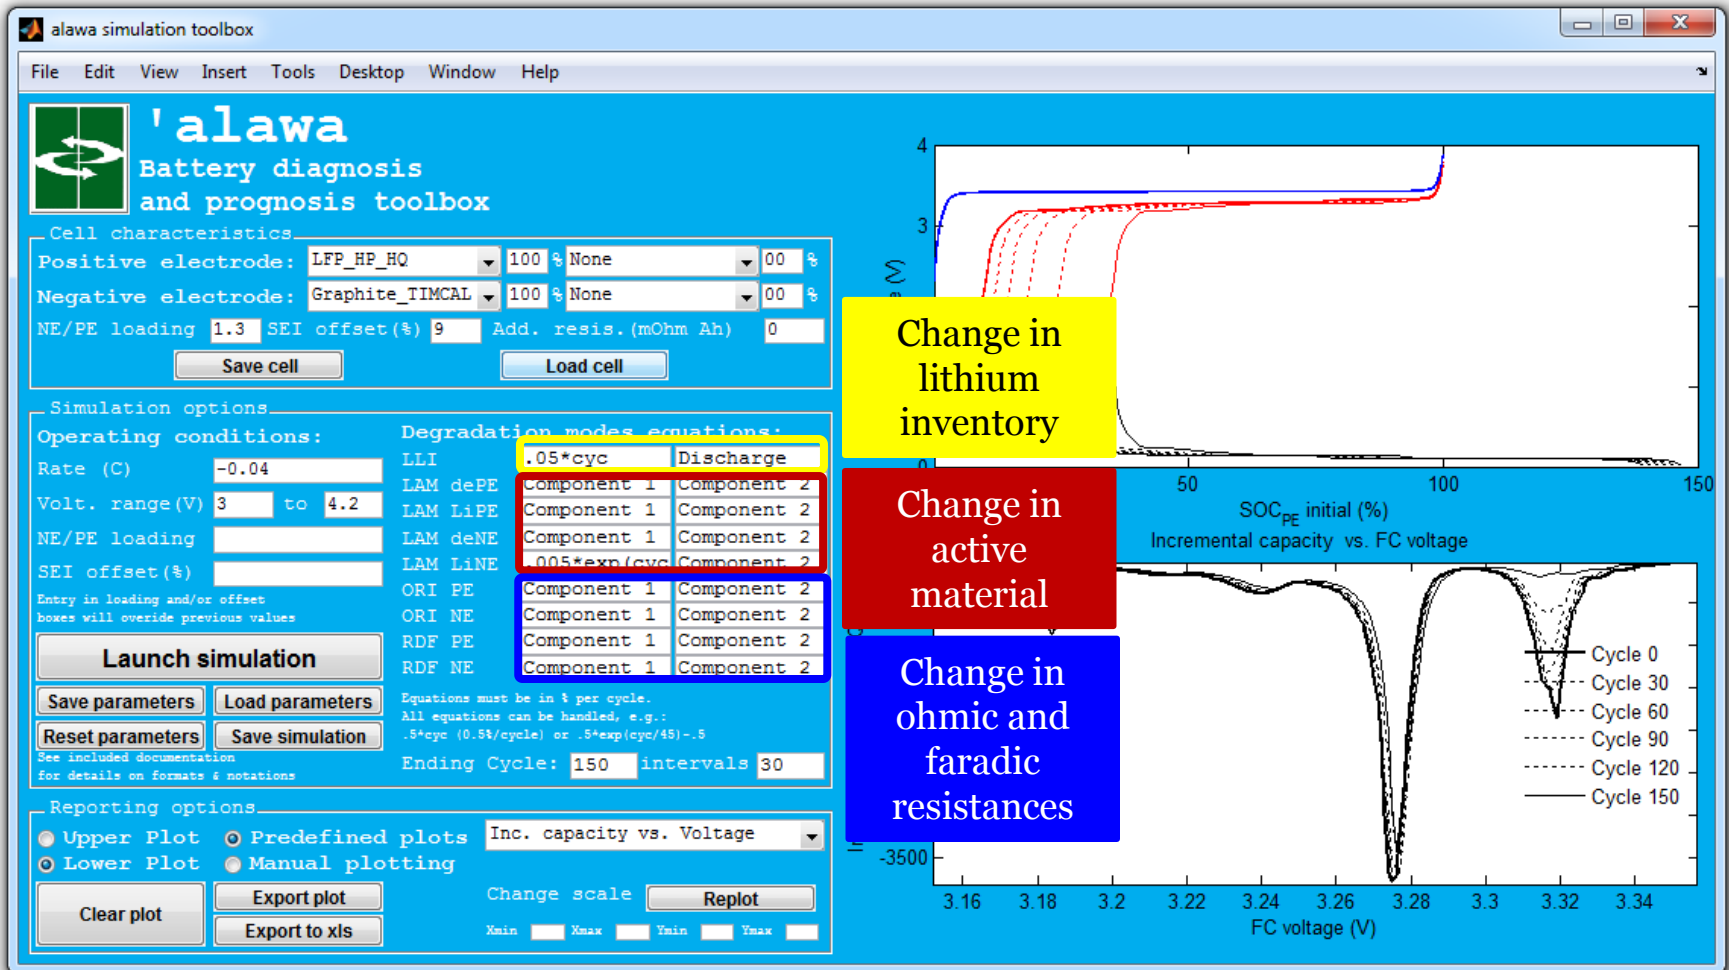
Mechanistic Battery Diagnosis and Prognosis Graphical User Interface: the 'alawa toolbox

Simple, fast, powerful and accurate diagnosis and prognosis tool

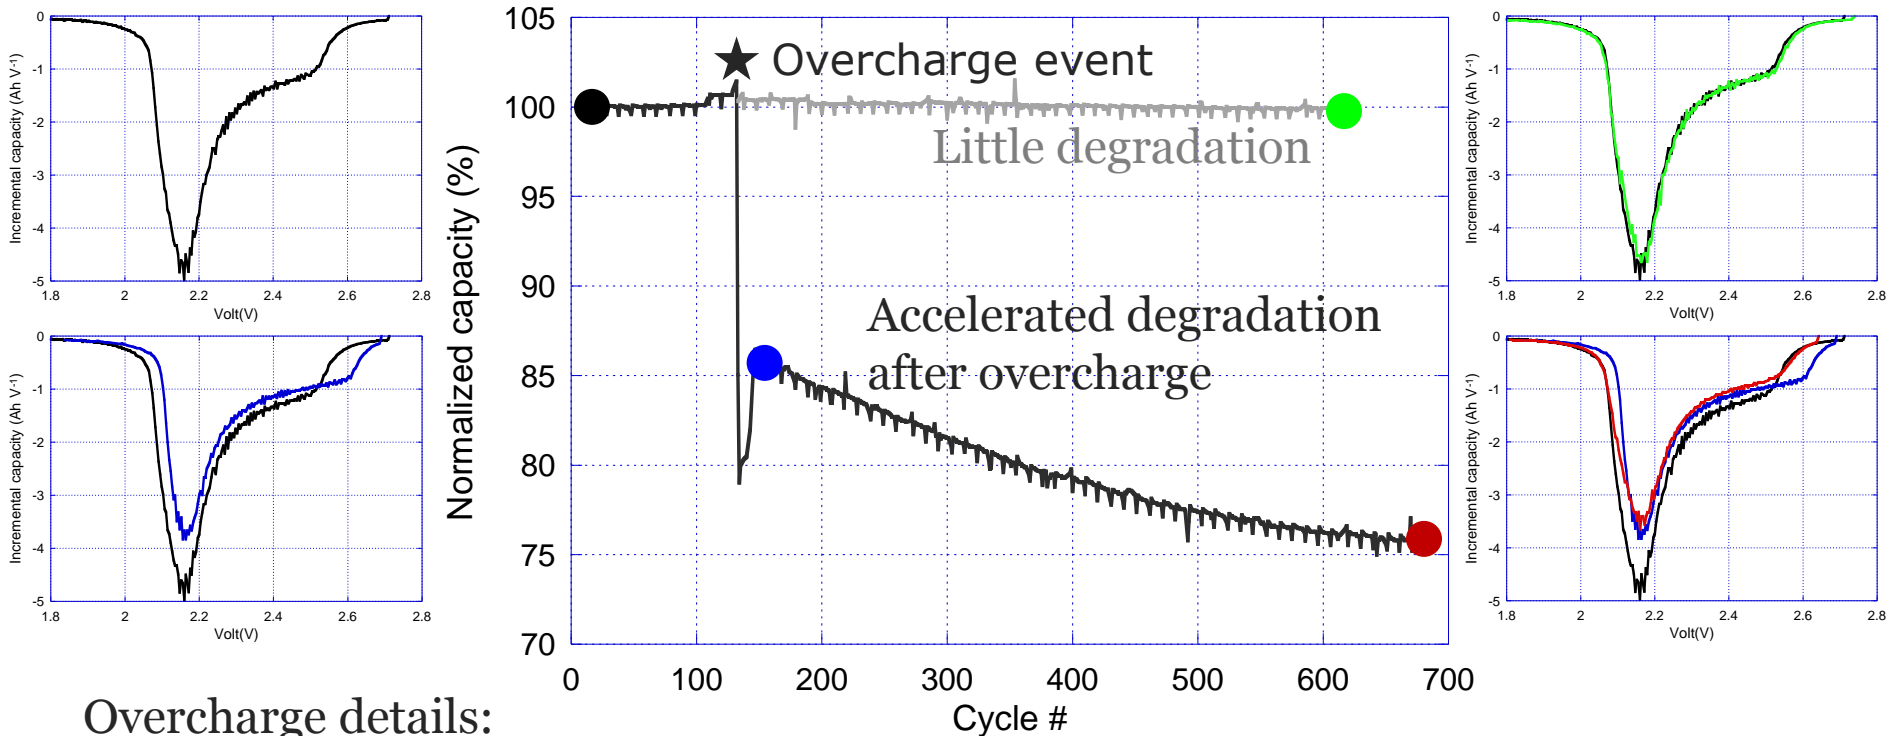
2 cells, regular C/3 cycling, 1 cell experienced 1 overcharge

Overcharge details:

On cycle 133 cell 1 overcharged 1 time to 3.6V instead of 2.8V.

All IC (dQ/dV) curves are C/25 discharges

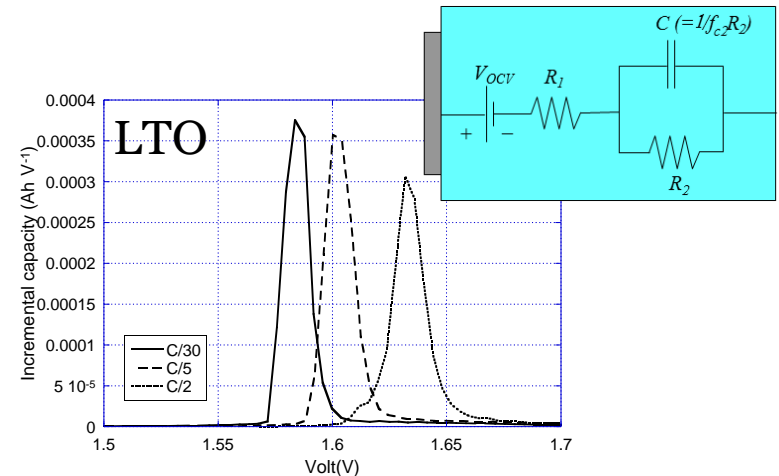
$V_{NE} (SOC_{NE})$

Chemistry, rate, extent of rxn

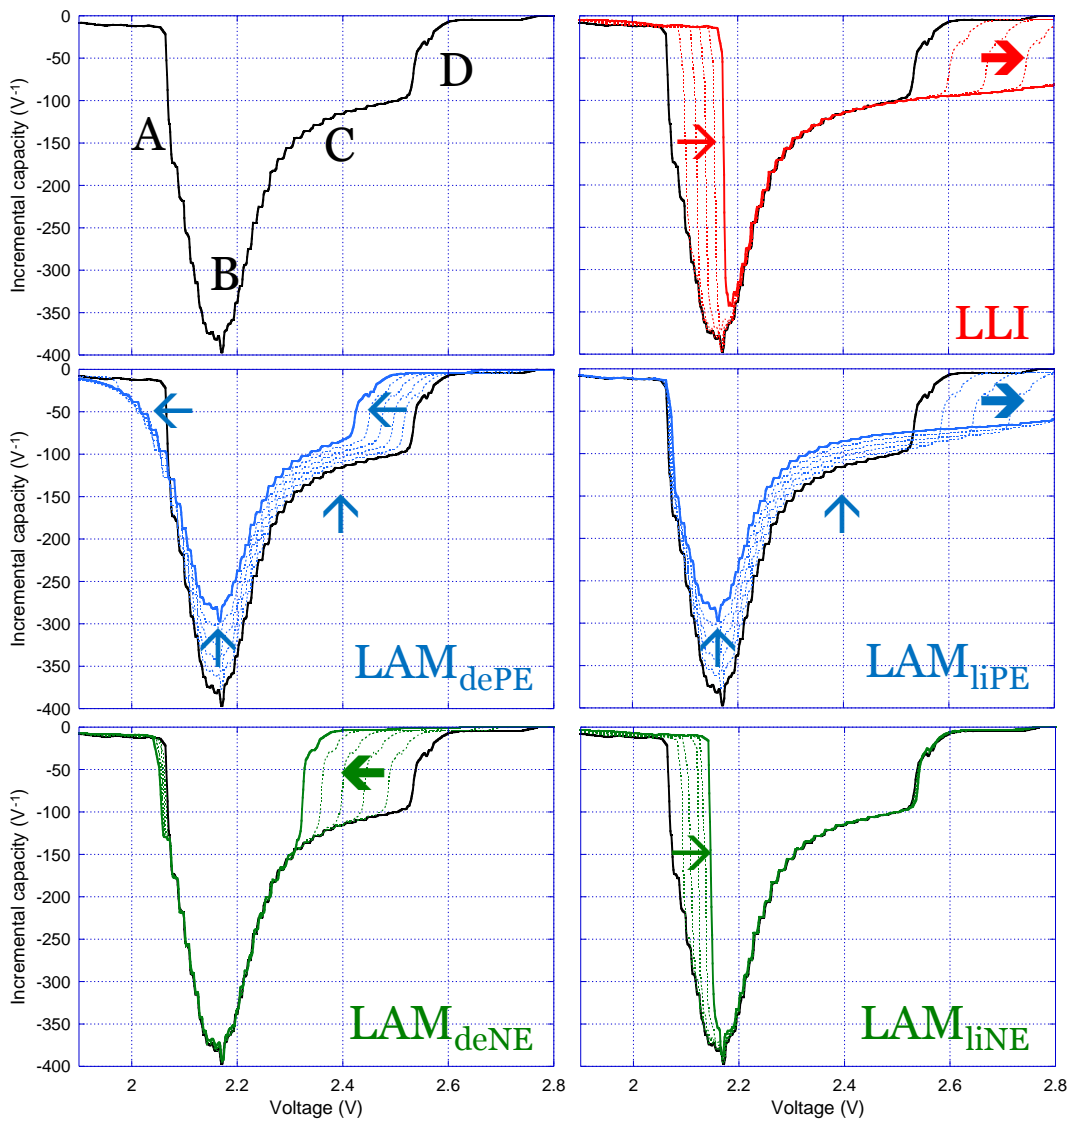
Symptoms: voltage & capacity evolution @ C/25

A	B	C	D
LLI	→			→
LAM _{dePE}	←	↑	↑	←
LAM _{liPE}		↑	↑	→
LAM _{deNE}				←
LAM _{liNE}	→

Symptoms from each mode can be unambiguously identified

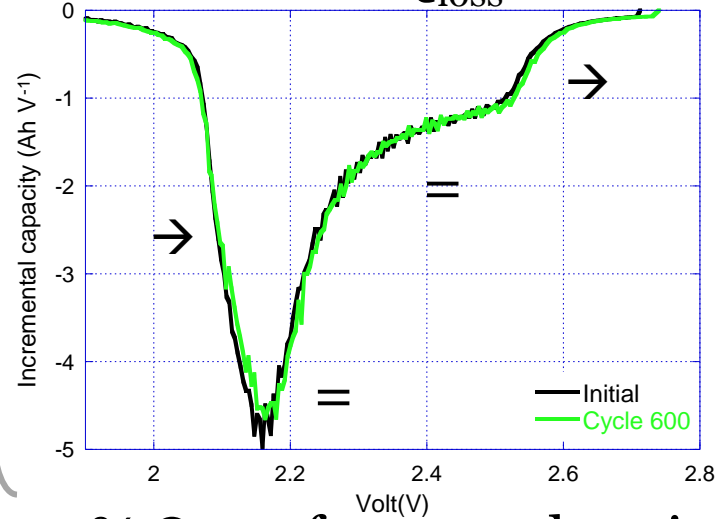
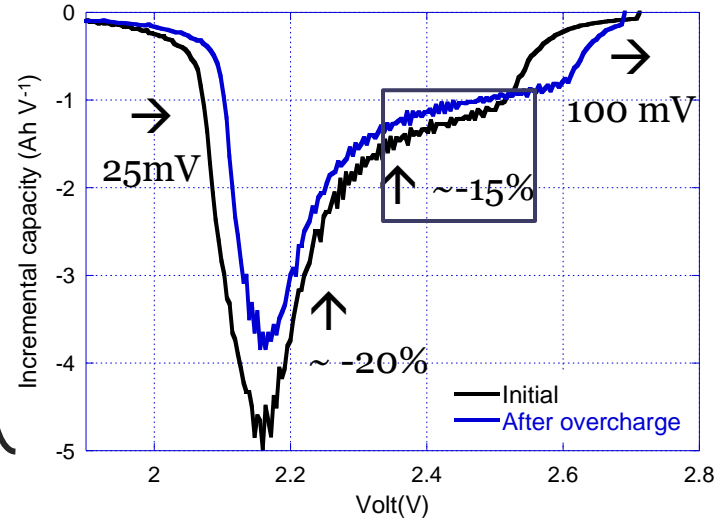
Overcharged cell

No single mode can explain all variations.
 → 15% LAM_{PE}
 → Multi-modes

15% Q_{loss} after overcharging event

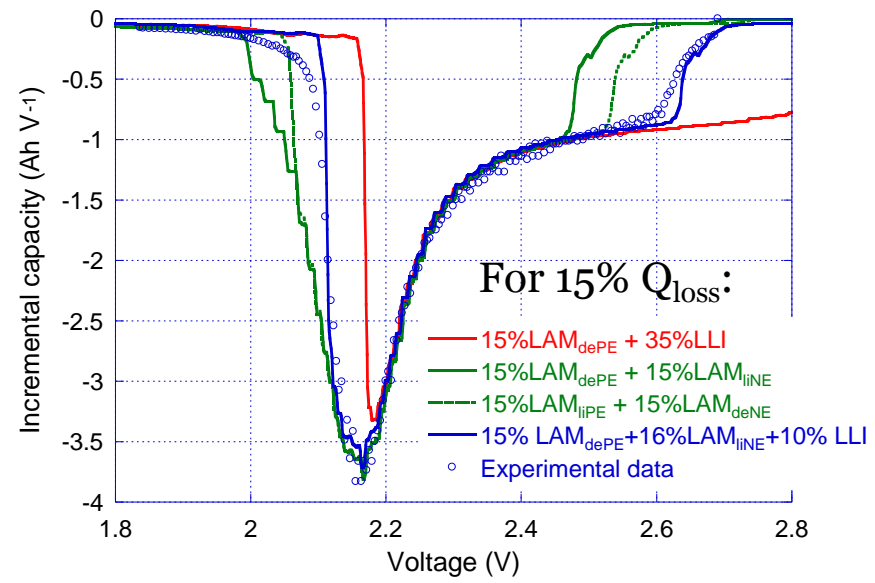
Known:
15 % LAM_{PE}
and 15% Q_{loss}

Unknown:
Quantify LLI
Quantify LAM_{NE}

To match Q_{loss}
 & shape

Only one combination gives the best fit

Overcharge induced **loss of active material** of same magnitude, ~15%, **on both electrodes** plus a **10% loss of lithium inventory**.
 Kinetics & resistance of the cell were not affected.

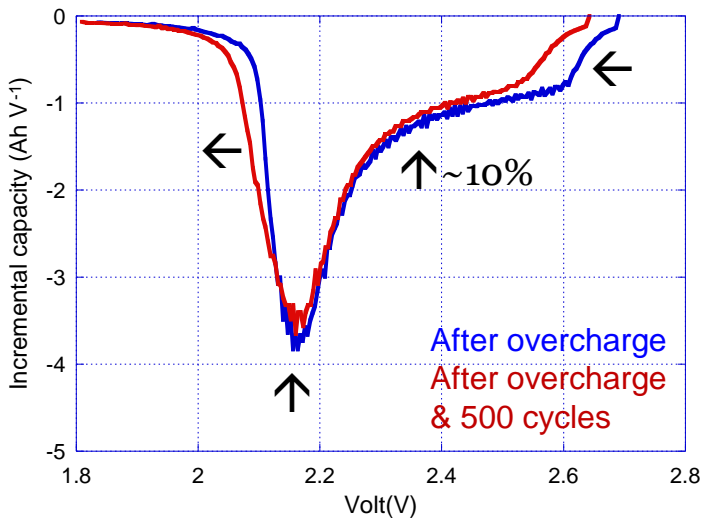
500 cycles, ~ 10% additional Q_{loss}

straight LAM_{dePE} ?

Overcharge permanently affects cell performance

Similar mode than of the overcharge event

10% Loss on each electrode

BUT Far less loss of lithium than of overcharge event:

~0.5%/1%AM vs. ~1.5%/1%AM

So probably no LLI at all
