# Hawaii National Marine Renewable Energy Center (HINMREC)

# OTEC Heat Exchanger Program: 2015 Ultrasonic Scanning for Corrosion Monitoring Report

Prepared by:  
Makai Ocean Engineering

February 2015

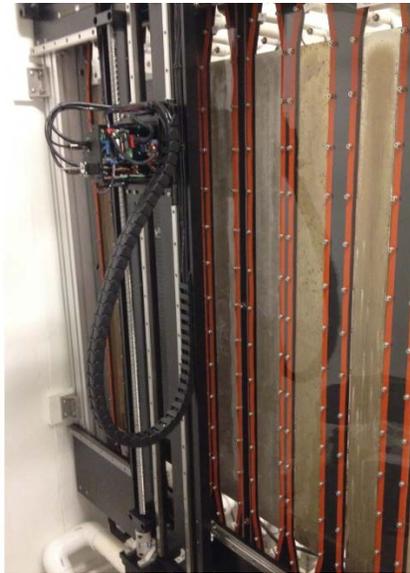
*Figure 1: Multi-column imaging racks used to expose samples to seawater flow. Seawater flows from the top of the columns. Cameras are mounted on an X-Y-Z stage and programmed to take daily images of sample surfaces.*

Makai Ocean Engineering has been using a custom designed multi-column imaging racks (MCIR) to expose metal samples to seawater (Figure 1). The acrylic windows enable real-time, in-situ observation of surface changes. Computer controlled cameras mounted on a motorized X-Y-Z stage take daily images of all samples. Both low (70 mm x 50 mm FOV, 27  $\mu\text{m}$  pixels) and high (1 mm x 0.8 mm FOV, 0.4  $\mu\text{m}$  pixels) magnification cameras are used. For each sample, low magnification images of the entire surface are recorded and smaller regions of interest are imaged at higher magnification.

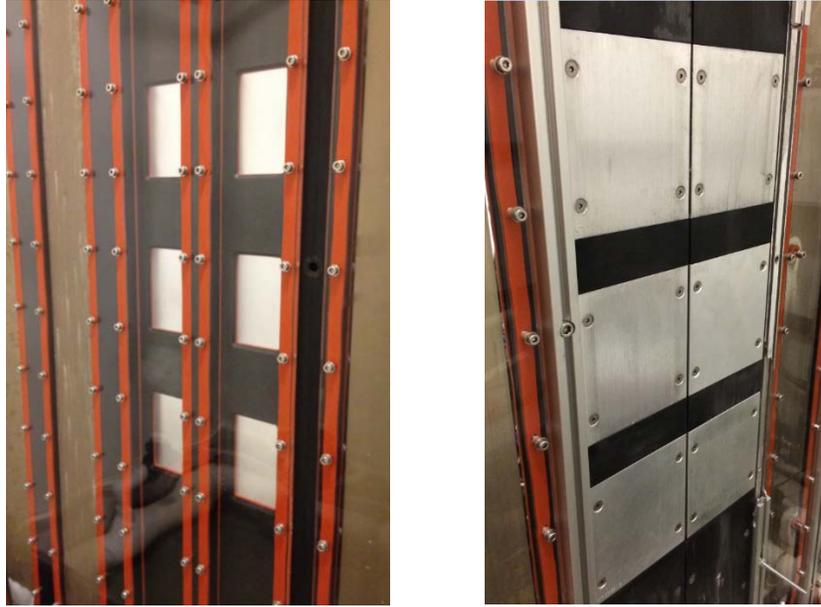
*Figure 2: Left – modified columns with multiple samples exposed to seawater. Right – the back of the samples where ultrasonic thickness measurements are taken.*

For this study, two of the MCIR columns were modified so three samples (one of each alloy) could be mounted in a single column with their backside of the sample accessible to the ultrasonic thickness scanner (Figure 2). Samples were placed in slightly indented frames and sealed with face gaskets made of silicone rubber at a compression of 20% (Figure 3).

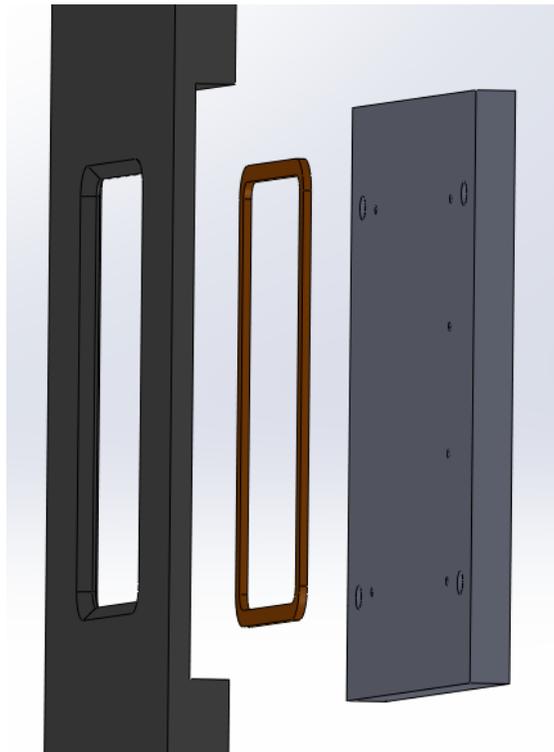
*Figure 3: Explosion view of the mounting frame, gasket and corrosion sample*

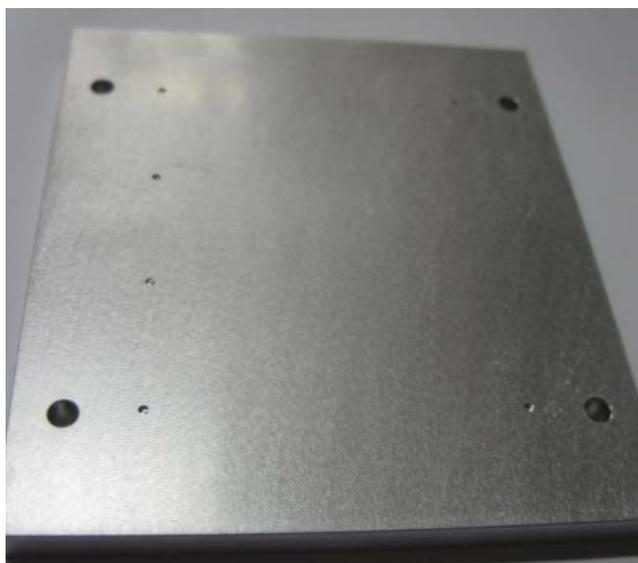
*Figure 4: Sample face prior to exposure to water. Small holes of various depths were added outside the flow area for calibration and to align the ultrasonic scans and optical images.*

Sample surfaces have light tool marks from the machining process. Care was taken during machining to prevent metal shavings or other contaminants from contacting sample surfaces. Holes of various depths (Figure 4) placed in each sample were used as calibration and reference points to align the ultrasonic scans to the optical images. The holes lie outside of the gasketed area and are not exposed to seawater flow. Prior to mounting, the samples were cleaned with Simple Green™ and rinsed with methanol.

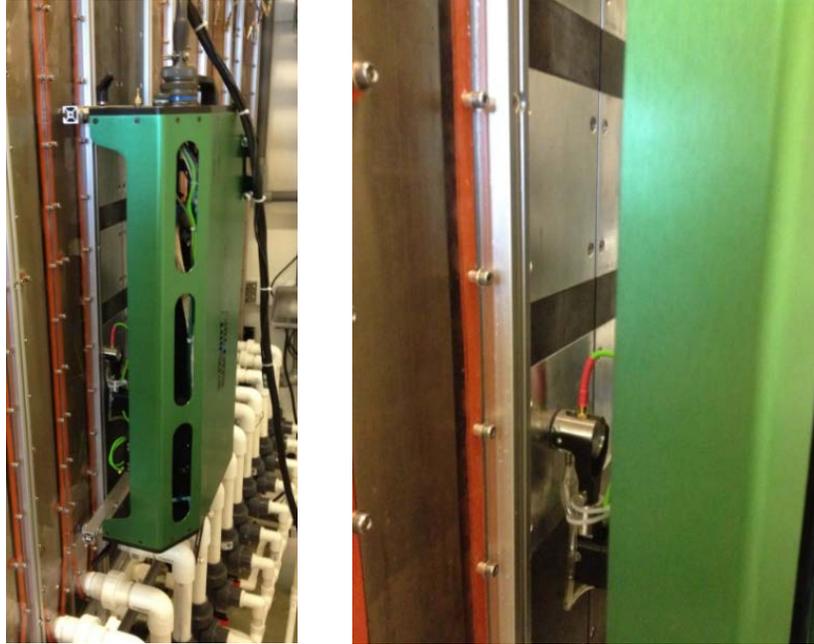
*Figure 5: Left - Scanning stage mounted to the back side of the imaging racks. Right - Ultrasonic transducer in contact with sample.*

An ultrasonic scanner manufactured by NDT Systems which integrates a Raptor© Imaging Flaw Detector with a 13 mm diameter 15 MHz ultrasonic transducer was used in this study. The ultrasonic thickness scanner sends a high-frequency sound pulse from the transducer placed on one side of a sample. The time it takes for the reflected pulse to return from the far side of the sample is a measure of the sample's thickness. A fresh water source is provided to the face of the transducer as a sonic couplant and also functions as a lubricant. Thickness measurements across the sample were obtained with an NDT System's Tunnelscan© motorized X-Y stage with a 300 mm x 450 mm scan area. An X-Y stage allows a 3-dimensional surface to be created from individual thickness measurements. Mounting this stage to the back of the imaging racks permitted monitoring of several corrosion coupons with one setup (Figure 5).

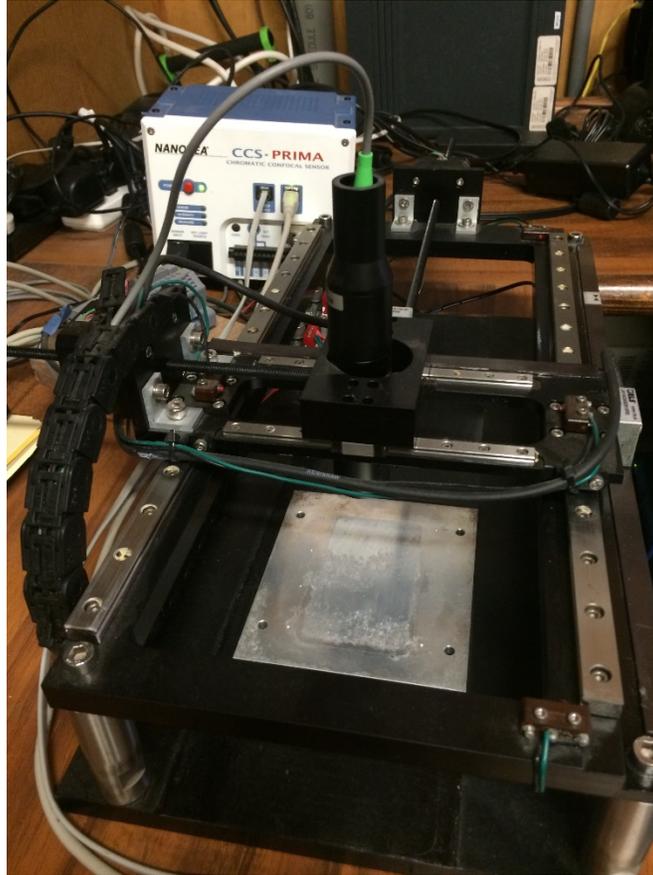
*Figure 6: The laser profilometer scans the surface of a sample to measure corrosion depths.*

A CCS Prima® manufactured by Nanovea and a custom built motorized X-Y stage (Figure 6) was used to create three-dimensional profiles of a sample surface. The laser profilometer uses chromatic confocal measurements to determine the distance to a surface from the laser head. The laser profiles can only be obtained prior to seawater exposure and after the sample is removed from seawater and corrosion product cleaned from its surface. The profilometer has high lateral and depth resolution, 8  $\mu\text{m}$  and 1  $\mu\text{m}$  respectively.

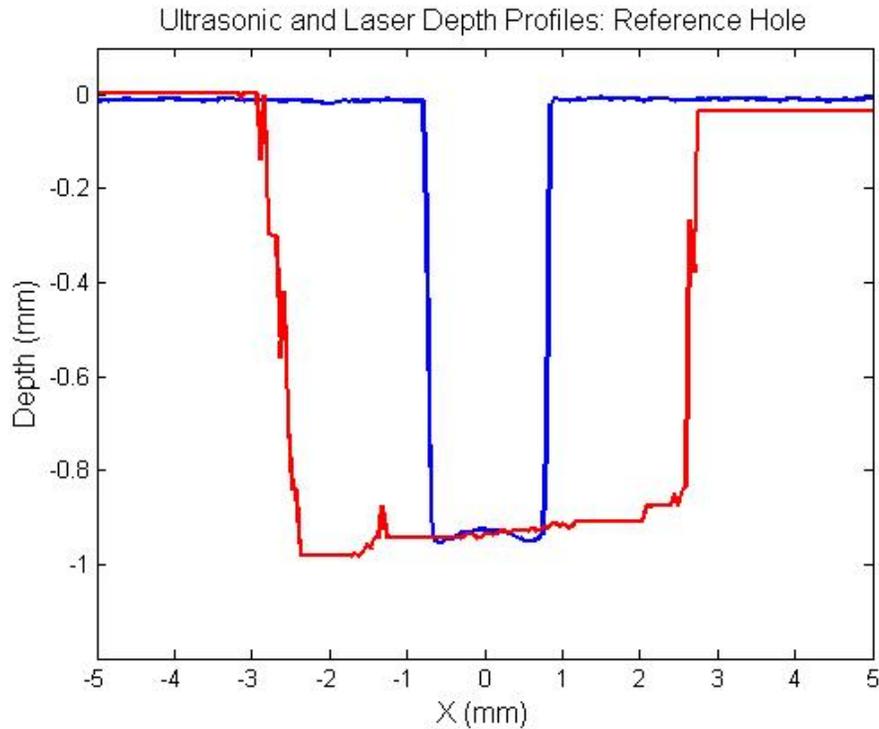
*Figure 7: Comparison of a 0.76 mm diameter reference-hole profile measured ultrasonically (red) and with the laser profilometer (blue).*

There are advantages and disadvantages to each of three different measurement techniques. The major drawback of the ultrasonic measurements is the large beam size of the transducer (13mm) makes pits look larger. Figure 7 compares ultrasonic and laser profilometer measurements of a pre-drilled flat-bottomed reference hole. Despite the difference in measured feature size, both techniques yield a consistent depth for the pre-drilled hole.

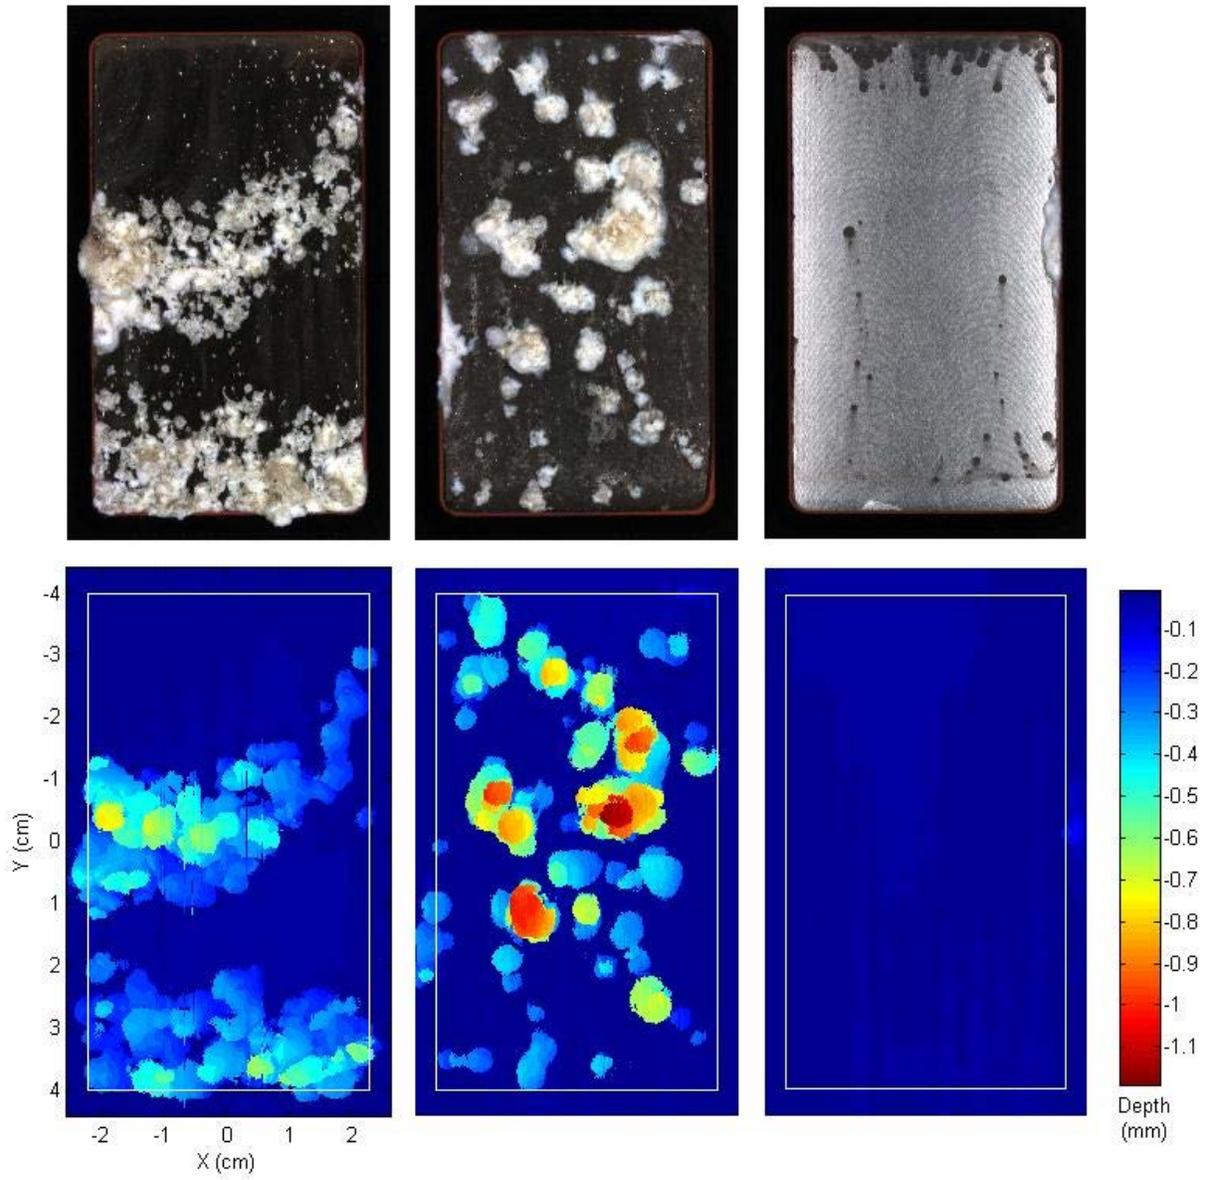
*Figure 8: Images (top) and corrosion depths measured by ultrasonic scanning (bottom) after 150 days in near-stagnant, cold seawater (left - Al 2024, middle - Al 6061, left - Al 5086). White box on ultrasonic images is the location of the gasket.*

The latest images and ultrasonic scans are shown below (Figures 8 and 9). Time lapses of each sample are shown in Appendixes A-E.

Al 2024 was chosen as a test alloy because of its high copper content which accelerates corrosion due to galvanic action. Although this alloy is not in consideration for OTEC heat exchangers, it was tested to allow us to quickly refine our analysis procedures. Al 2024 was the first to corrode; corrosion product appeared on the surface after 3 days in both near-stagnant and flowing water. Corrosion was detected ultrasonically on both samples one week later. Pitting corrosion and gasket corrosion were the dominant modes of corrosion. The sample surfaces developed a dark-red color over time. Corrosion product build-up was different between the two flow environments; the flowing seawater sample had smaller but more numerous accumulations in the center of the sample compared to the near-stagnant seawater sample.

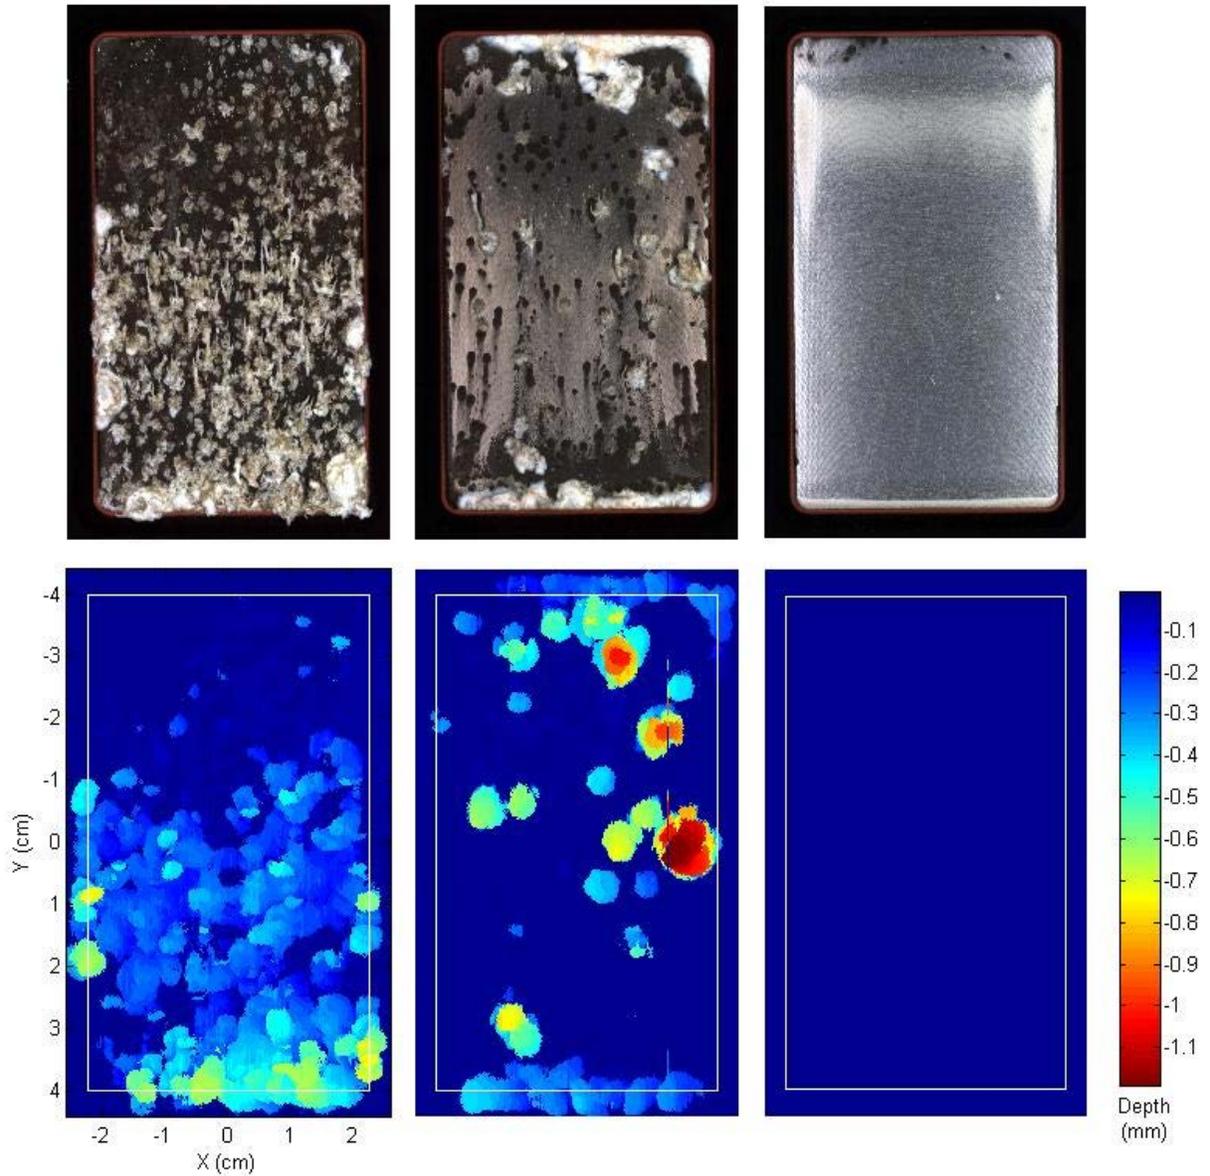
*Figure 9: Images (top) and corrosion depths measured by ultrasonic scanning (bottom) after 150 days in 1 m/s flowing cold seawater (left - Al 2024, middle - Al 6061, left - Al 5086). White box on ultrasonic images is the location of the gasket.*

The Al 6061 samples also corroded quickly; corrosion product appeared on the surfaces after 20 days for the near-stagnant and flowing seawater samples. Pitting and gasket corrosion were the primary modes of corrosion. Pits were first detected ultrasonically after 25 and 40 days for the near-stagnant and flowing seawater samples respectively. In stagnant seawater, a dark red background color covered the surface similar to the Al 2024 samples. Corrosion product accumulation was greater and more distinct in the near-stagnant sample relative to the flowing seawater sample. In flowing seawater, the uniform dark red color was not established on the surface; instead, dark spots which are bacterial colonies have taken hold (Figure 10).

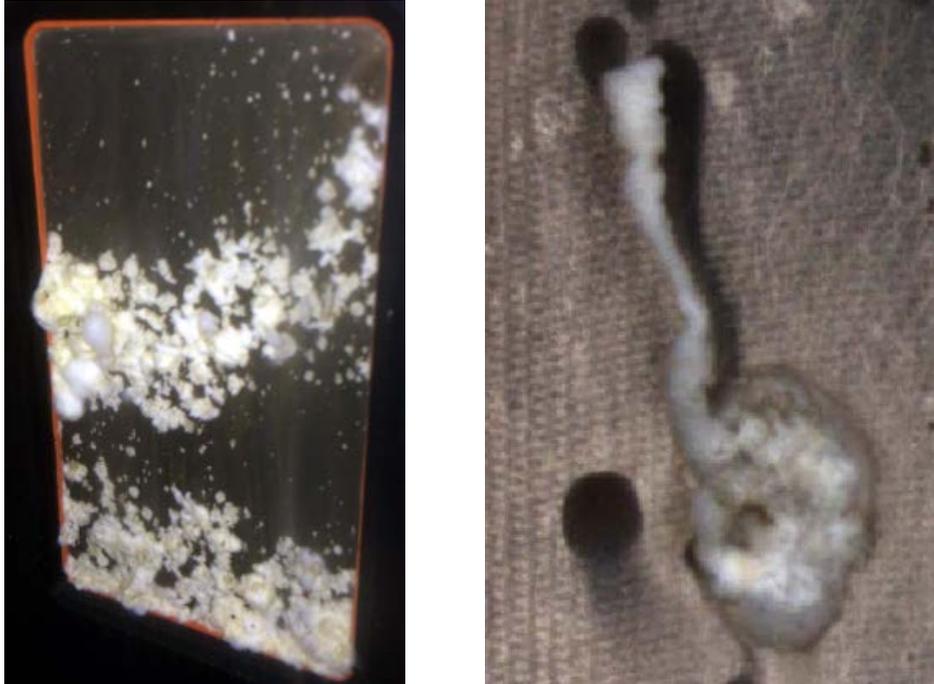
*Figure 11: Left - White corrosion product built up from the surface of the Al 2024 sample in near-stagnant seawater. Right - Corrosion product growing in the upstream direction on the Al 6061 sample in flowing seawater.*

Corrosion product (aluminum oxide) builds up from a sample surface as white gelatinous accumulations. In flowing water ‘stalagmites’ can grow upstream from the pit locations (Figure 11). The accumulation of product can extend many millimeters from the surface. Pieces of the corrosion product occasionally break off and then regrow, especially if a change in flow conditions occurs.

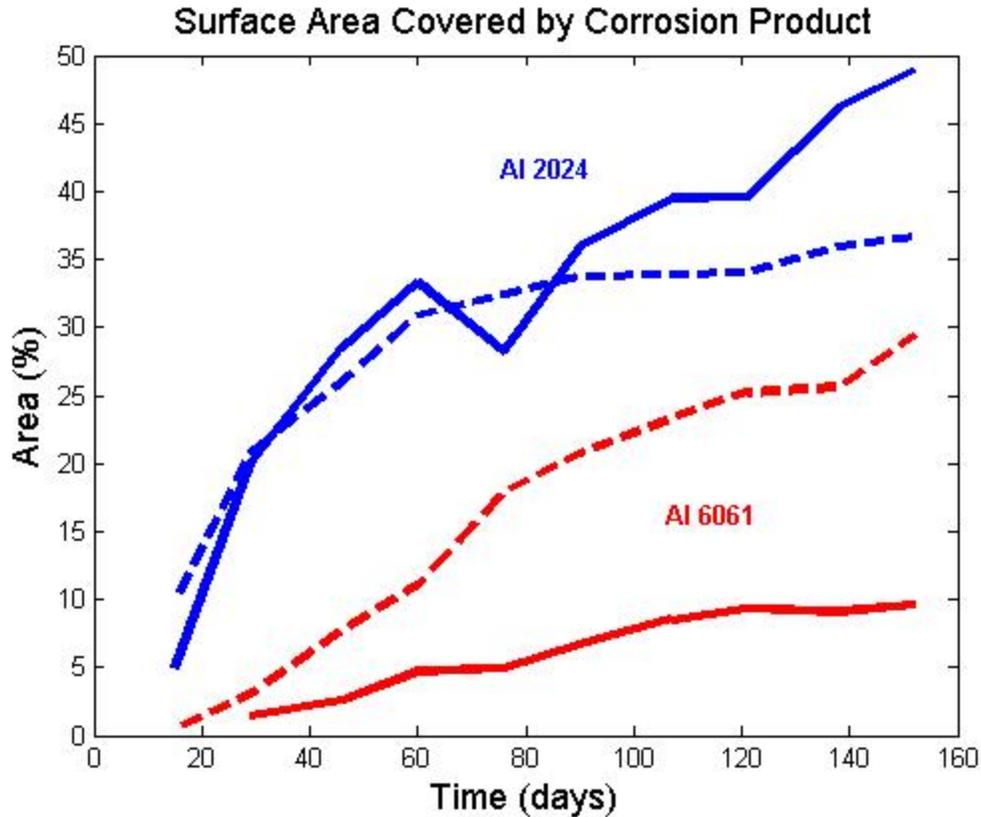
Figure 12: Surface area covered with corrosion product for the two alloys exhibiting pitting corrosion. Dashed lines are samples in near-stagnant seawater, solid lines are in 1 m/s flowing seawater.

Figure 12 plots the accumulation of corrosion product on the sample surfaces over time. This is an important parameter because corrosion product buildup can restrict flow channels, change local flow regimes, decrease thermal conductivity and ultimately, significantly reduce heat transfer performance of the heat exchanger. If alloys are poorly selected, corrosion product could cover more than 10% of the surface within a few months.

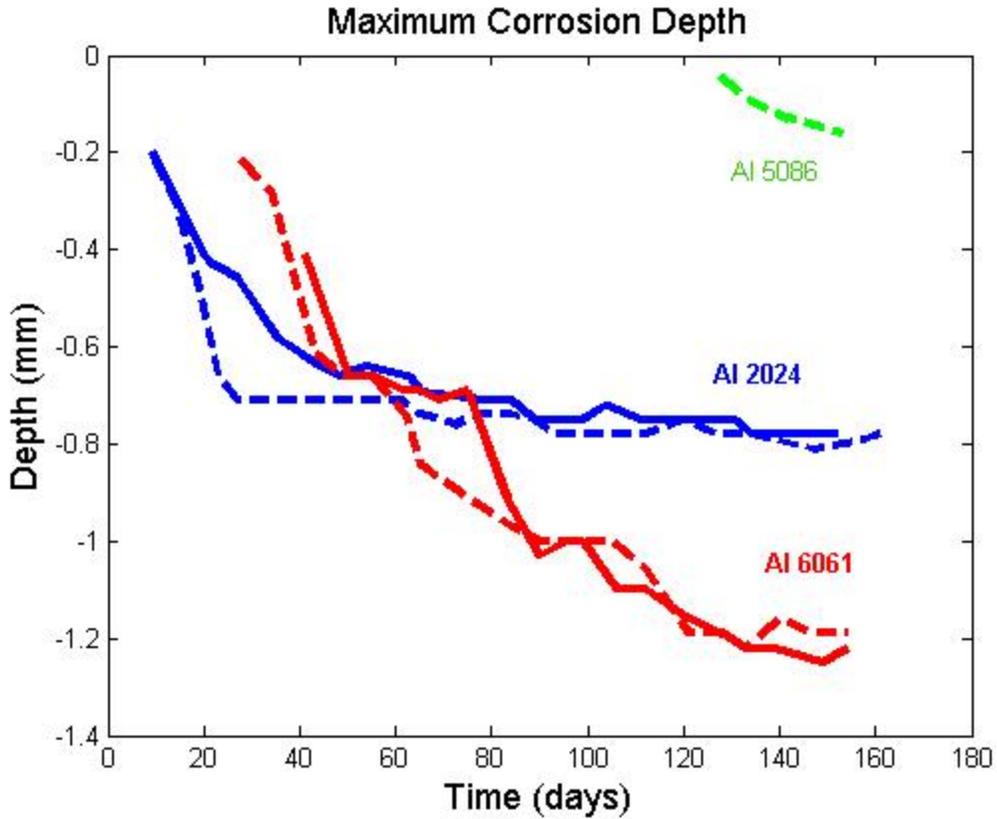
Figure 13: Maximum corrosion depth over time for the alloys showing corrosion. Dashed lines are samples in near-stagnant seawater, solid lines are in 1 m/s flowing seawater.

The maximum pit depth is plotted versus time in Figure 13. After a few weeks of rapid pit growth, deepening of pits on Al 2024 samples slowed down. The Al 6061 samples show a nearly uniform rate of corrosion deepening. With pits depths of approximately 1 mm within a few months, a typical shell-and-tube heat exchanger made from Al 2024 or Al 6061 would quickly fail. Al 5086 has so far performed better, only showing signs of corrosion at the gasket in near-stagnant seawater.

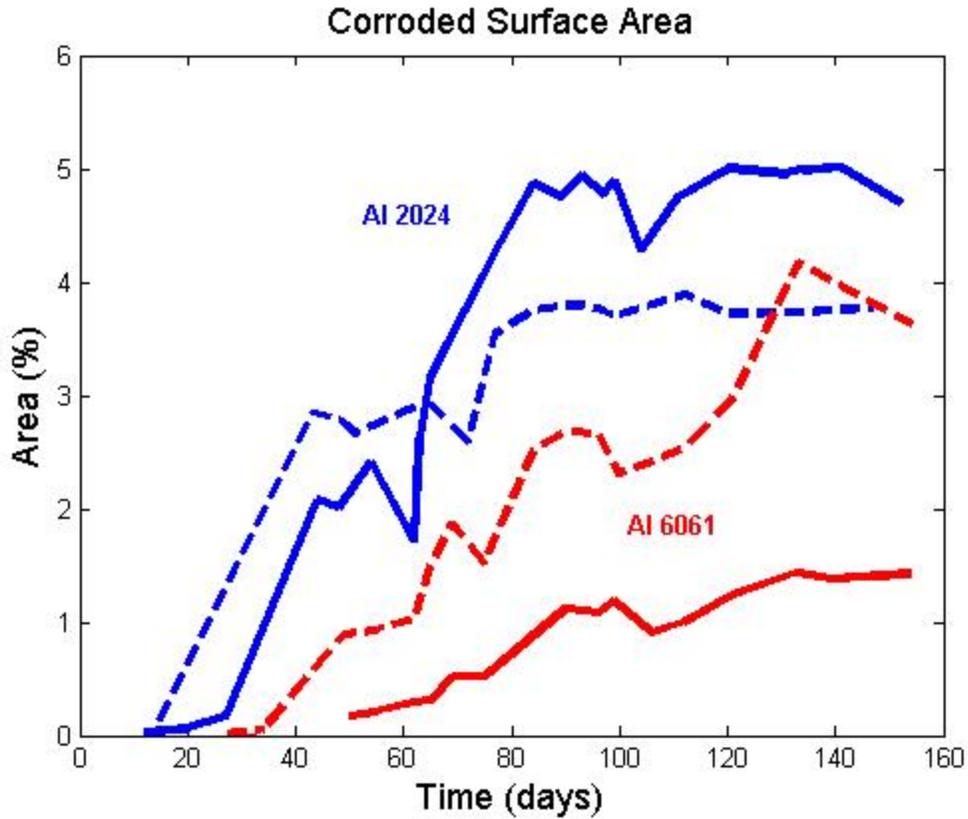
Figure 14: Estimates of corroded surface area over time. Dashed lines are samples in near-stagnant water, solid lines are in 1 m/s flowing water.

Another parameter determined from the ultrasonic measurements is the surface area covered by pits (defined as the area with pits depths greater than 0.1 mm). Because the large ultrasonic beam size makes accurate measurement impossible, the results were normalized based on laser profilometer scans of samples that were removed. While the percent area coverage is an estimate, the relative behavior over time is reflective of corrosion development (Figure 14). Increases in the corroded surface area followed the same trend as increases in the maximum pit depth. The rate of increase in corroded surface area slowed over time for Al 2024 but remained constant for Al 6061.

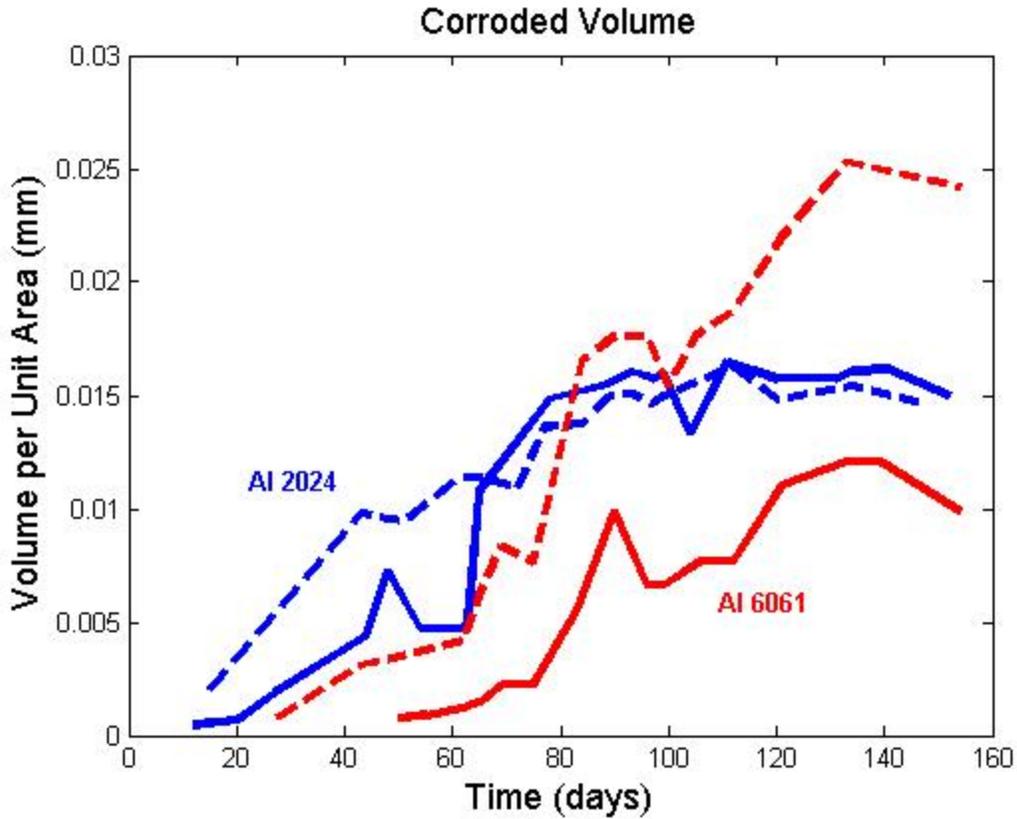
Figure 15: Estimates of total volume of material removed over time. Dashed lines are samples in near-stagnant seawater, solid lines are in 1 m/s flowing seawater.

The total volume of material removed was estimated by calculating the mean corrosion depth over the corroded surface area (Figure 15). These measurements were also normalized based on post-processing profilometer data, but the relative trends are informative and were similar to the corroded surface area and maximum pit depth trends.

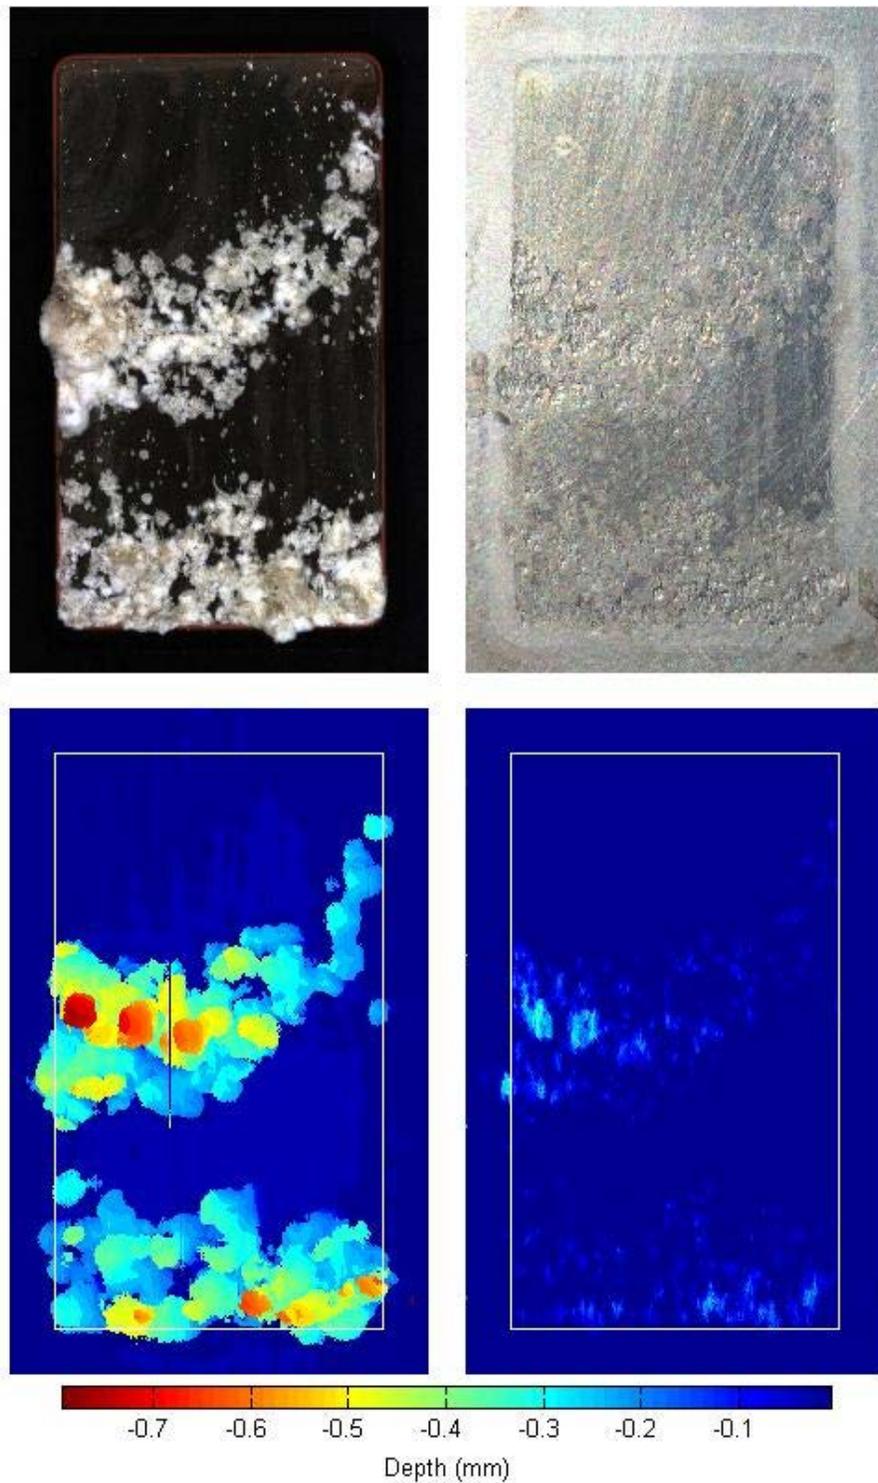
*Figure 16: Al 2024 sample in near-stagnant seawater before and after processing. Upper left - surface image while the sample was still in seawater, upper right - sample after corrosion product was removed, lower left - ultrasonic scan performed during testing, lower right - laser profilometer scan after corrosion product was removed. White box shows the location of the gasket's inner edge.*

Three samples were removed from the experiment for post-processing (Al 2024 from both seawater sources and Al 6061 from the near-stagnant seawater source). The remaining samples continue to be tested to record their long term corrosion development. After removal from seawater, corrosion product was removed from the surface and samples were scanned by the laser profilometer. Figures 16 through 18 compare the different measurement techniques for each removed sample.

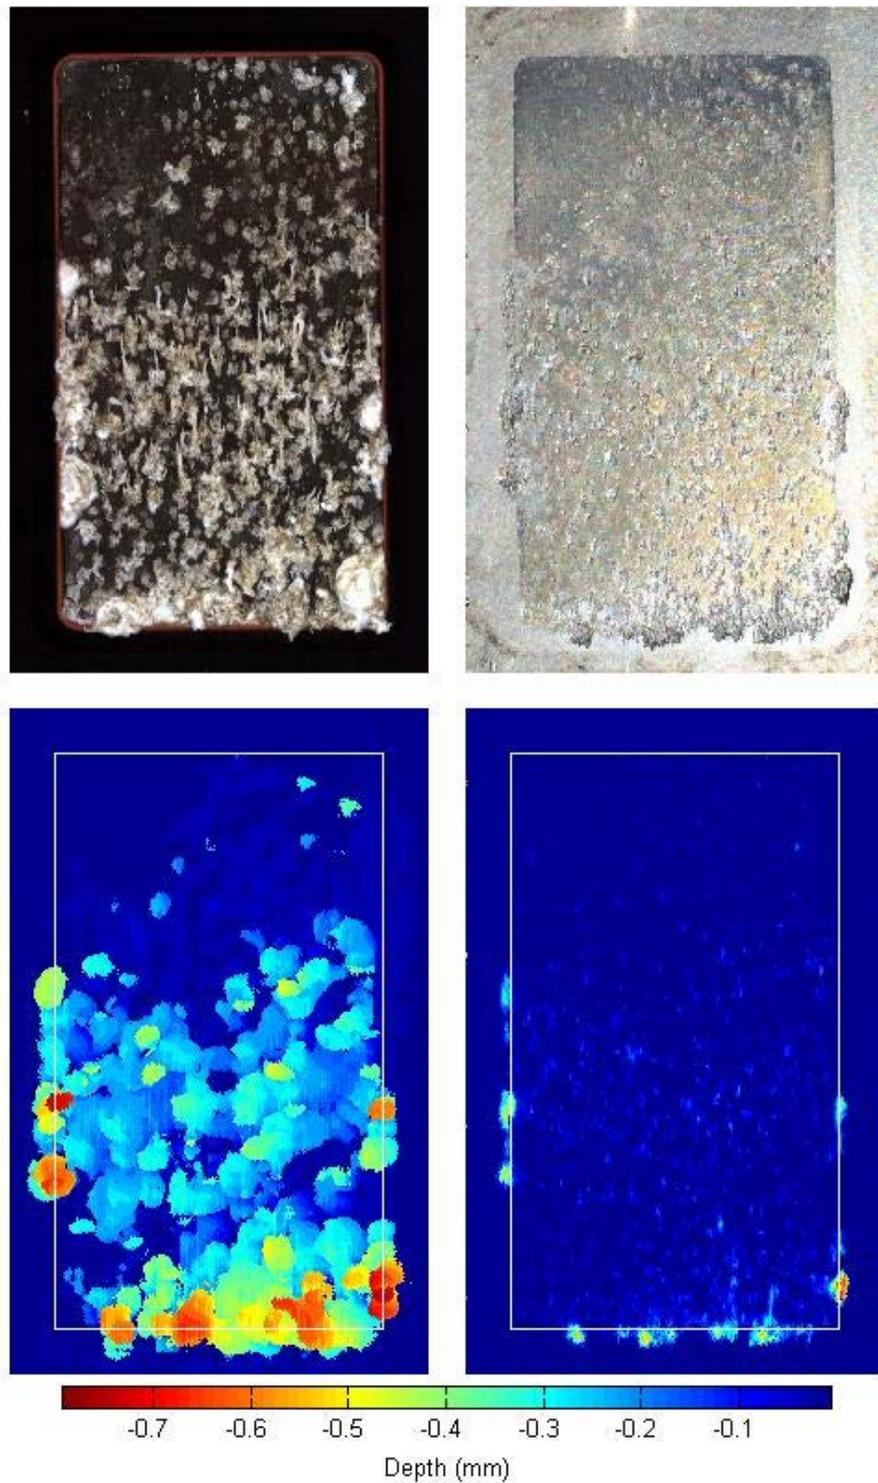
*Figure 17: Al 2024 sample in 1 m/s flowing seawater before and after processing. Upper left - surface image while the sample was still in seawater, upper right - sample after corrosion product was removed, lower left - ultrasonic scan performed during testing, lower right - laser profilometer scan after corrosion product was removed. White box shows the location of the gasket's inner edge.*

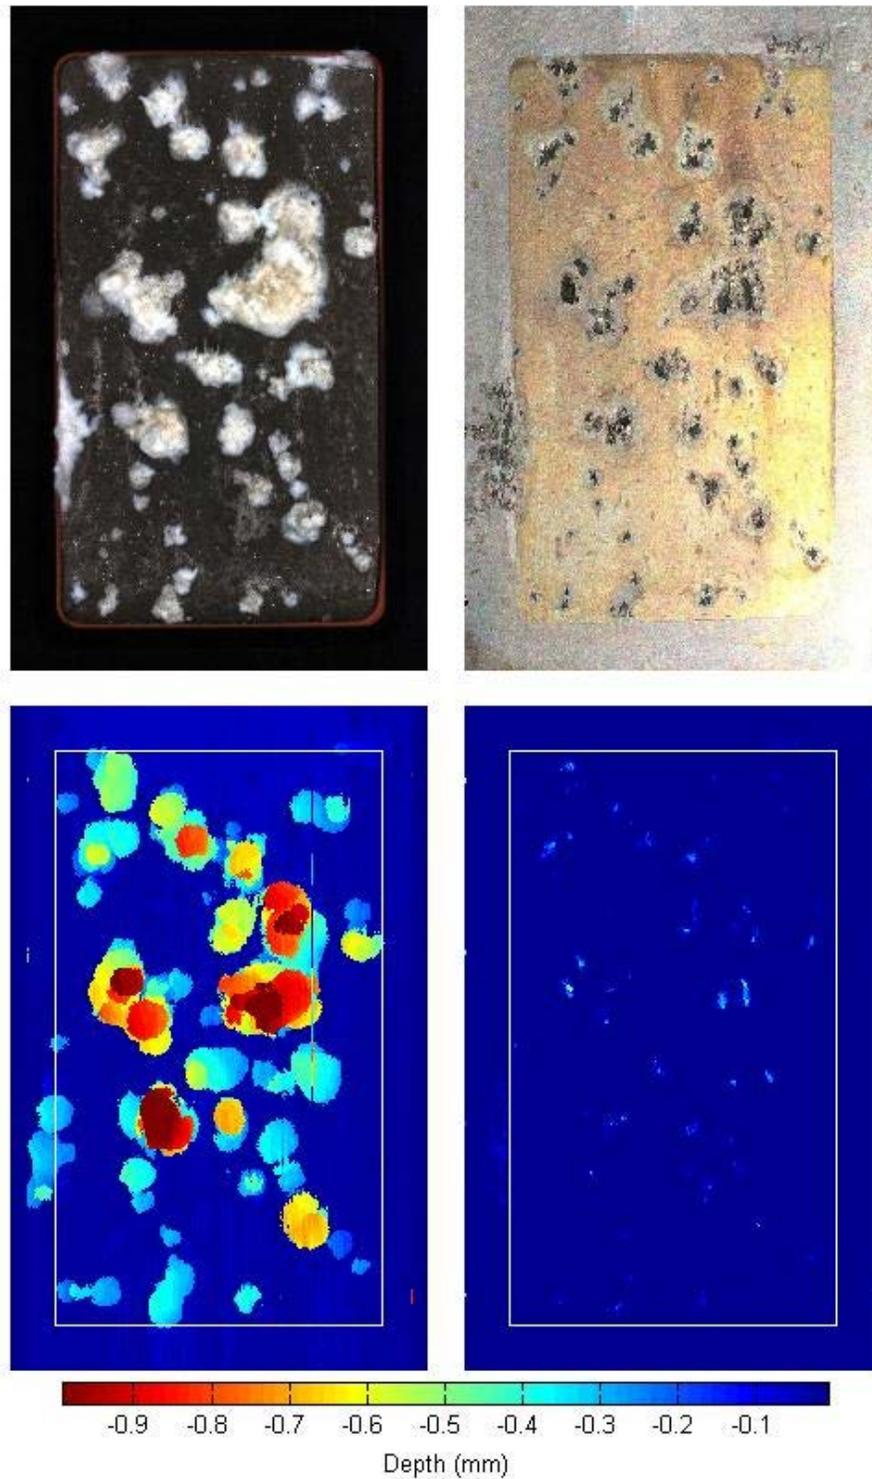
*Figure 18: Al 6061 sample in near-stagnant seawater before and after processing. Upper left - surface image while the sample was still in seawater, upper right - sample after corrosion product was removed, lower left - ultrasonic scan performed during testing, lower right - laser profilometer scan after corrosion product was removed. White box shows the location of the gasket's inner edge.*

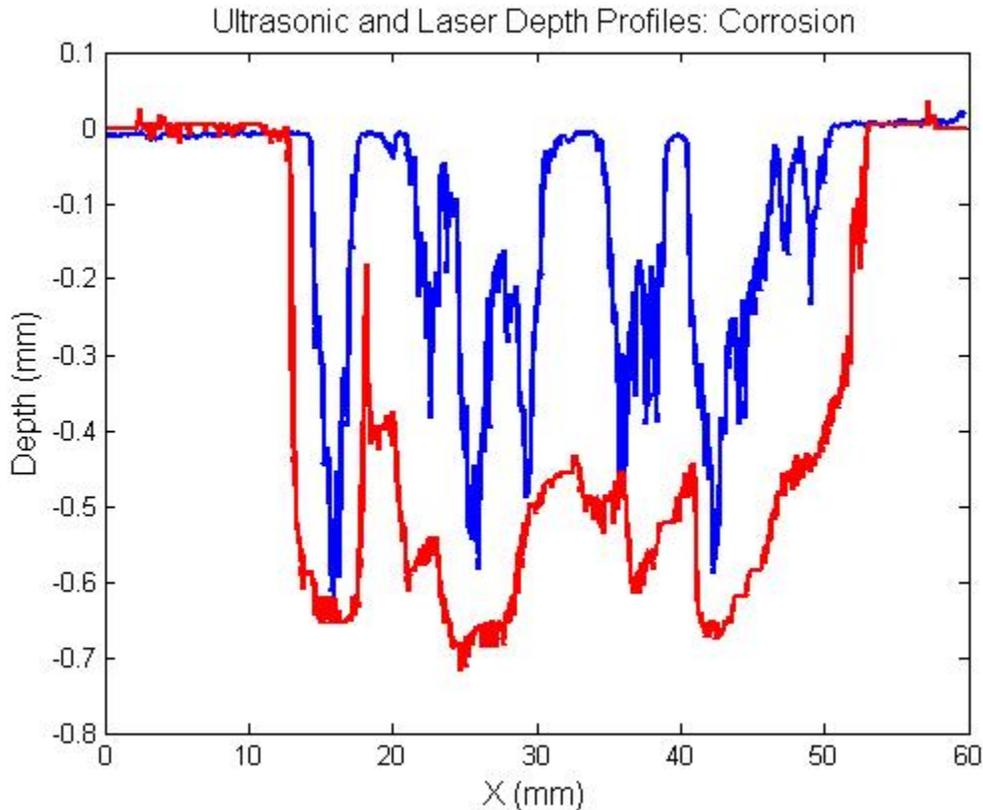
*Figure 19: Corrosion profiles across a sample measured ultrasonically (red) and with the laser profilometer (blue).*

The locations of corrosion product accumulation and pitting is strongly correlated. Ultrasonic pits appear wider than pits identified in profilometer scans due to the large transducer beam size. However, there is an unaccounted-for discrepancy between ultrasonically measured and laser profilometry measured pit depths. Profilometry measured pits are shallower than ultrasonically measured pits (Figure 19).

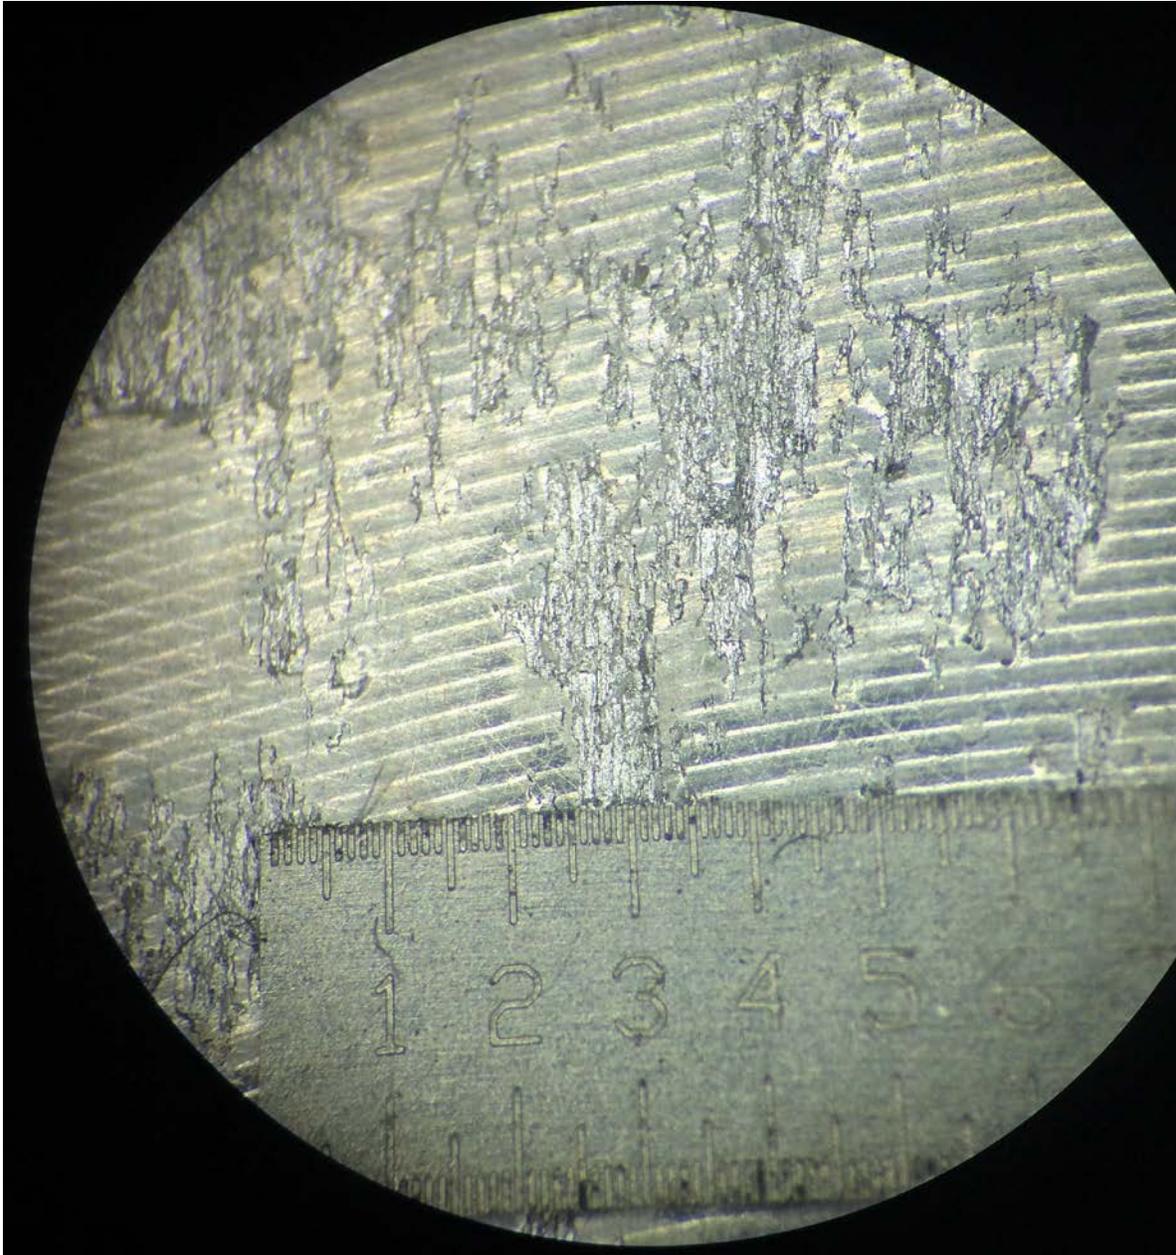
*Figure 20: Pits on the surface of the Al 2024 sample in near-stagnant seawater. Pits are porous and develop preferentially along the extrusion direction.*

Visual observations show that pits are craterous and porous and can develop undercuts (Figures 20 through 22). Furthermore, the removal of corrosion product can cause changes in the shape of pits as some areas swell and metal fragments that were held in place with corrosion product are removed. Since the profilometer can only measure line-of-sight depths, we hypothesize that inherent pit features obstruct the laser profilometer from measuring the full pit depth. Because the ultrasonic scans pick up the sound reflected from the first surface discontinuity encountered (i.e., the deepest extent of corrosion penetration), the ultrasonic scans are a more conservative measurement of pit growth. Previous pitting studies that used pit depths obtained solely by laser profilometer may have underestimated the extent of pit penetration.

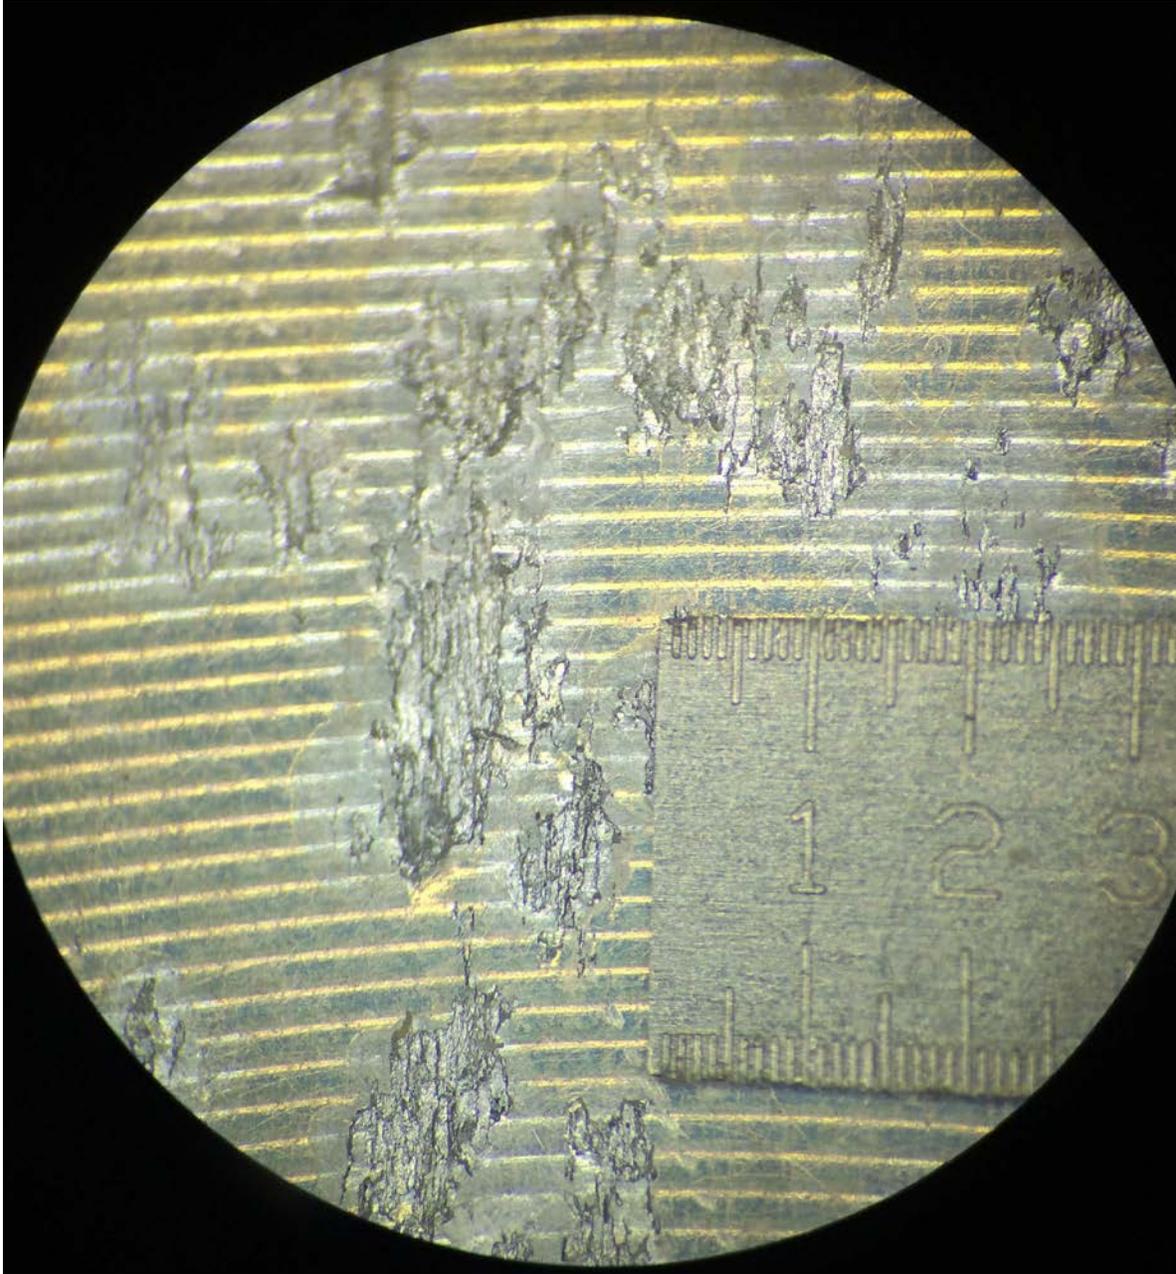
*Figure 21: Pits on the surface of the Al 2024 sample in 1 m/s flowing seawater. Pits are porous and develop preferentially along the extrusion direction.*
