# Hawaii National Marine Renewable Energy Center (HINMREC)

# OTEC Heat Exchanger Program: 2015 Ultrasonic Scanning for Corrosion Monitoring Report

Prepared by:  
Makai Ocean Engineering

February 2015

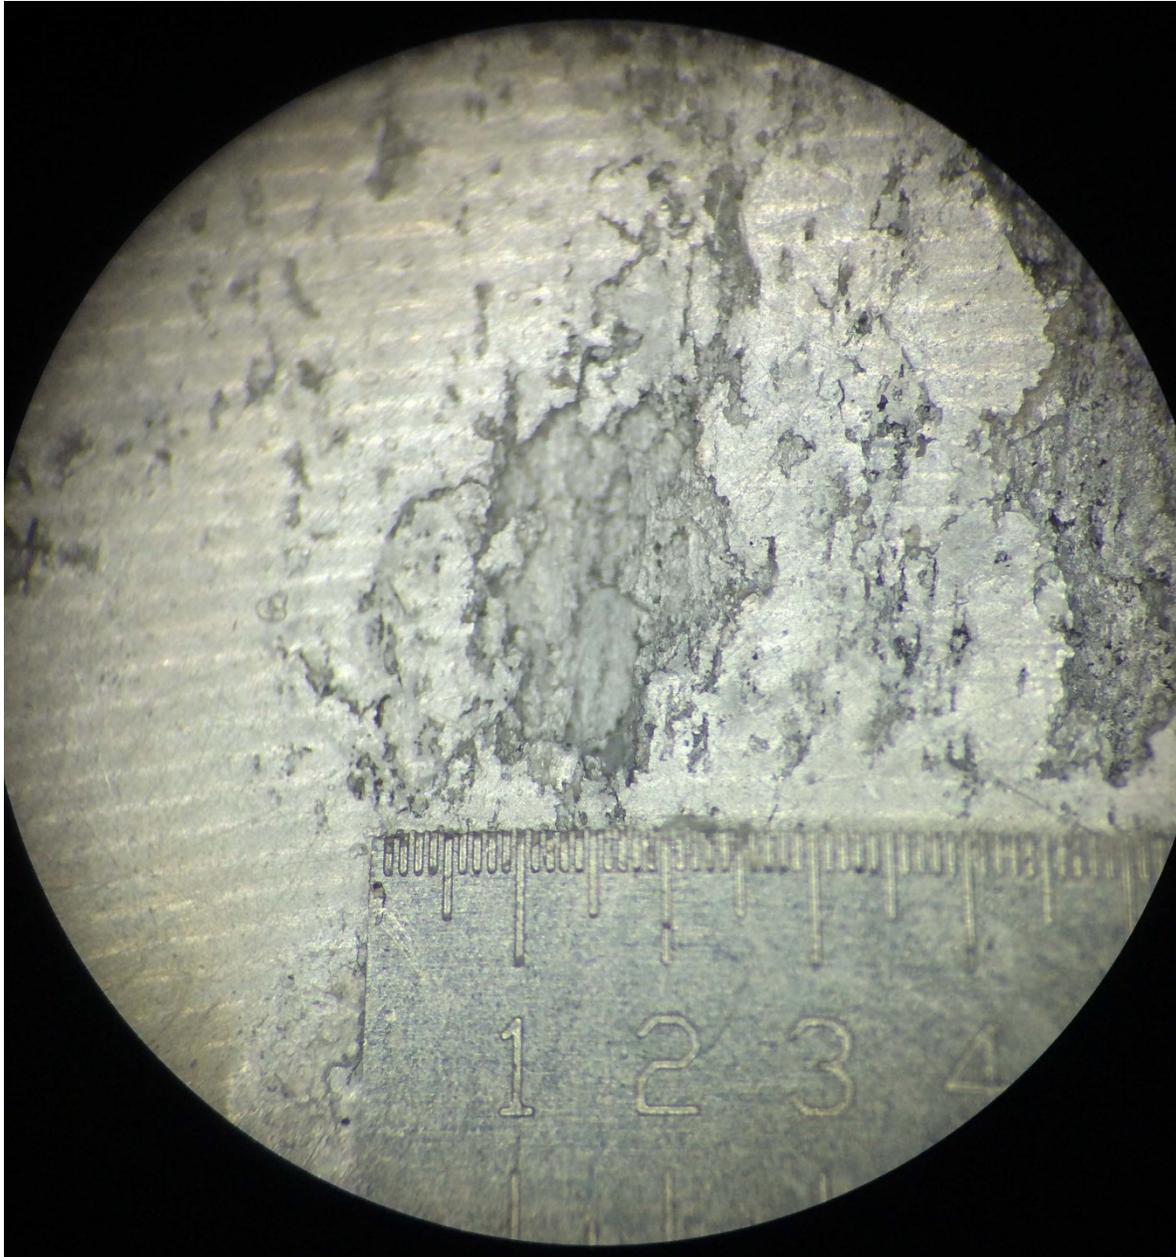
*Figure 22: A pit on the surface of the Al 6061 sample in near-stagnant seawater. Pits are porous and develop preferentially along the extrusion direction.*

Visual observations show that pits are craterous and porous and can develop undercuts (Figures 20 through 22). Furthermore, the removal of corrosion product can cause changes in the shape of pits as some areas swell and metal fragments that were held in place with corrosion product are removed. Since the profilometer can only measure line-of-sight depths, we hypothesize that inherent pit features obstruct the laser profilometer from measuring the full pit depth. Because the ultrasonic scans pick up the sound reflected from the first surface discontinuity encountered (i.e., the deepest extent of corrosion penetration), the ultrasonic scans are a more conservative measurement of pit growth. Previous pitting studies that used pit depths obtained solely by laser profilometer may have underestimated the extent of pit penetration.

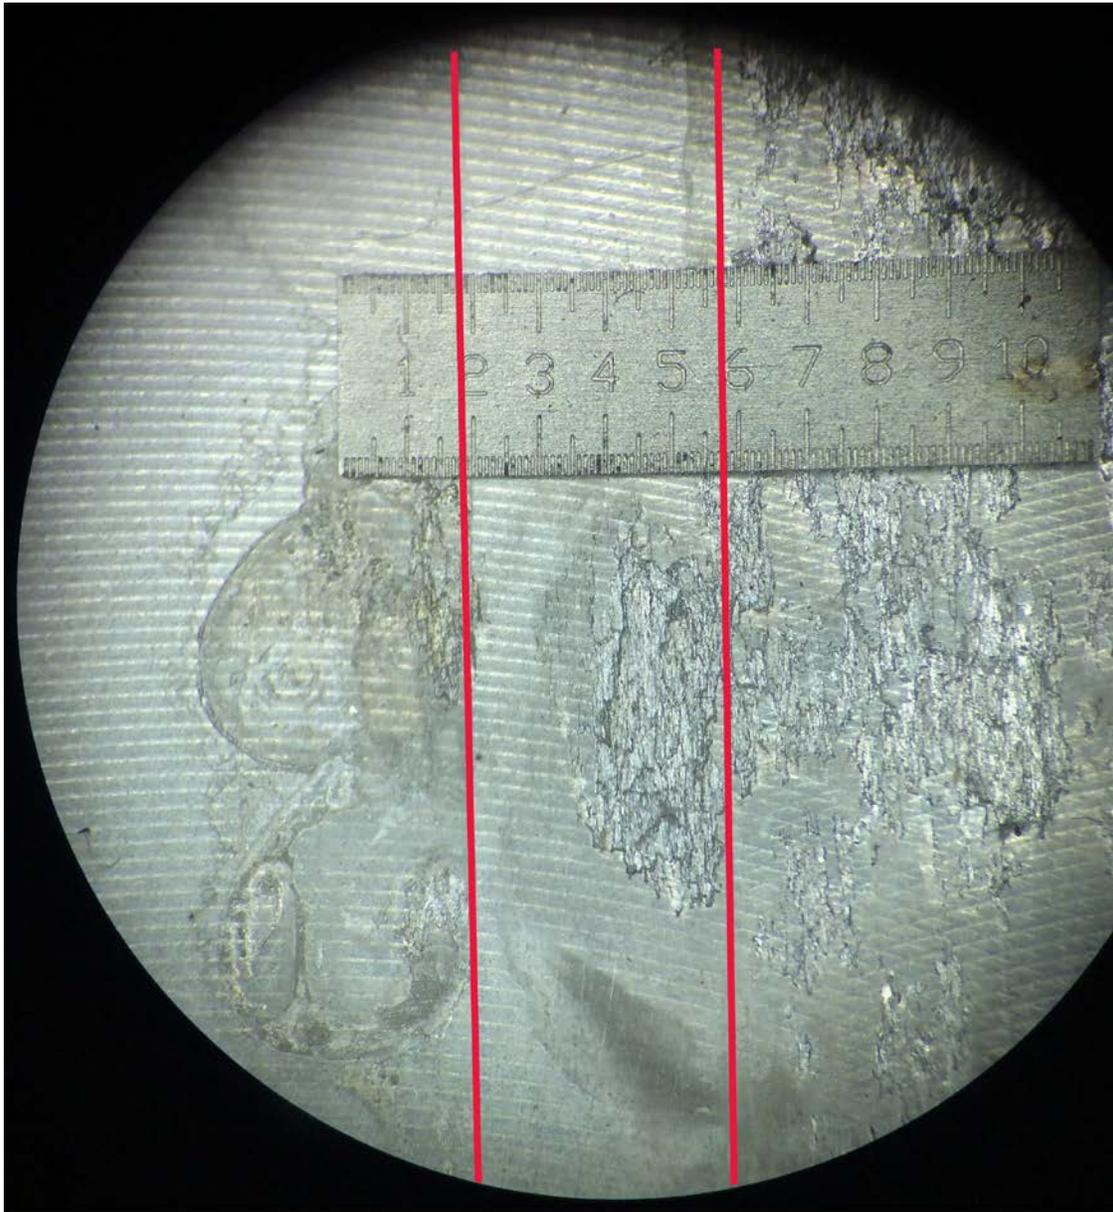
*Figure 23: Corrosion at the gasket (indicated by the red lines) on the Al 2024 sample in near stagnant seawater. Seawater flow is to the right of the gasket and air is to the left. In this sample corrosion has developed outside the gasket, indicating seawater penetration under the gasket.*

All samples (except Al 5086 in flowing seawater) developed crevice corrosion at the gasket interface (Figures 23 through 25). This form corrosion can slowly open a channel for seawater to leak under the gasket from the heat exchanger into the environment. Although leaks were not observed in any of the samples, the Al 2024 and Al 6061 samples in near-stagnant water developed corrosion outside the gasket, indicating seawater had penetrated under the gasket to the non-exposed side.

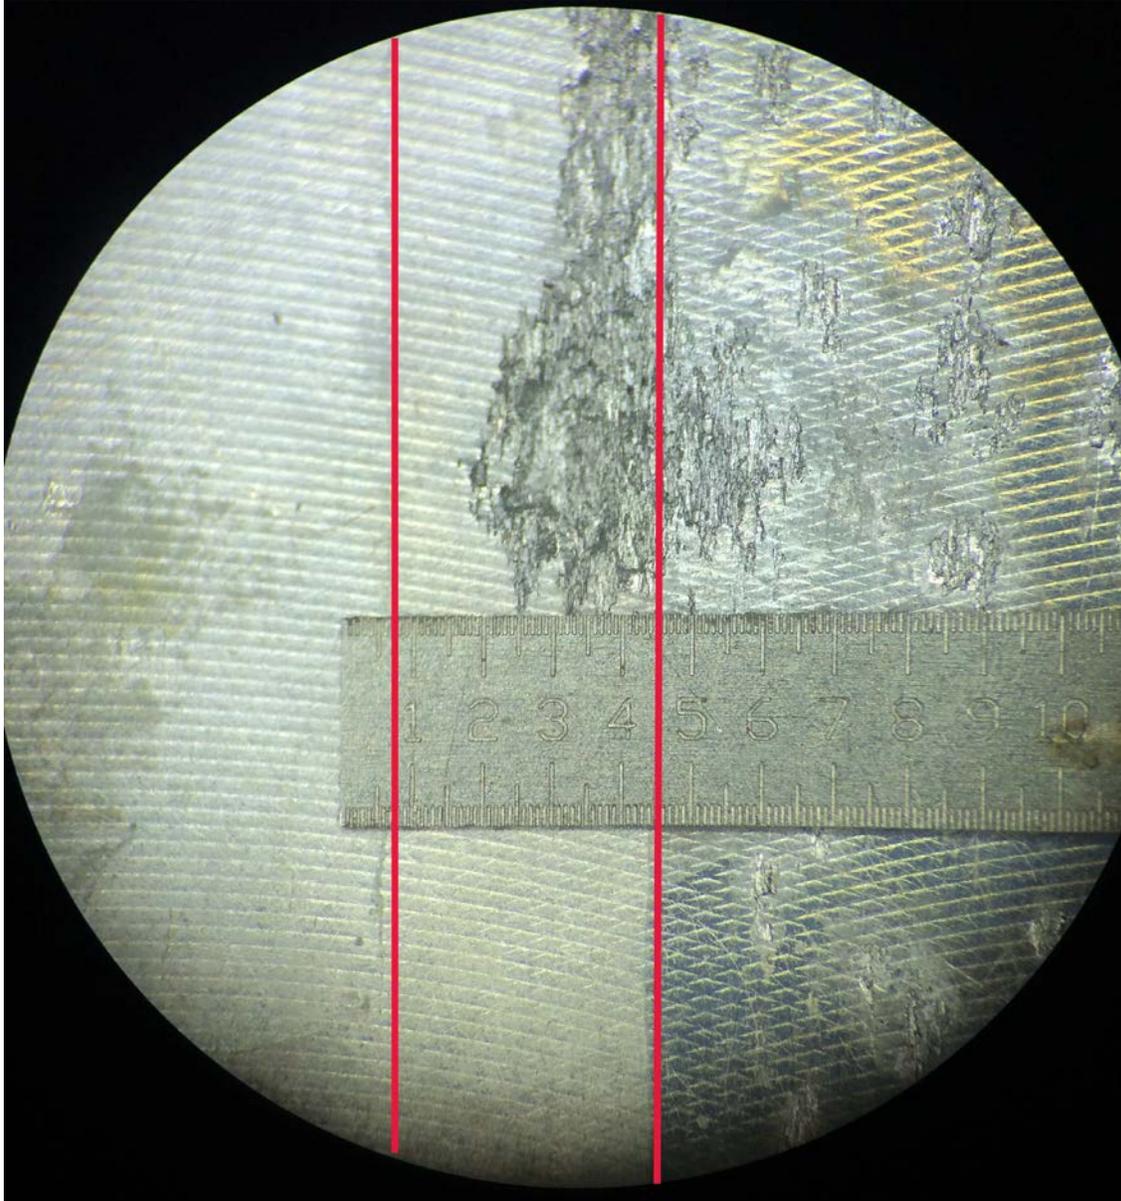
*Figure 24: Corrosion at the gasket (indicated by the red lines) on the Al 2024 sample in 1 m/s flowing seawater. Seawater flow is to the right of the gasket and air is to the left. In this sample there is no indication of seawater penetration under the gasket.*

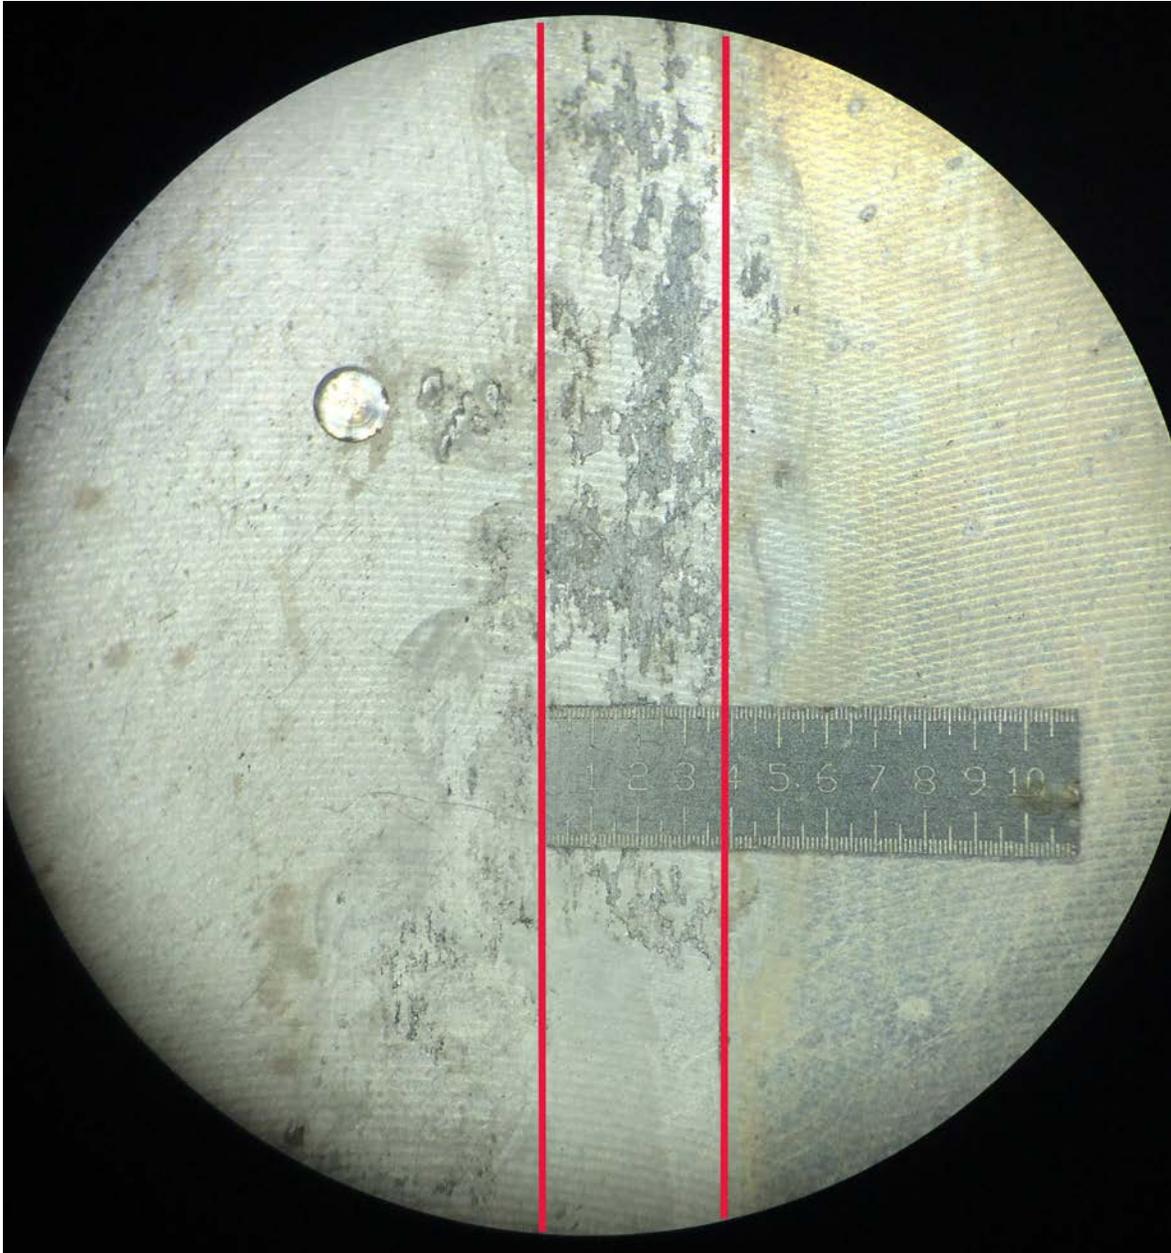
*Figure 25: Corrosion at the gasket (indicated by the red lines) on the Al 6061 sample in 1 m/s flowing seawater. Seawater flow is to the right of the gasket and air is to the left. In this sample corrosion has developed on the outside of the gasket, indicating some degree of seawater penetration under the gasket.*

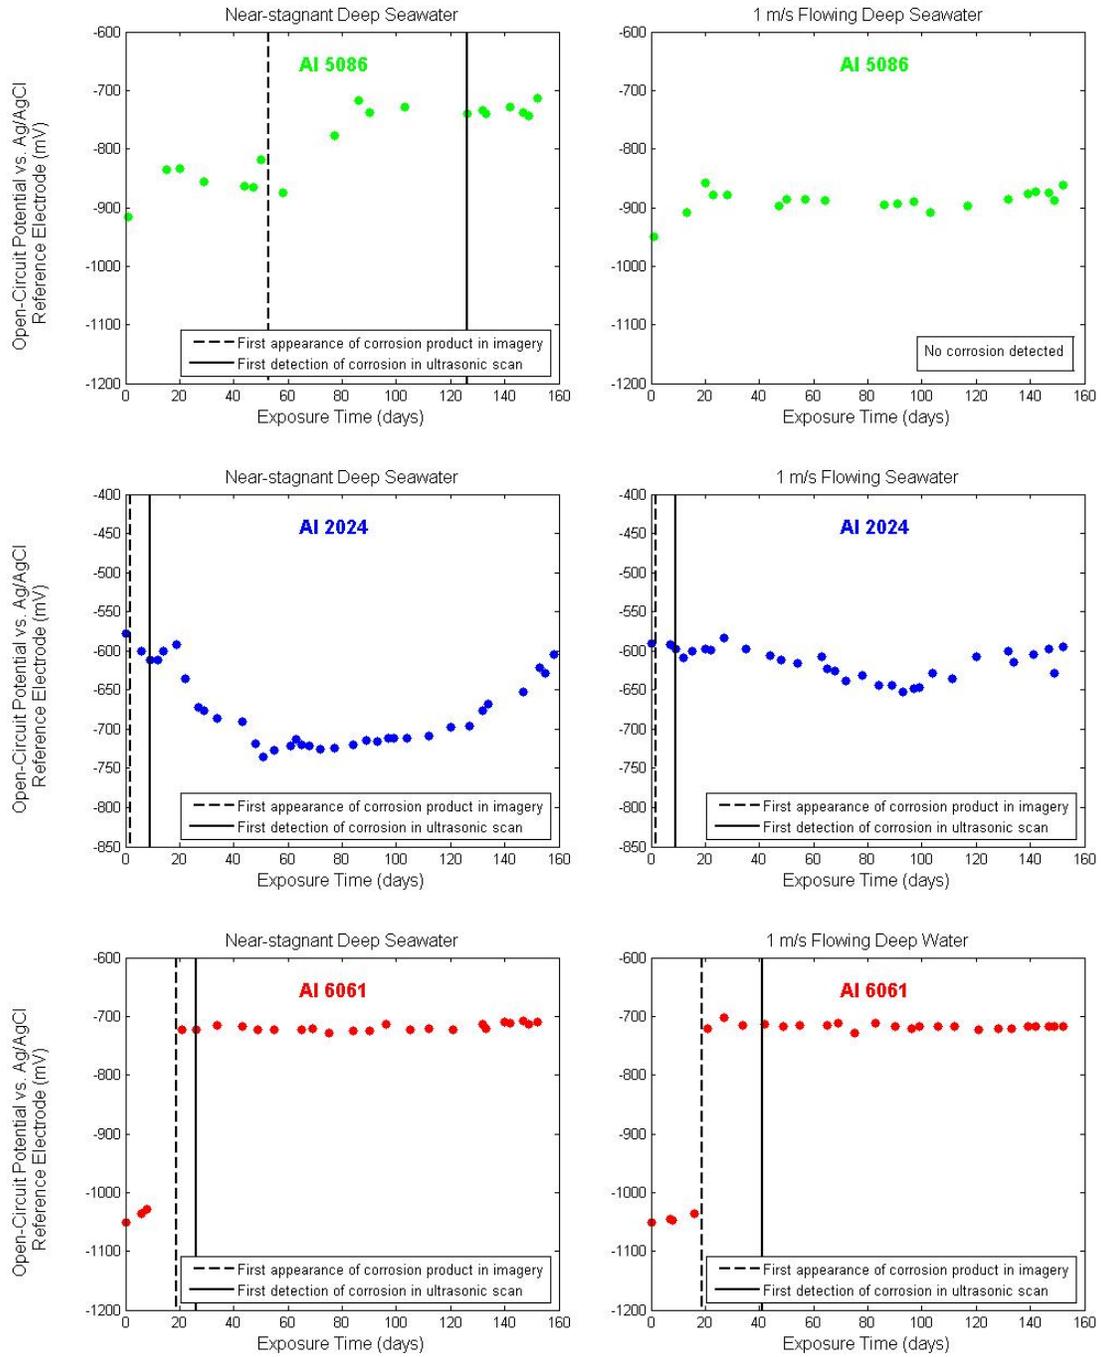
Figure 26: Open-circuit potentials against an Ag/AgCl reference electrode.

OCP of all samples is shown in Figure 26. Al 6061 samples showed a dramatic change in OCP when corrosion product was first observed on the sample, rising abruptly from approximately -1050 mV to approximately -700 mV. OCP of the corroding Al 5086 sample also showed a change in OCP about the time that corrosion was observed, changing from approximately -900 mV to -700 mV. The Al 2024 samples show no dramatic change in OCP upon the appearance of corrosion, but continued to change over time.
