Energy Audit Results for Forest City Phase I and Phase II

Subtask 3.5: End-use Energy Efficiency and Demand Response

Project Report 2: Energy Audit Results for Forest City Phase I and Phase II

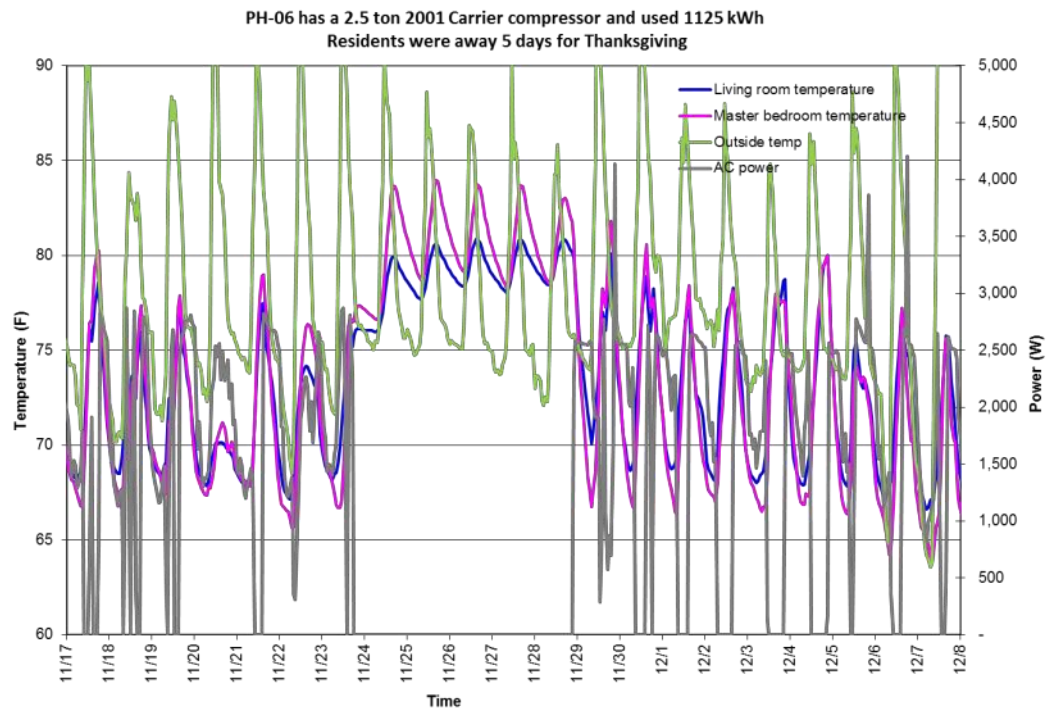
Figures 5 and 6 show the indoor temperatures achieved in two houses that are both equipped with 2.5- ton, 2001 Carrier compressors. PH-03 uses 342 kWh/mo for AC, has a programmable thermostat in the living room and the temperature in that room remains remarkably stable, in the 74-76°F range. The upstairs bedroom temperature is not as stable and reaches 80°F occasionally, indicating it is not receiving enough of the conditioned air. In comparison, PH-06 uses 1,125 kWh/mo for AC, has a manual thermostat and can achieve 70°F at night, but the temperatures reach 80°F in the afternoon both upstairs and downstairs. Further investigation is needed to determine the problem with PH-06, which could stem from leaky ducts or a problem with the compressor. Turning off the AC while they were gone for five days at Thanksgiving saved approximately 237 kWh for the November billing.

Figure 6. AC compressor power use vs. temperatures for home PH-06 which used 1,125 kWh/mo for cooling.

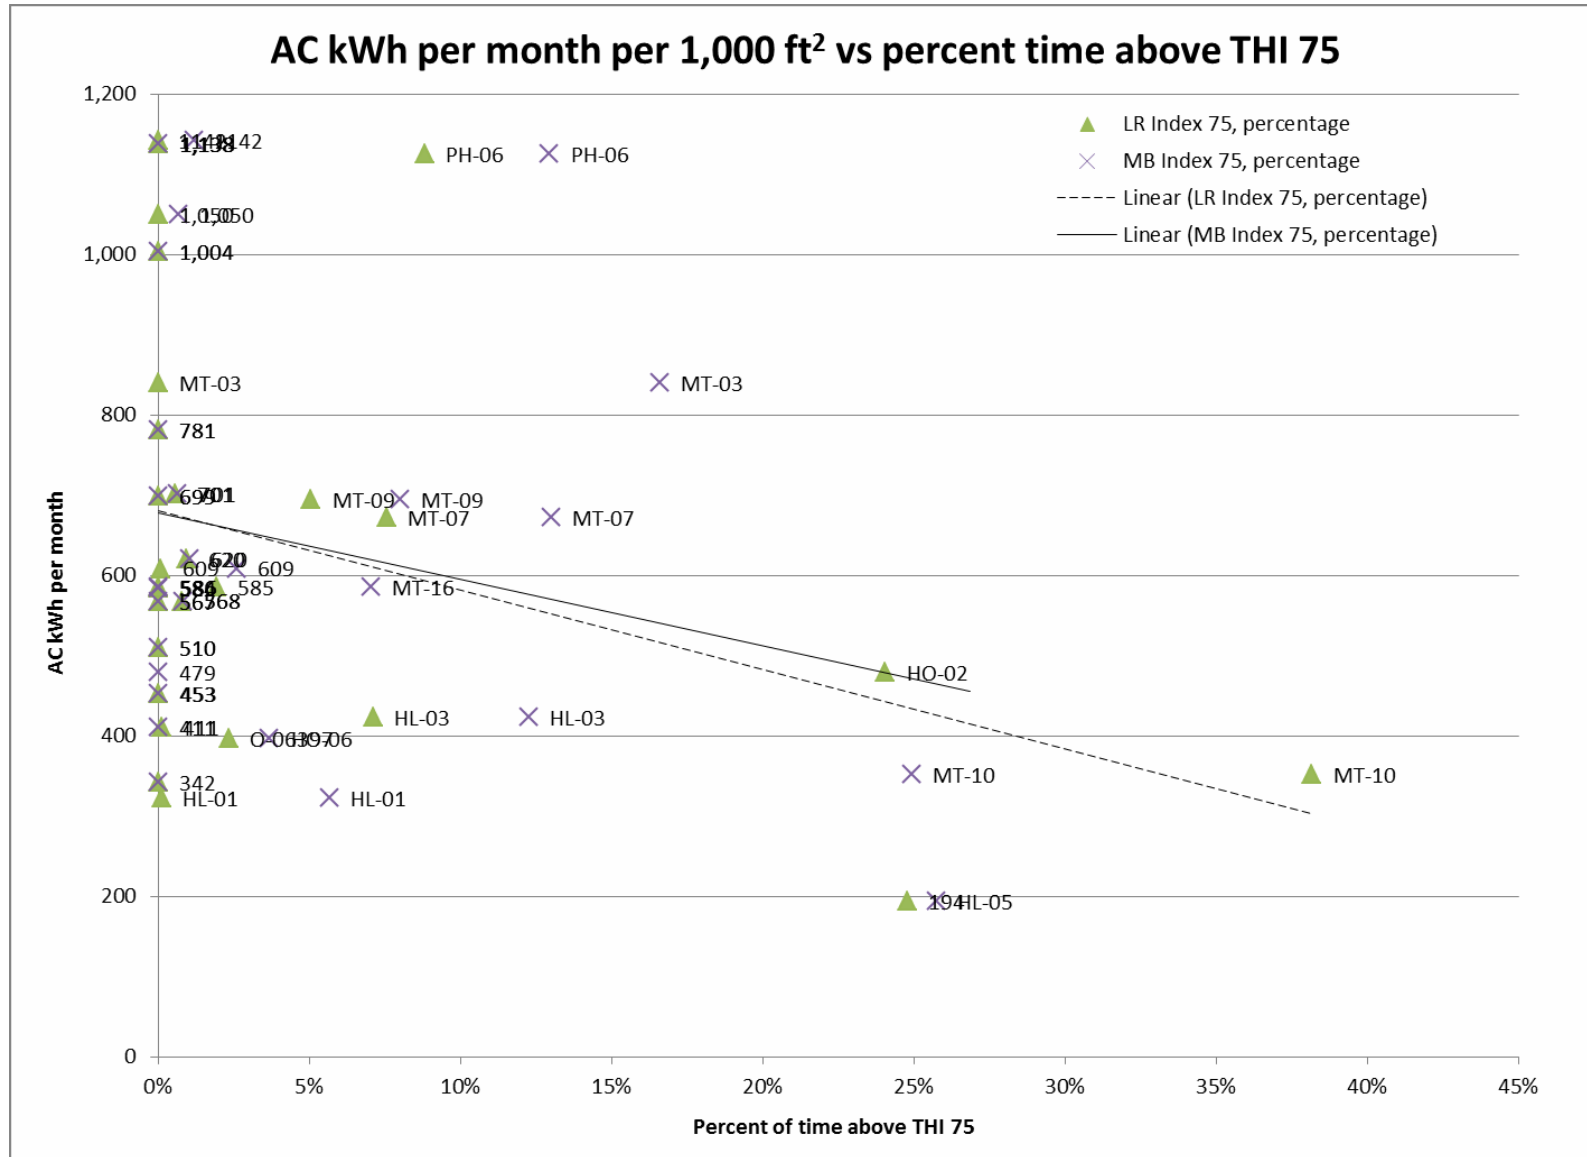
Although the above issues can affect the individual heating patterns of a home, all the homes were built in a similar manner and exist in a similar environment, therefore should follow a basic pattern of: more air conditioning equals more comfort. Several homes did not follow this trend and show high internal temperatures despite extremely high air conditioning use. Figures 9 and 10 show the relationship between air conditioning energy use vs. comfort in the homes. The ideal home would use little to no air conditioning yet be low in the percent of time above THI 70 (some people report discomfort) and THI 75 (at least 50% of people would report discomfort). Thus the lower left corner of the graph represents an ideal situation and the upper right hand corner represents the worst scenario.

Figure 10. Percent time THI was over 75 vs AC energy (kWh/month per 1,000 ft²).

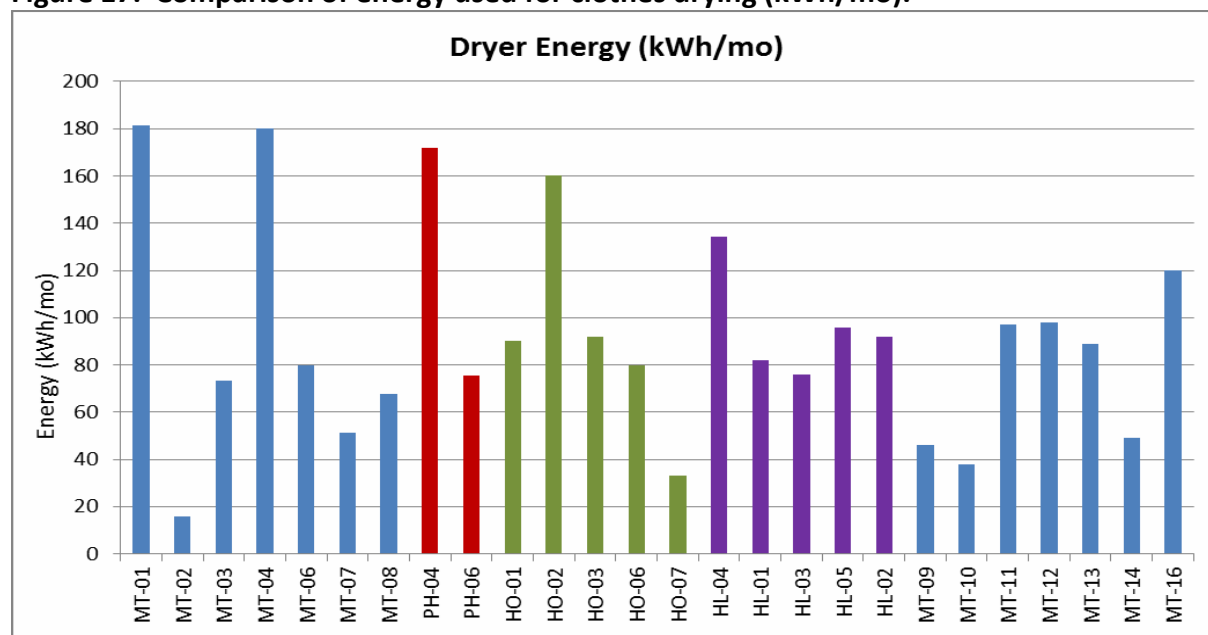
Energy used monthly for drying clothes varied from 16 to 181 kWh (Fig. 17). Monthly hours of operation ranged from 7 to 95 hrs. This is mainly due to variations in lifestyles, but dryer efficiency could play a role. Some of the ventilation ducts were long and not venting the hot, humid air properly - adding to the heat and humidity (“latent heat”) load of the home. A typical 12-pound load of dry laundry can hold 8 pounds of water when taken out of the washer.

Figure 17. Comparison of energy used for clothes drying (kWh/mo).

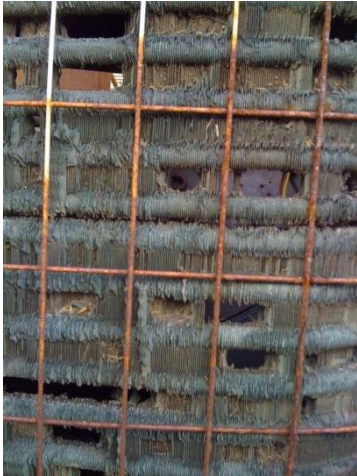
Photo 1. Corroded cooling fins.

1. Choose a compressor with good grill protection of cooling fins – the few observed with good protection were in good condition.
2. Specify anticorrosion coating compressor fins.
3. Air handler located in an indoor closet is good; in the garage is the very worst. If not well sealed, hot and sometimes contaminated air (exhaust fumes, etc.) will be distributed into the home.
4. High Temperature differential between floors: need a better balance of ducts/grill size – zoning and distribution.

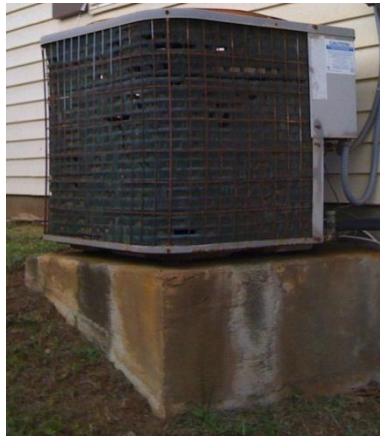
Photo 2. Compressor on concrete pad protects it.

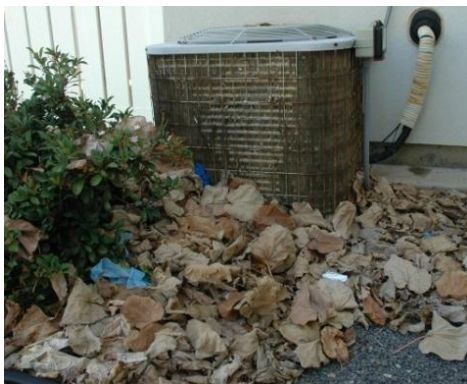
Photo 3. Leaves piled up by compressor.

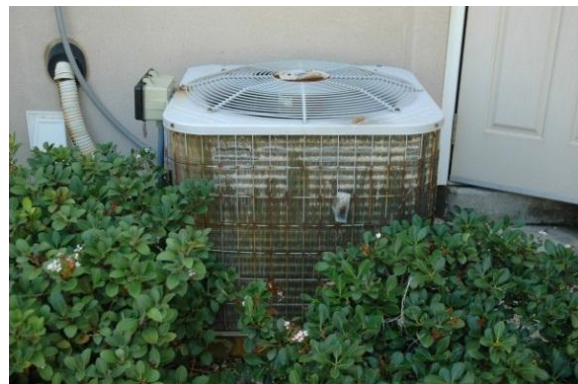
Photo 4. Bushes growing too close.

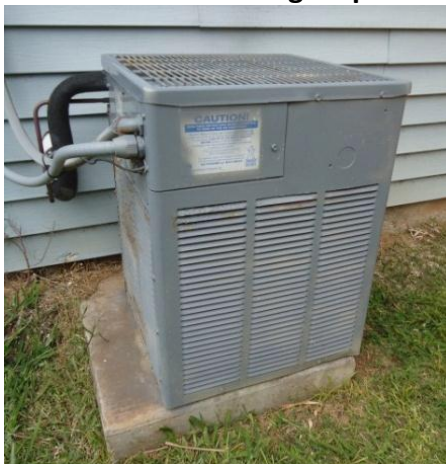
Photo 5. Good cooling fin protection.

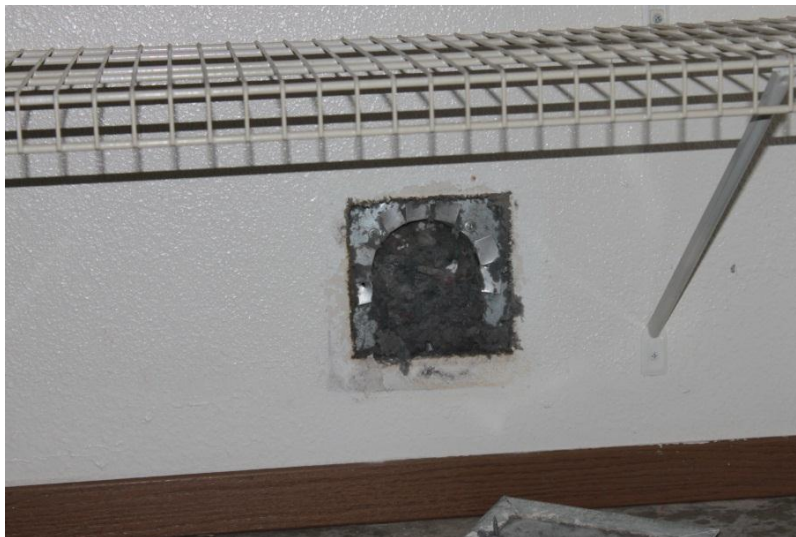
Photo 8. Clogged dryer duct in an empty home.

1. Dryer duct lengths are often too long with a couple of 90° elbows. Avoid this in new builds and retrofit existing houses with long duct runs by installing a clean-out access. In one 2-story house we inspected, the dryer duct ran from the first floor up to the attic.
2. Dryer duct needs regular inspection/clean out.
3. Dryer located in the garage is a good idea – it is isolated and will keep heat and humidity out of house.

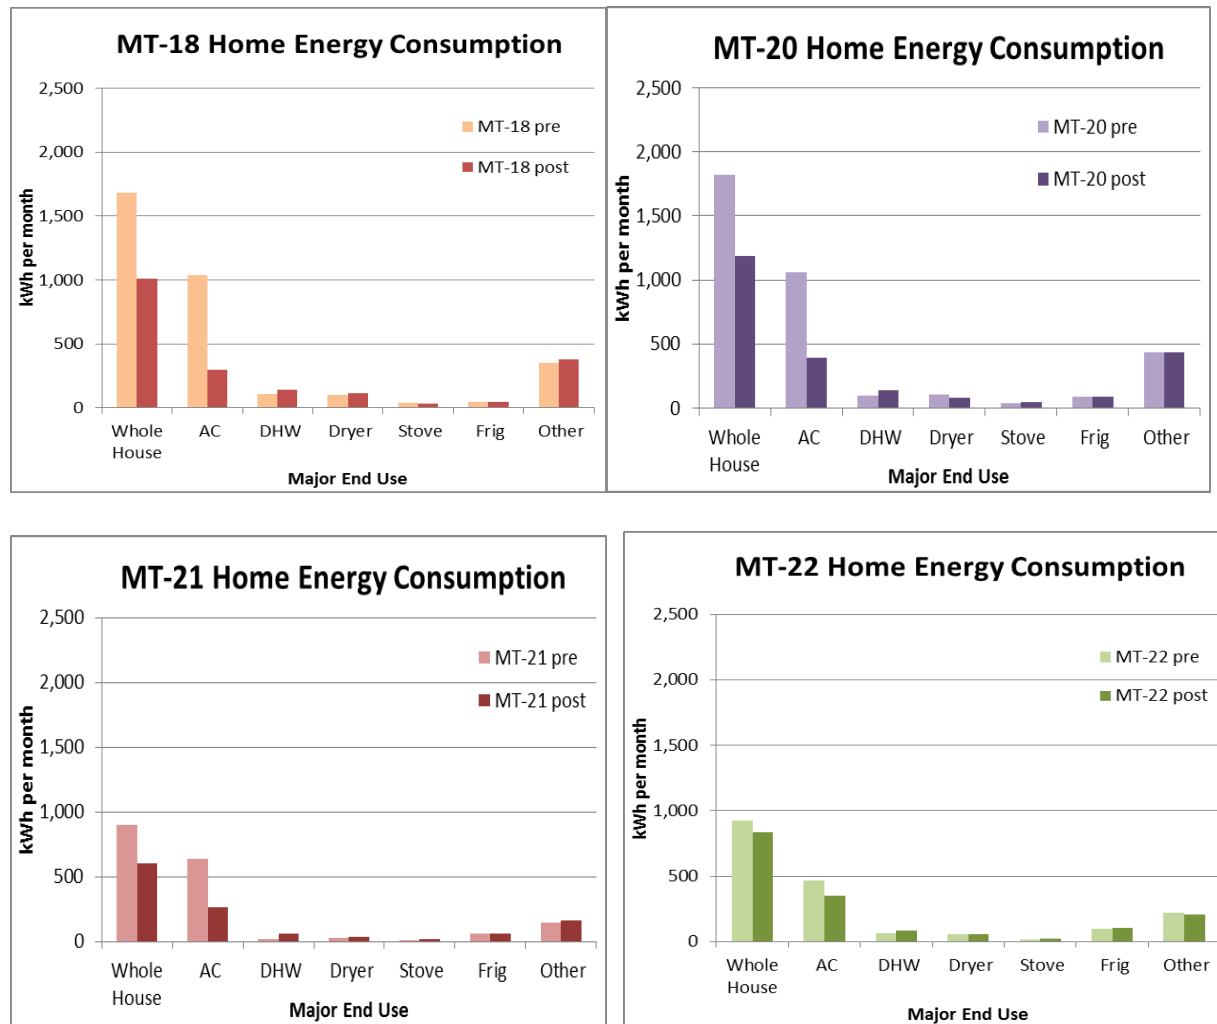
As seen in Phase I, air conditioning is the predominant end-use in Forest City homes in Hawai'i. Figures 19 and 20 show the energy consumption of air conditioning compared to other major appliances in the home.

Figure 19. Comparative energy use of major appliances, pre- and post-retrofit.

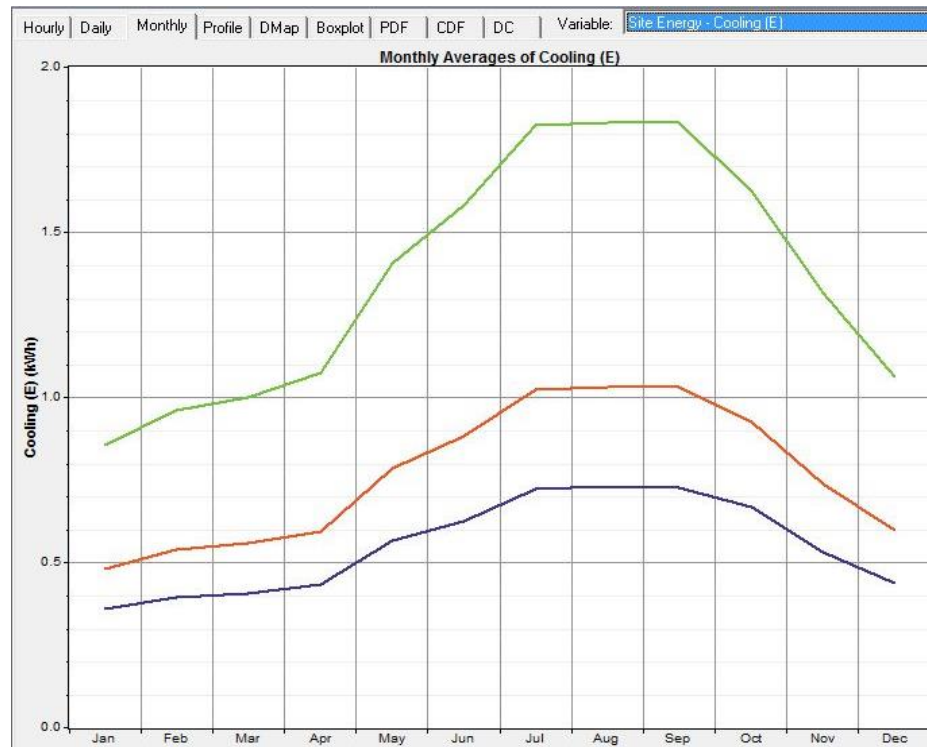
Figure 23. Energy simulation graphical output from BEOpt showing energy use over the year of a house before retrofit (green line), a retrofitted house (red line), a hypothetical retrofitted house with a deeper retrofit.
