# Hawai'i Energy and Environmental Technologies (HEET) Initiative

## TASK 4 ALTERNATIVE ENERGY SYSTEMS 4.1 OTEC Heat Exchanger: Testing Program Annual Report

Prepared by:  
Makai Ocean Engineering

# OTEC HX Testing Program Annual Report

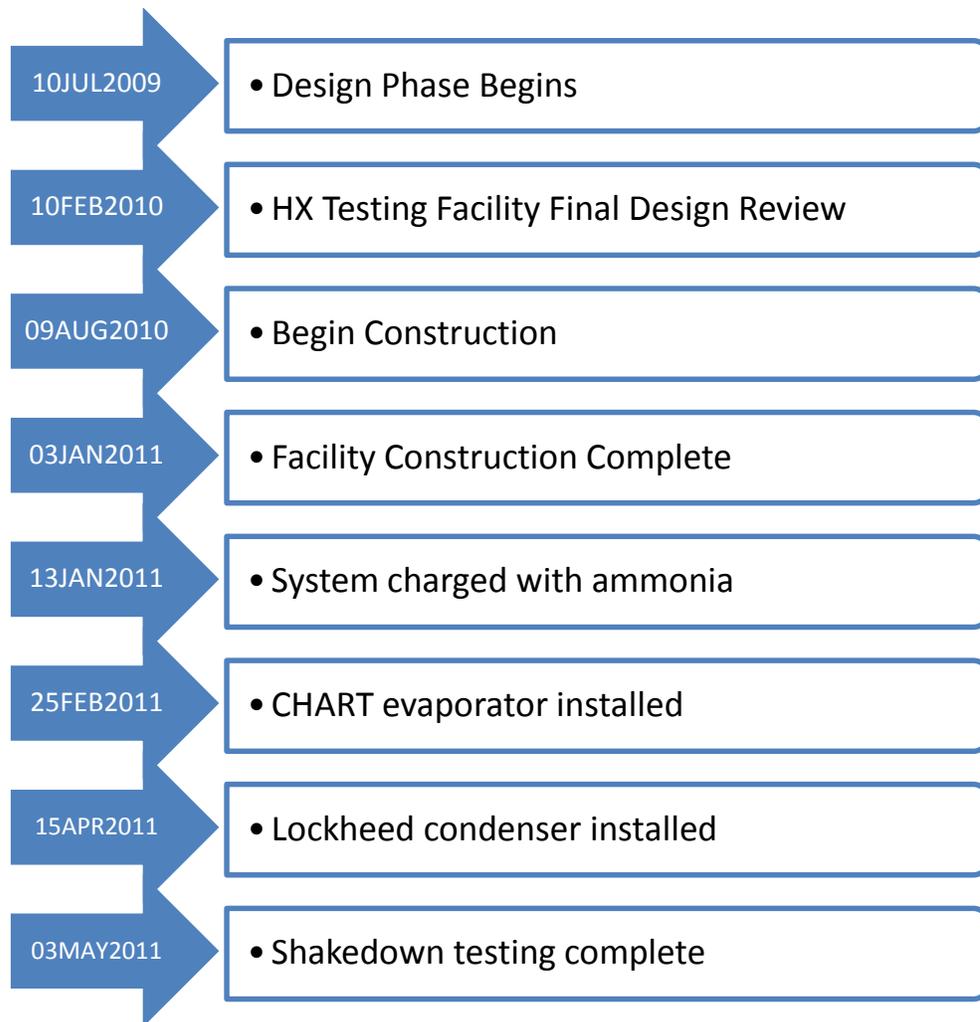
Key milestones in the Heat Exchanger (HX) Performance Testing Facility have been met this year.

The HX Testing Facility can support testing of up to six heat exchangers (testing is only expected on one pair of heat exchangers at a time). Warm and cold seawater are siphoned to the top of the facility via a vacuum priming system and flow downwards through the heat exchangers and discharge into a common NELHA discharge trench. During testing, liquid ammonia is pumped from the receiver tank into the evaporator using the recirculation pump. The ammonia vapor-liquid mixture exiting the evaporator is separated in the mesh of the separator tank. Ammonia liquid is collected in the separator tank and travels back into the receiver tank via the separator-receiver line. Ammonia vapor exits the separator and travels through the expansion valve and is condensed in the condenser. Liquid ammonia exiting the condenser gravity drains into the buffer tank. A feed

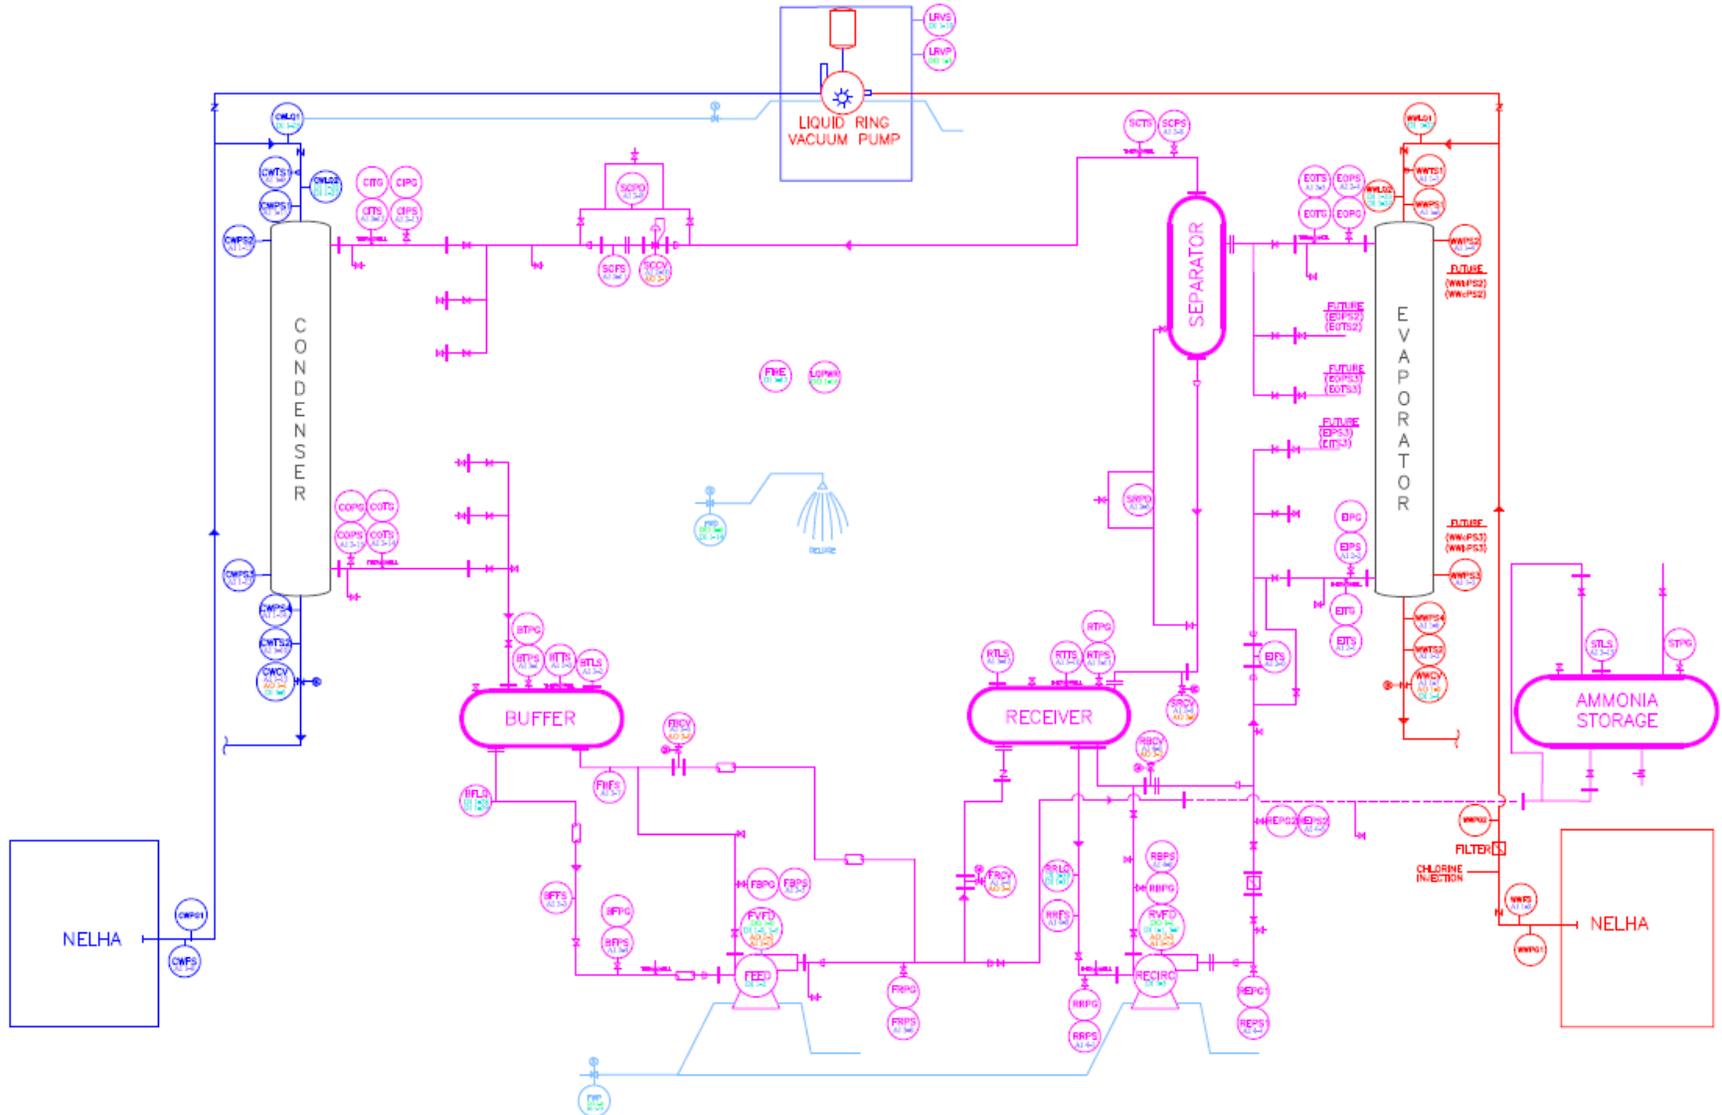
Figure 1. Schematic of HX Testing Facility showing major components and fluid flow paths.

pump moves the liquid ammonia from the buffer tank into the receiver tank. Both ammonia pumps are located in the pump pit. During idle periods, most of the ammonia in the system will be held in the buffer and receiver tanks and in the piping in the pump pit. Reserve ammonia for the facility is stored in the storage tank.

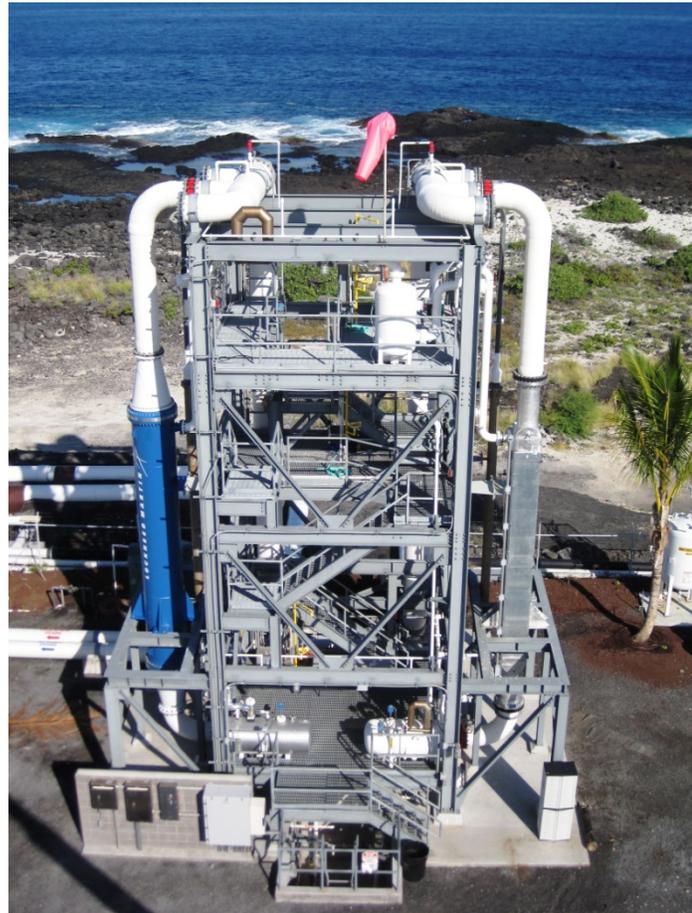
The majority of construction on the HX Testing Facility was completed in November 2010. A recent photograph of the facility is shown at right. Two significant issues encountered during the facility construction phase were passing the electrical inspection and achieving vacuum in the ammonia system.

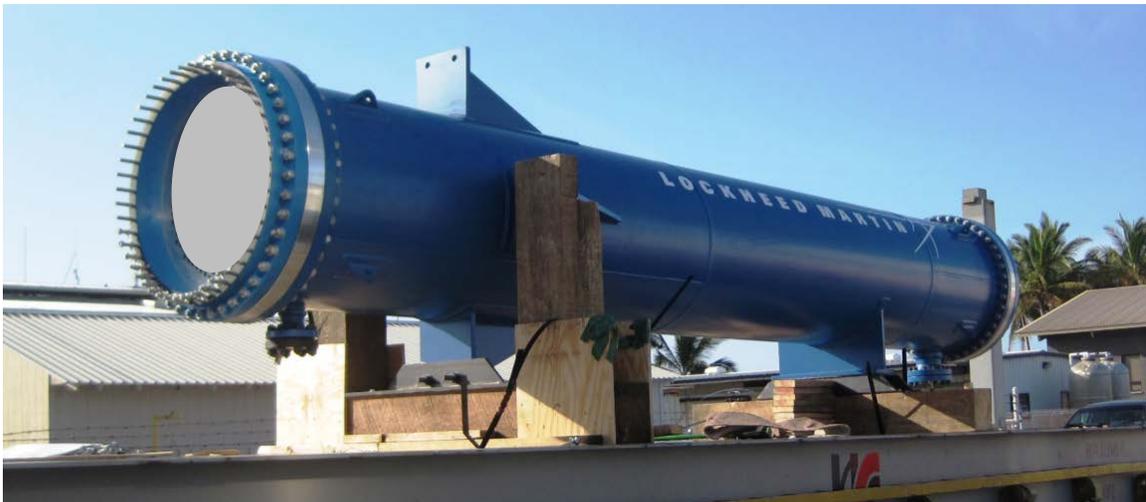
The condenser is a 36" diameter shell and tube unit with the tubes friction stir welded into the tubesheet. The tubesheets are attached to the shell with bolted and gasketed flange joints. The majority of heat exchanger fabrication was completed prior to shipment. The only assembly undertaken by Makai was installation of the cold water nozzles on each end of the unit.

Friction stir welding (FSW) allows for a full strength joint while avoiding a corrosion-prone heat affected zone because instead of melting the metal in the weld seam, the joined area is plasticized from frictional heat generated by the rotating tool. The rotating tool traverses the seam to create a solid-state weld. Lockheed has modified the FSW method and tooling so that it can be used to join circular seams.

**Figure 2. Lockheed condenser upon delivery to OTEC HX Testing Facility site. Cold water nozzles were installed by Makai just prior to condenser installation.**

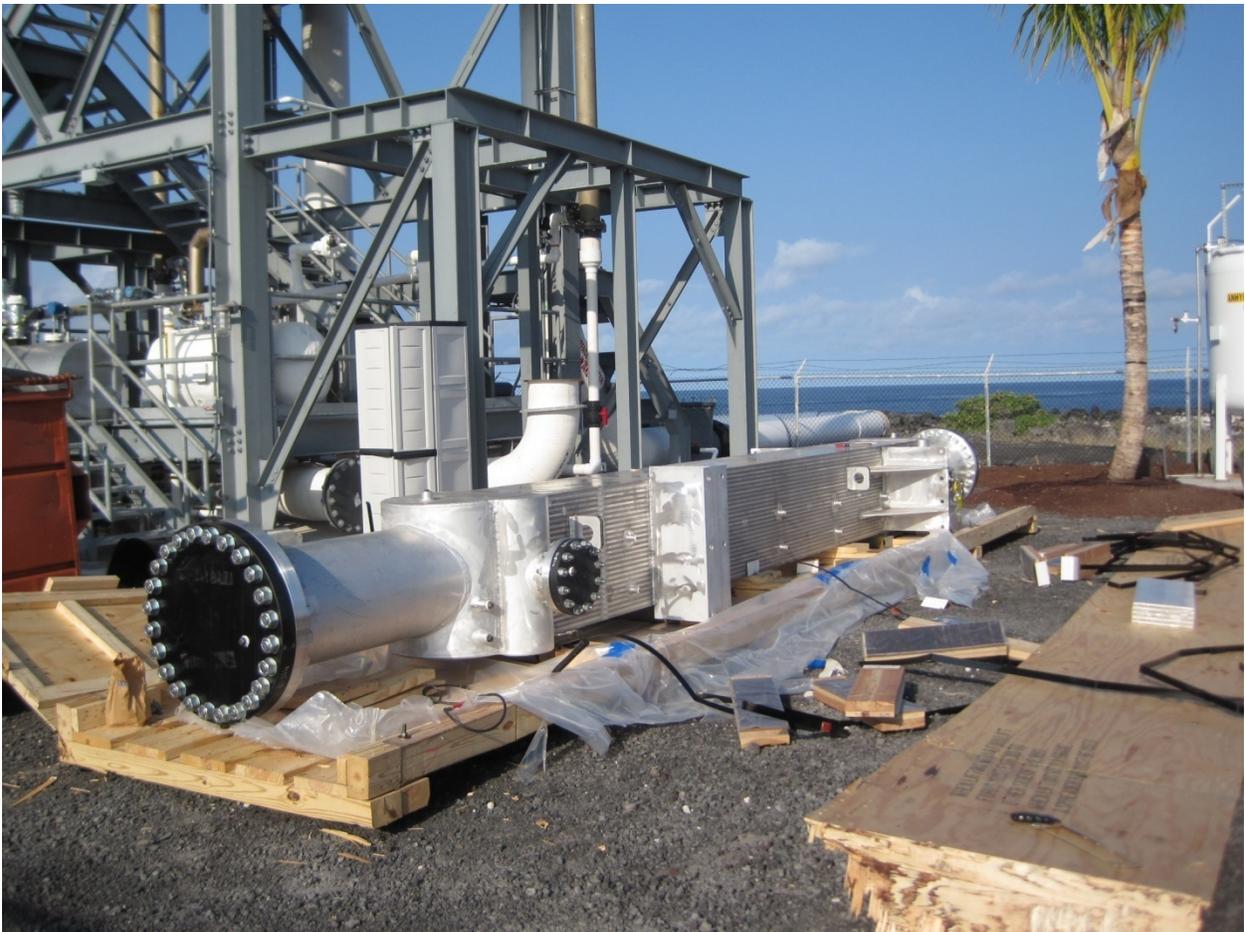
The evaporator is a 5.5 m tall brazed fin aluminum (BAHX) unit. The entire heat exchanger is made of 3003 aluminum. The waterside passages are made from extrusions that form parallel 10 mm square passages. The outer walls and inner webs are all 2 mm thick. The ammonia-side passages are made from herringbone ammonia fins. The fin density is 787.4 fins/m and the fin thickness is 0.4064 mm. Waterside layers and ammonia-side layers are stacked one atop another, alternating the working fluid in each layer. Both outer layers are ammonia layers. Working fluid connections are made via bolted and flanged connections.

**Figure 3. Chart Industries evaporator upon delivery to OTEC HX Testing Facility site. All heat exchanger fabrication was completed prior to shipment.**

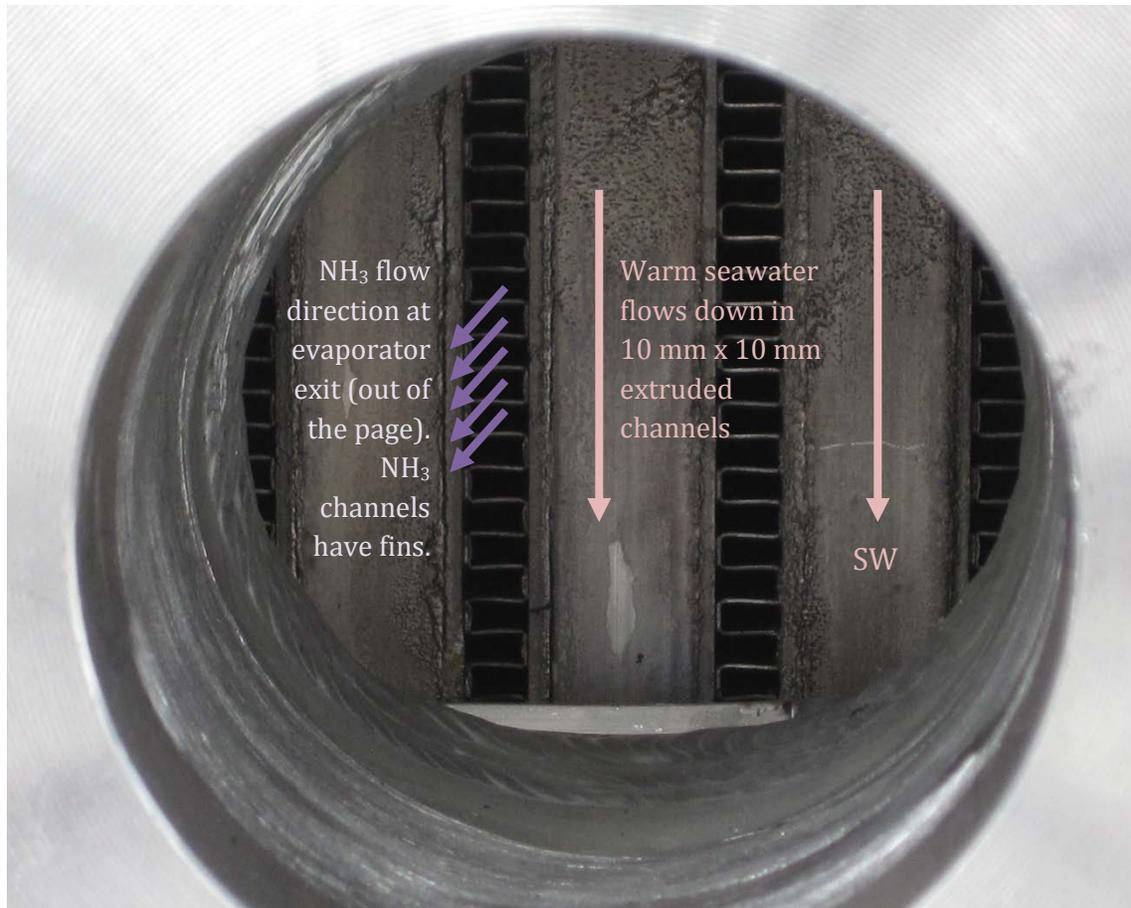
**Figure 4. Looking inside the ammonia outlet port of evaporator. Solid bars are the ends of the waterside passages. Fins are part of the ammonia exit header. Water flows vertically from top to bottom through the waterside passages. Ammonia will flow straight out of the page and into the ammonia exit header. Note that ammonia flows vertically from bottom to top through most of the heat exchanger – the ammonia header fins turn the flow horizontally.**

Standard practice for BAHX area calculations is to use the flat plate area. This is the heat transfer area neglecting the fins. The flat plate area is calculated based on dimensions provided by the manufacturer. The effective length of the heat exchanger is 5.06 m. The effective length neglects heat transfer area associated with the ammonia headers at the top and bottom of the unit. The effective width of the heat exchanger is 0.53 m. The heat transfer area of a single surface is 2.68 m<sup>2</sup>. There are 50 heat transfer surfaces in the heat exchanger (2 per waterside layer), and the total heat transfer area of the heat exchanger is 135 m<sup>2</sup>.

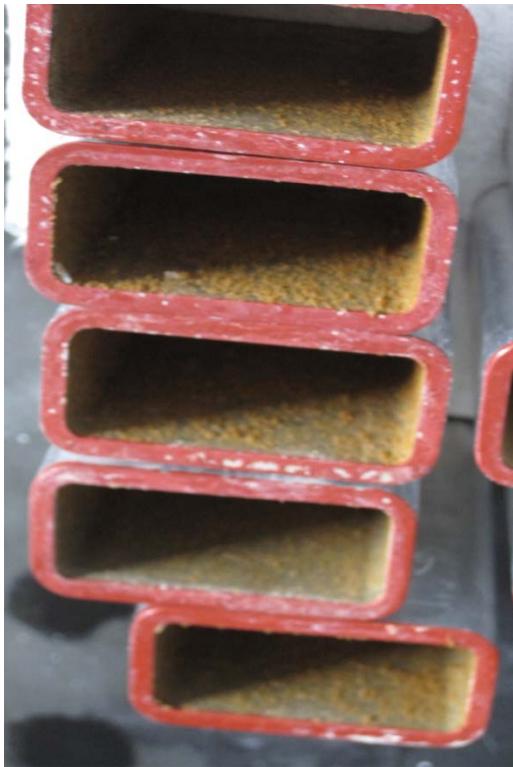
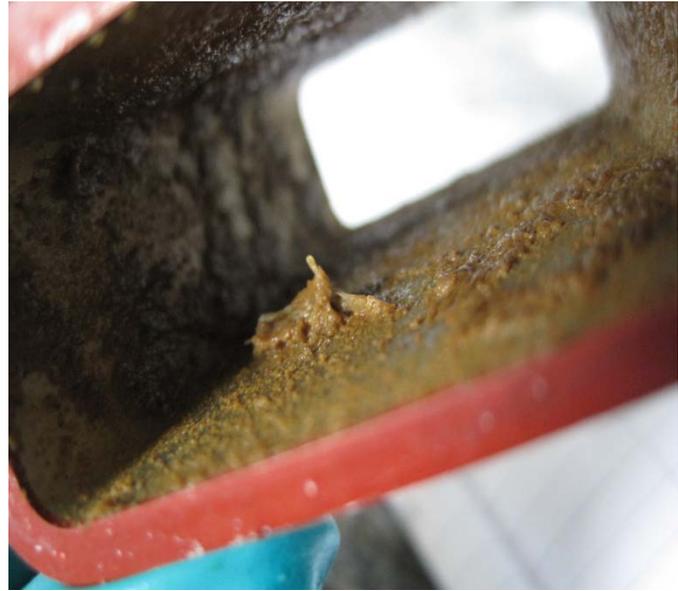
*Visual Inspection Results.* In warm seawater the 18-month samples had severe biofouling. Pits were observed in Alloy 1100 in warm seawater; however, small discolorations that are indicative of pits were present on the other alloys exposed to warm seawater. Pitting has been observed in all alloys in the one-year and 18 month samples exposed to the 674-m and 915-m cold seawater. Except for Alloy 1100, not all coupons had pits in cold seawater. In most coupons, only small pits were present. The presence of pits does not automatically exclude aluminum as a heat exchanger material. In aluminum, pits can self-passivate and material integrity is maintained. The rate of pit growth may also be low enough so that it provides an acceptable heat exchanger lifetime.

Figure 5. Biofouling on 18-month warm seawater samples.

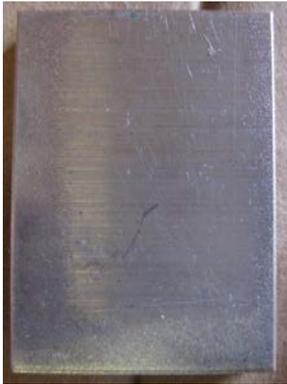
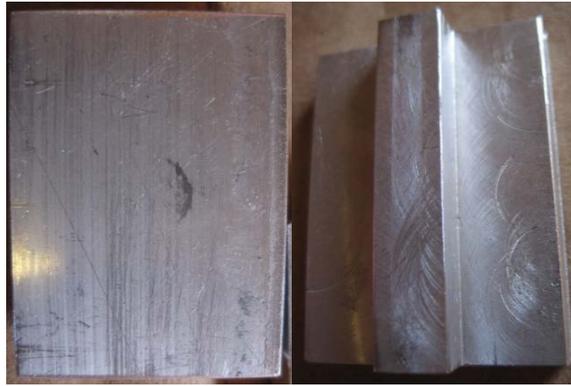
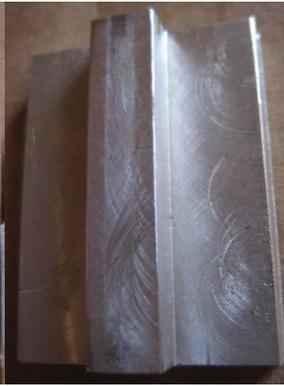
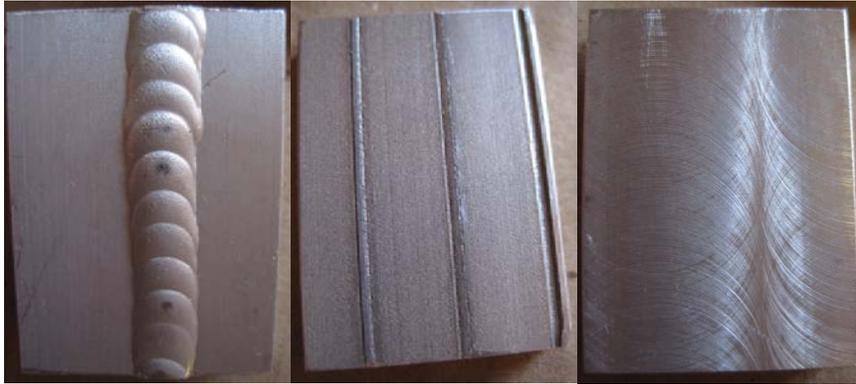
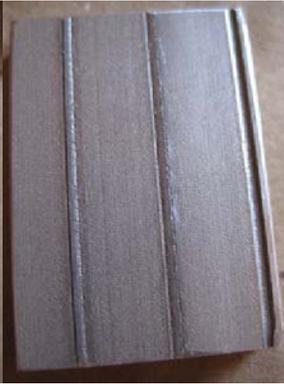
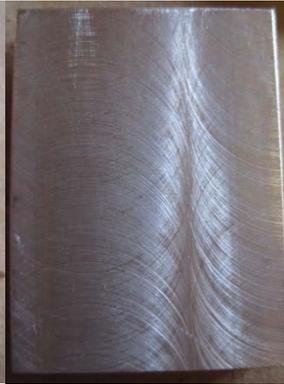
- 3003V – control sample: pure Alloy 3003
- 3003H – same as 3003V with braze process heat treatment (no braze material)
- 3003T – brazed tee-joint
- 3003W – weld joint
- 3003S – sandwich brazed
- 3003M – same as 3003S but with braze surface machined flat

The brazed joints were preferentially attacked in both water sources. For 3003S, large craters at the brazed joints were found on the samples exposed to warm seawater while in cold seawater, the craters were smaller but more numerous. For 3003M and 3003T, corrosion of the braze joint was more severe in cold seawater than in warm seawater. 3003W has performed well in both water sources. 3003H has formed some pits in cold seawater. 3003V is comparable in both water sources.

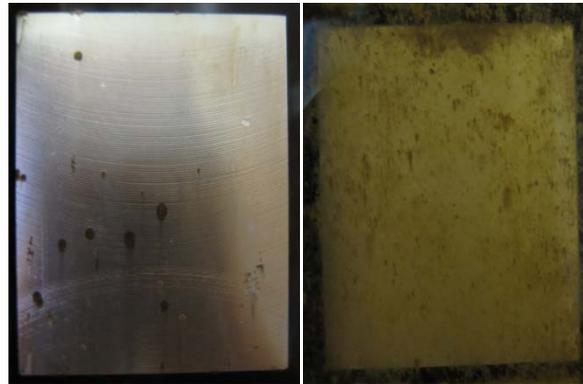
FSW in cold seawater    FSW in warm seawater

The cold seawater FSW coupons have developed dark spots that are likely pits. The warm seawater FSW coupons do not appear to have pits; however, the coupons are covered with biofouling (most likely caused by light exposure through the clear acrylic lid).
