**Asia Pacific Research Initiative for Sustainable Energy
Systems 2021 (APRISES21)**

**Ocean Thermal Energy Conversion (OTEC)
Heat Exchanger Development
(November 2024 to July 2025)**

Task 5

MAKAI OCEAN ENGINEERING
ANNUAL REPORT

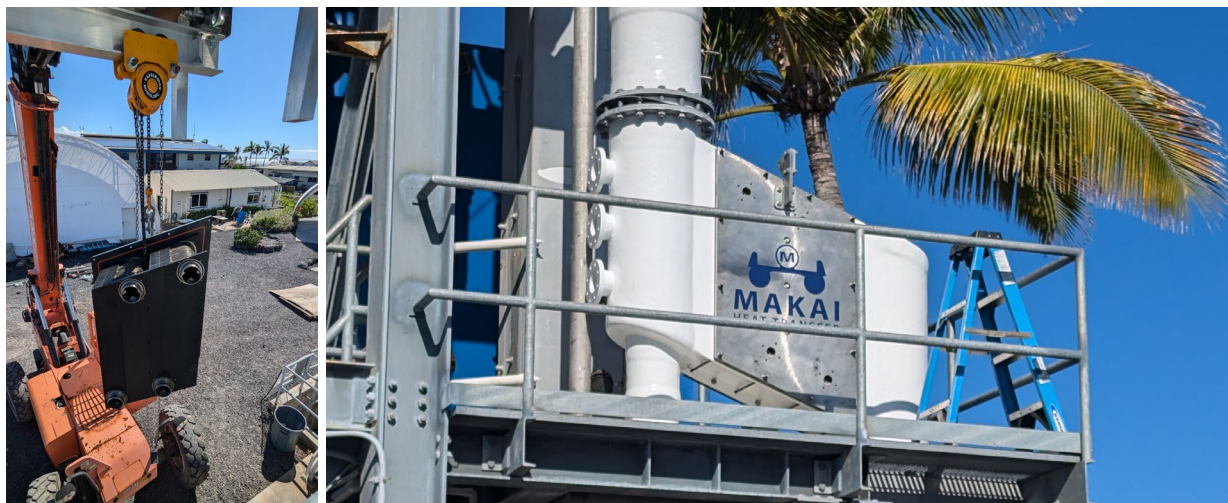
Makai previously reported on the design, construction (under separate funding), and installation of the cassette-style design for large-scale heat exchangers (Figure 1). In this period, Makai commissioned the heat exchangers and the newly upgraded HX Test Facility.

Figure 1. Cassette design

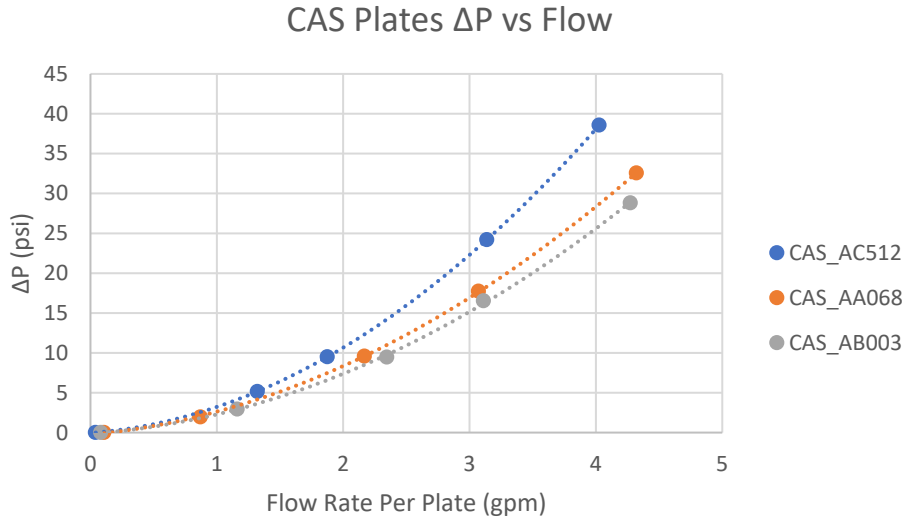
The effective internal channel sizes are 0.515mm, 0.616mm, and 0.678mm for AC, AB, and AA designs, respectively. In theory, the AA design should have a lower pressure drop than the AB design, however, the larger welds used in the AA pattern likely cause the fluid to accelerate and decelerate more to get around the welds compared to the smaller welds used in the AB pattern and contribute to the higher pressure drop for a larger effective channel. One additional area that requires additional examination is the effect of the transition zone. Makai's test plan for the next work period includes trying different transition zones and orientations for the pattern weld design.

Figure 5. Single plate pressure drop test

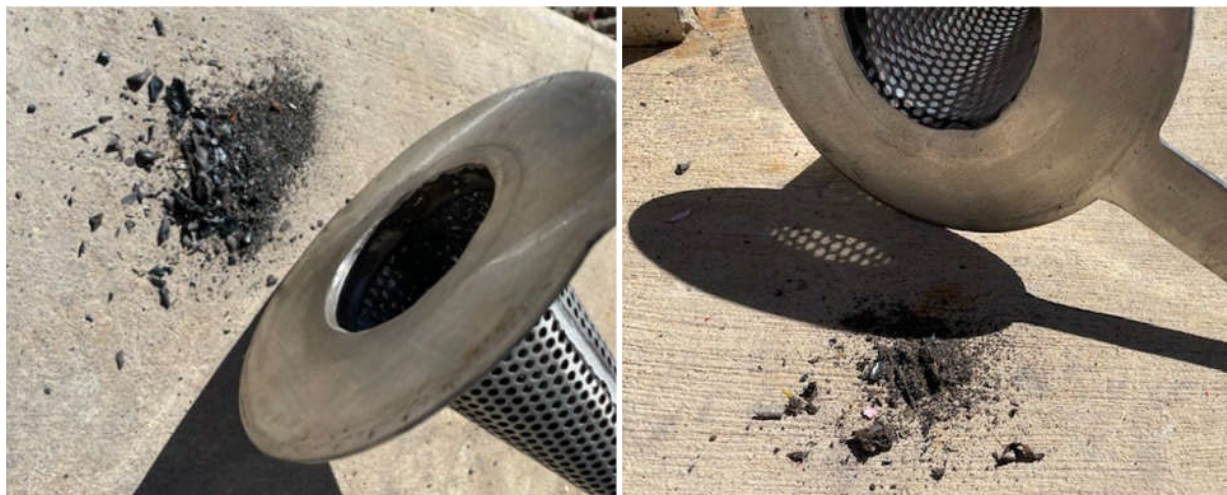
Both pumps seized during startup checks. Upon inspection, the amount of fine particles that passed through the filters at the pump inlets (Figure 6) combined with tight clearances of the pump design, led to damage on the interfacing surfaces of both pumps (gears, bearings, casing) (Figure 7 and Figure 8). The particles were removed and gouges were polished to the best of our ability and the pumps were re-assembled for operation. In addition, a finer mesh filter was added inside the existing filter.

Figure 6. Debris in ammonia piping caught in strainer.

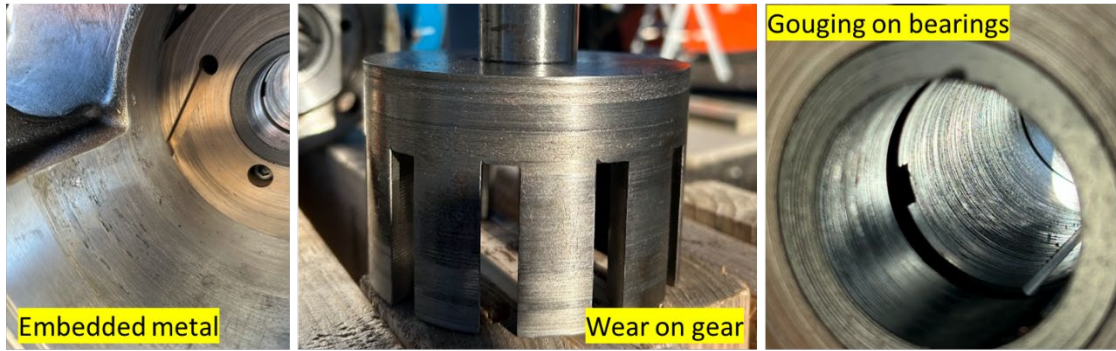
Figure 7. Recirc pump damage.

Inspection after 2-weeks of intermittent operations suggest that both debris and cavitation resulted in wear/grinding between the pump head and rotor. Large metal particles were also embedded in the pump head and suction side of the pump casing (Figure 9). The physical interference also contributed to bearing damage which then exacerbated the problem because the pump was no longer rotationally balanced and the wobbling caused more wear damage. Makai performed light polishing of the surfaces to remove interference and then replaced the bearings, which is a complex process requiring heating and dry ice. Both pumps were returned to service and have been mostly trouble-free during operations.

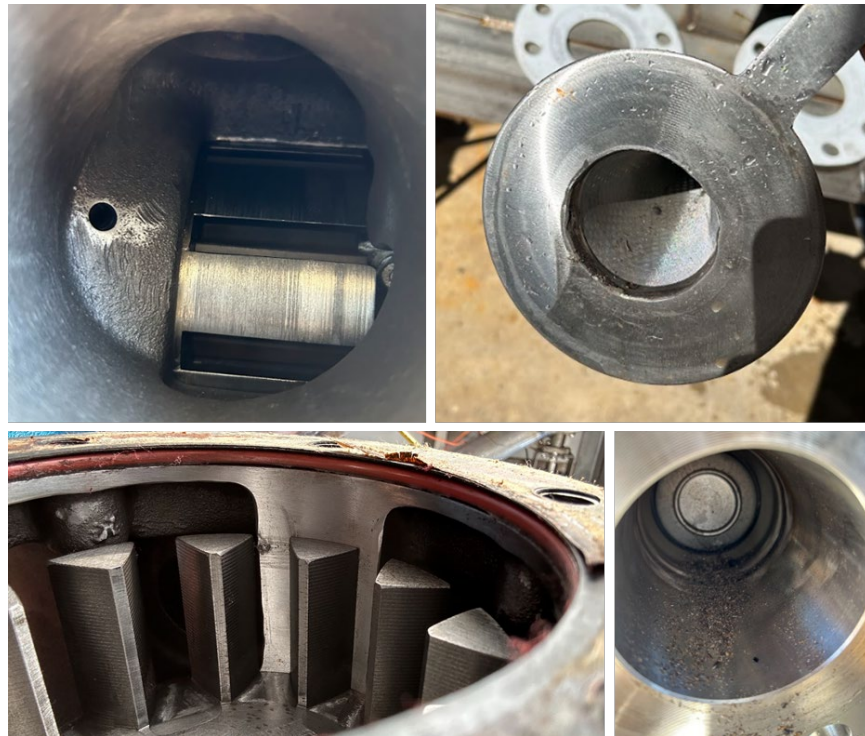
Figure 8. Feed pump damage.

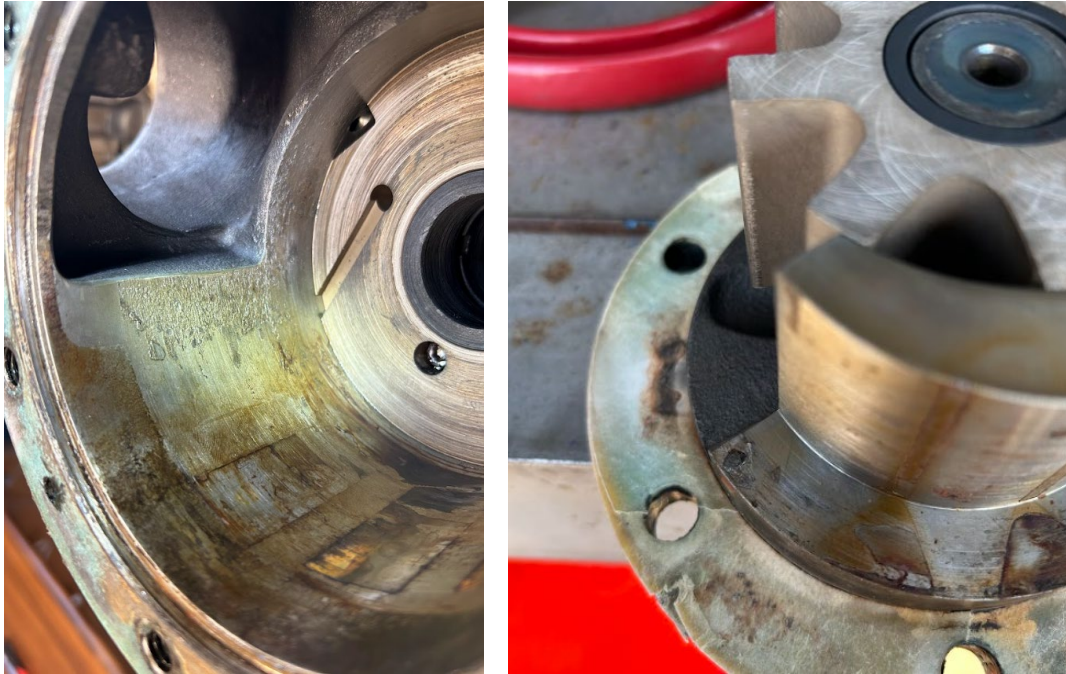
Figure 9. Metal chunks embedded in the pump casing (left) and pump head (right).

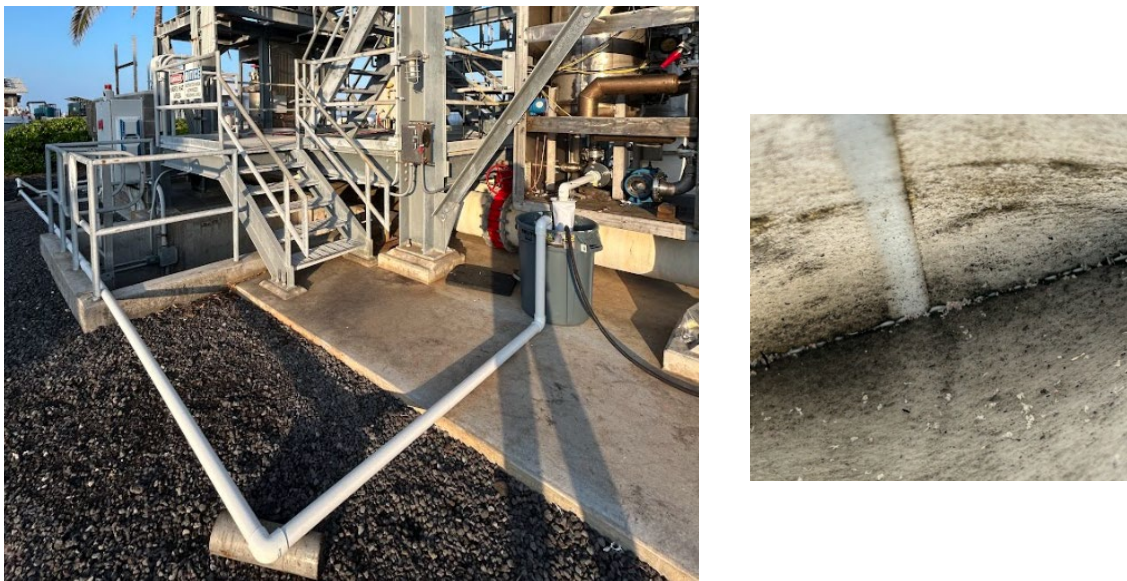
During the overhaul period, Makai installed a backflush line to use water to clean the piping from the feed pump outlet to the recirc pump inlet. Very little debris was flushed out (Figure 10); either most of the debris was already removed in the strainer at this point or the debris was generated by wear and/or cavitation within the pump.

Figure 10. Flushing the ammonia line between the feed pump outlet and recirc pump inlet did not remove significant amounts of shavings/debris.

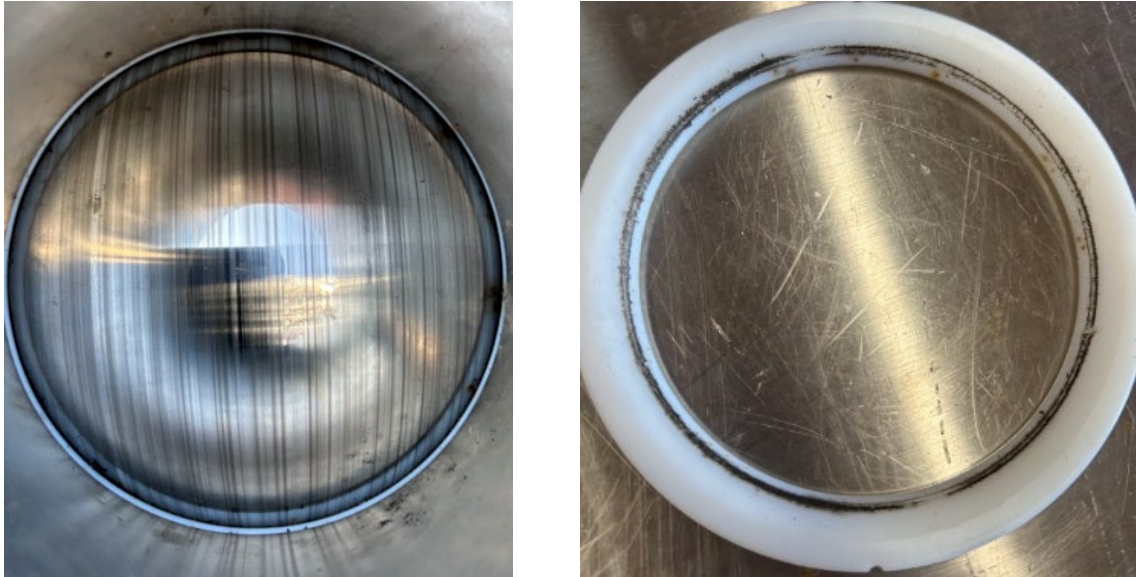
quick close valves to isolate the condenser but the quick close valve at the condenser exit (between the buffer tank inlet and condenser outlet) was found to leak. Makai found weld slag on sealing surfaces that interfered with the seal (Figure 11). Once repaired, the valve was verified to seal prior to returning to ammonia service.

Figure 11. Weld slag in valve seating surfaces prevent quick-close valve from sealing.

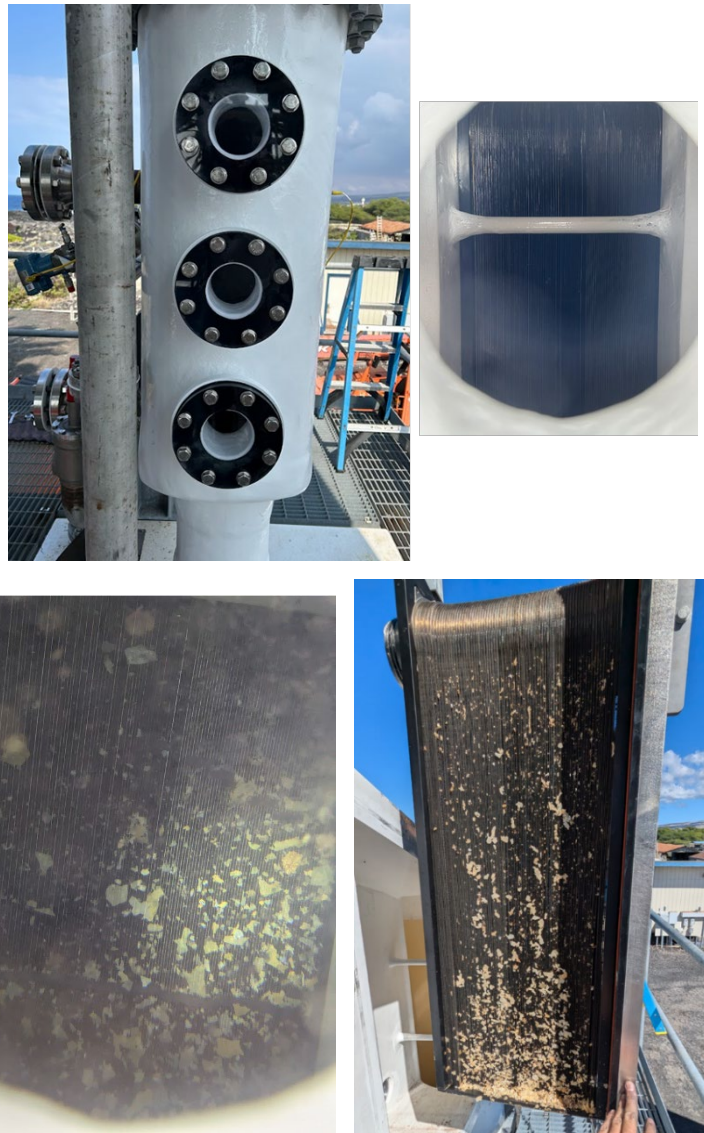
Instead of relying on pressure drop, Makai installed three viewports to observe the evaporator inlet face during operations and a backflush to remove some of the debris without having to remove the evaporator. The viewports also allowed access to manually brush the leading edges. Neither backflushing or brushing were 100% effective but was enough to complete initial performance data collection.

Figure 12. (top) View ports installed to monitor evaporator leading edge. (bottom) Debris from seawater piping system collected at the evaporator leading edge as seen through the viewport and when evaporator was removed for cleaning.

Future operations will use a sump pump when the intake strainer needs to be emptied. This effort prevents debris falling into the bottom of the piping during strainer removal. Makai also lined the strainer with a finer mesh screen so less debris can pass through the strainer.

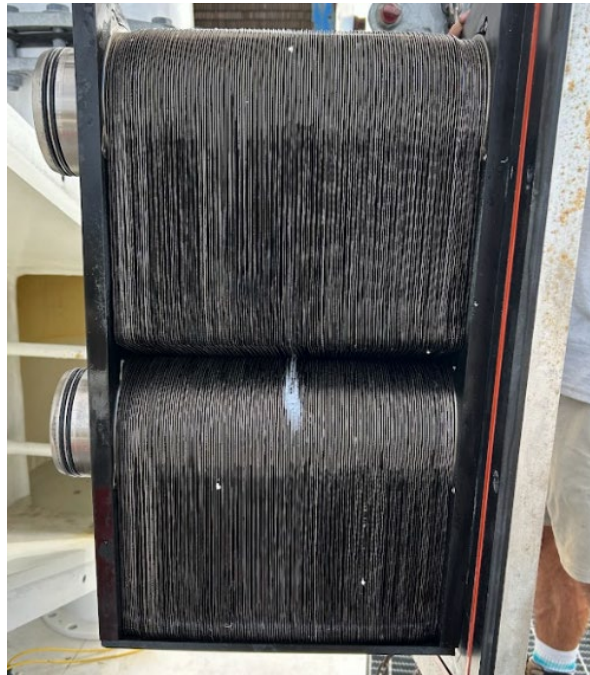
Makai previously established that the TFHXs must be flooded with seawater prior to being placed into ammonia service. This is for safety and because the cassette, housing, and hardware was designed to have seawater pressure counteracting some of the internal ammonia pressure. When seawater priming was lost following emergency system testing, the condenser began to slowly drain. Once priming was lost, cold seawater was no longer flowing to cool the condenser or the buffer tank. Ammonia temperature (and pressure) increased to ambient conditions (30°C, 1166 kPa) and the condenser stack began to leak. Makai attributes the leak to several compounding factors: the condenser experienced plate shift but was still sealed so the condenser was not removed to fix the plate shift; the manifold bolts were bent due to the plate shift event; there was no longer seawater pressure acting on the plates; the ammonia pressure was high, although not to the point of lifting a relief valve. The shifted stack was clearly misaligned in the center and this likely reduced the safety factor for maintaining compression and the TFHX experienced a leak at the center of the stack (Figure 13).

Figure 13. White residue at the center of the stack is indicative of an ammonia leak.

In addition to implementing automatic priming to maintain seawater priming, the control program will send alerts if seawater priming is lost or if based on flow and pressure measurements, the seawater side is draining/drained.

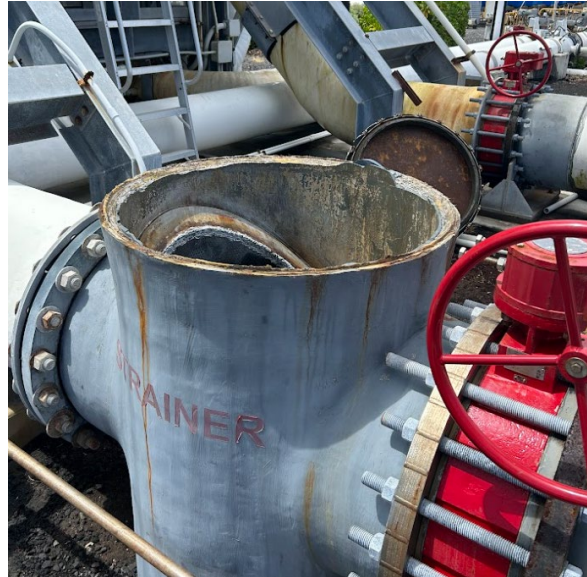
A separate incident occurred as the result of an upstream user at NELHA. After running high flow rates (~6,000 gpm) of warm seawater, flow was instantly stopped by shutting a valve. Makai's HX Test Facility is typically open/connected to the NELHA system (i.e., warm and cold seawater inlet valves are open). Because the NELHA pumps cannot respond instantaneously, the sudden stop by the upstream user produced a pressure transient that sheared off the top part of the FRP inlet strainer housing to Makai's HX Test Facility.

Figure 14. Top part of the strainer sheared off.

Makai replaced the damaged plates, re-stacked and re-installed the evaporator. The strainer body required extensive fiberglass work but has been repaired. This event has emphasized the importance of serviceability of the cassette concept and the TFHX.

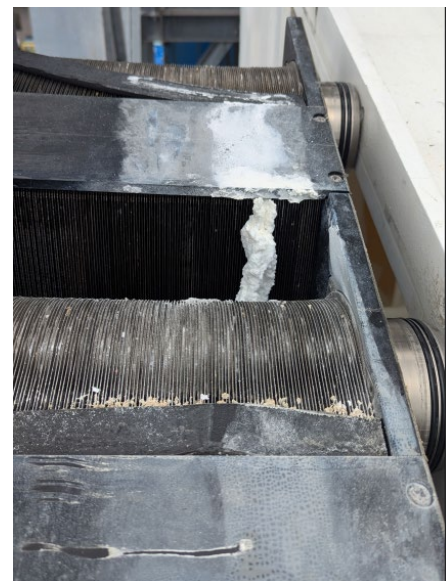
Makai personnel were on site and able to manually close an upstream valve to stop seawater from flooding the area. In addition to severing the strainer housing, the TFHX evaporator was also damaged. After removing the evaporator, pinhole leaks in the transition zone were found on several plates. Makai observed dents in the foil at the leak locations that are likely from debris that was wedged in between the plates. Makai suspects the evaporator had experienced multiple pressurization pulses since placed in service and debris was worked in between the plates during each cycle. Ultimately, one major event led to leaks in several plates.

Figure 15. TFHX evaporator showing residue from ammonia leak and debris around the manifolds.

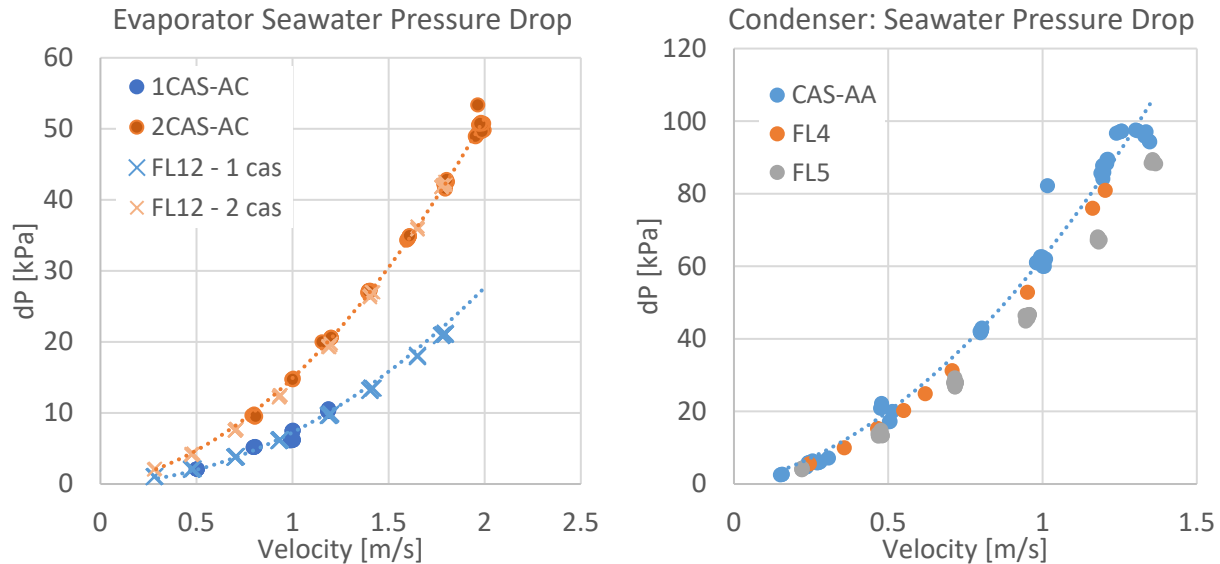
The discrepancy in the condenser is most likely attributed to uneven plate spacing. The condenser was assembled first and there was a clear sag in the middle. Because the condenser was pressurized and leak checked in place, there was some permanent deformation and the seawater channels were visibly uneven.

Although the condenser was restacked using spacers after the leak due to loss of seawater priming / cooling, the plates were already warped and the channels were still visibly uneven. Comb spacers were not installed in the condenser, although, in the next iteration, comb spacers (or comparable method) will be added to aid in maintaining the seawater channel spacing.

Figure 17. Seawater pressure drop.

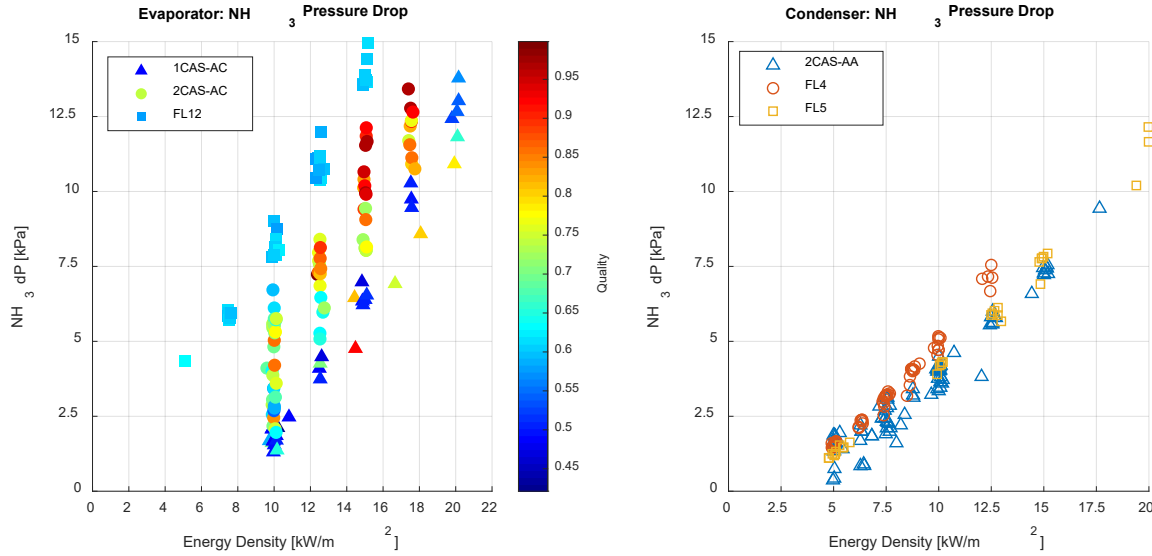
likely varying with quality, at each energy density. In the single-cassette test, for the same energy density, lower quality points had higher pressure drops whereas in the two-cassette testing, there is no clear trend. However, the reported quality is averaged between the two cassettes and individual quality in a single cassette may be different and account for the variation.

Figure 18. Ammonia pressure drop.

In the condenser, the ammonia pressure drop was either slightly lower or comparable to the previously tested 100-kW units (FL4 and FL5).

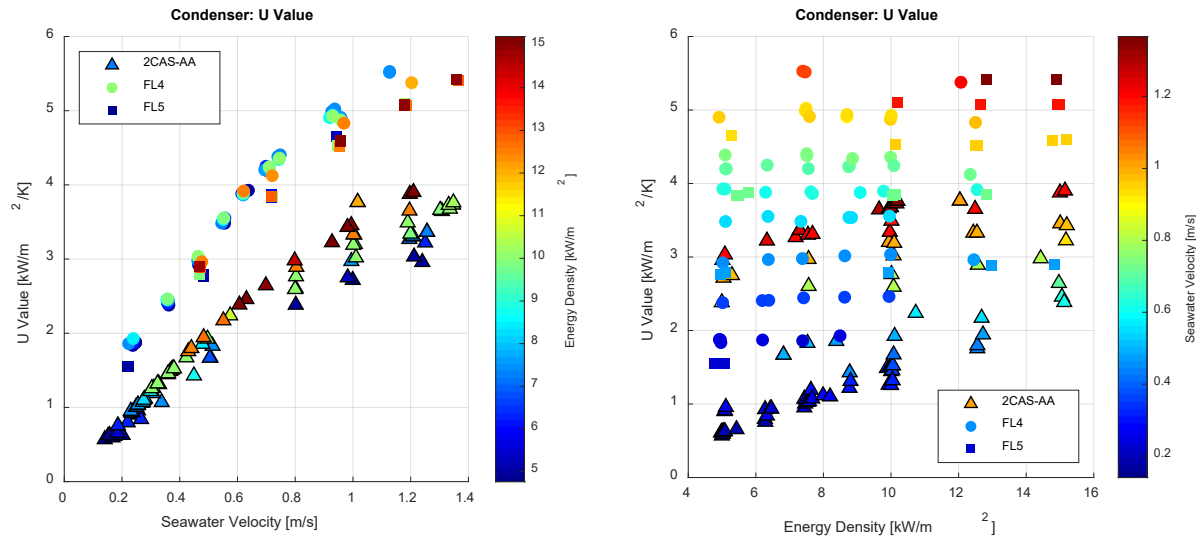
effectively not contributing to heat transfer and reducing the effective area. Makai plans to construct and test a new condenser, using the spacers bars during stacking and comb spacers during operation to maintain even seawater channel spacing, to verify the less-than-expected performance was due to uneven channel spacing and not due to the horizontal orientation or issues with scaling from 100-kW test results.

Figure 19. Condenser U-value varies with seawater flow and energy density.

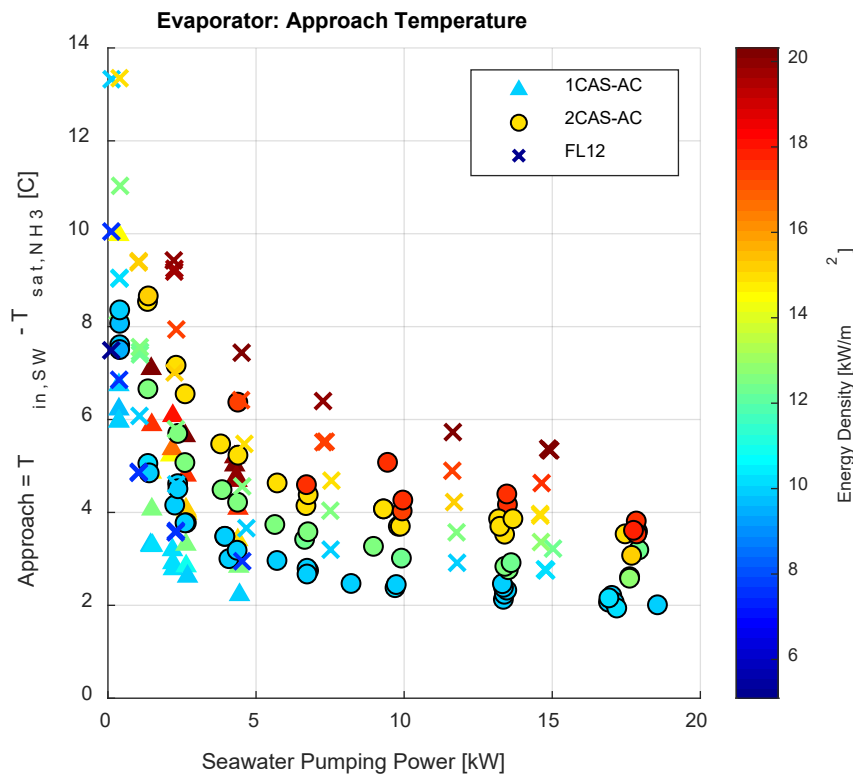
One way to compare heat exchanger performance is to plot the approach temperature versus energy density and pumping power through the heat exchangers (for the same heat exchanger area, Figure 21 and Figure 22).

Figure 21. Evaporator approach temperature.

While the single-cassette unit had the lowest approach temperature, it is not the most practical design because the seawater path is short and in order to meet the required duty, arranging all the units would require a lot of frontal area (and a larger system size). The two-cassette unit had the same as or better approach temperatures compared to FL12. Makai also expects slight improvement in two-cassette performance if higher qualities could be tested, particularly at high energy densities.

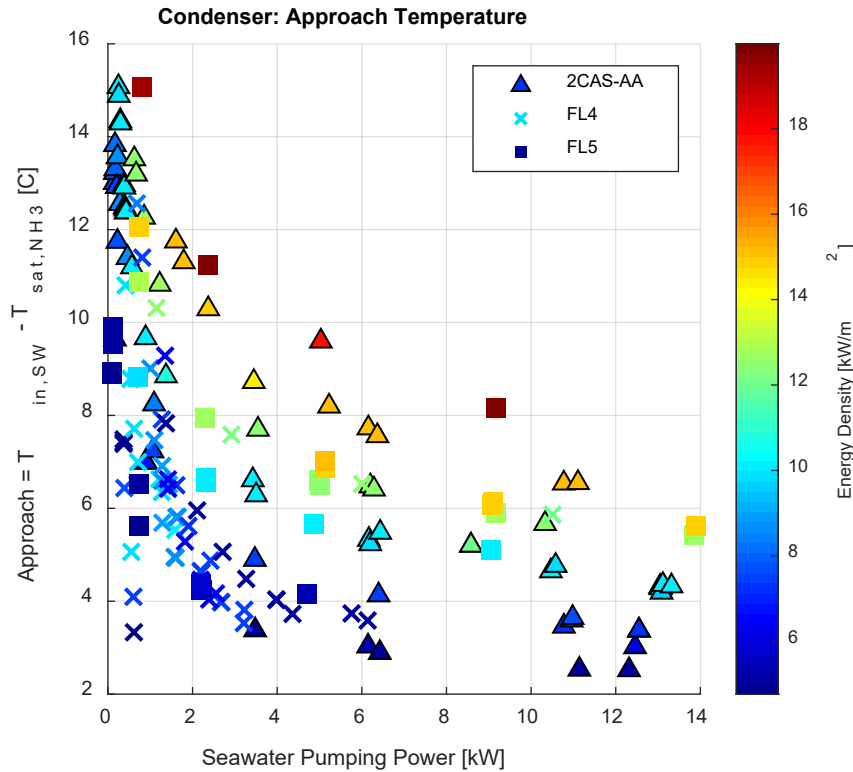
Figure 22. Condenser approach temperature.

The condenser approach was higher than both FL4 and FL5 at lower pumping powers but comparable at higher pumping powers. This result is not unexpected based on the mismatch in seawater pressure drop and U-values.

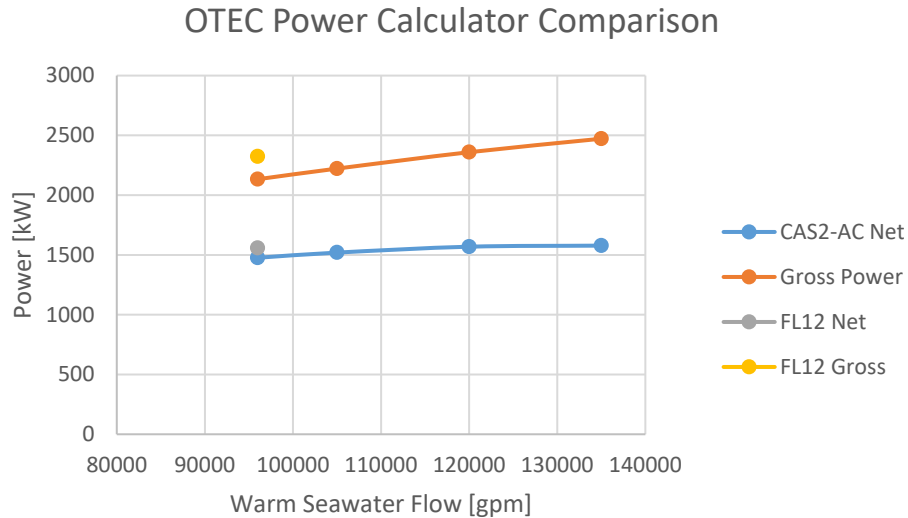
For the evaporator, a 1:1 area replacement of FL-12 with the two-cassette unit produces ~10% less gross power and 7.5% less net power. This is because the two-cassette unit is oriented the crossflow configuration and at the same volumetric flow rate, the velocity through the heat exchanger is lower (because the cross-section flow area is larger in crossflow). Increasing the flow rate produces more power (gross and net) but requires larger ducting to manage the volume at reasonable pressure drop. Without increasing the ducting, the increase in parasitic losses exceeds the gains in gross power. This also means by increasing the volumetric flow rate and ducting size, the same net power can be achieved with less heat exchanger area.

Figure 23. For the same area, the two-cassette unit requires higher seawater flows (and increasing duct size) to match net power.

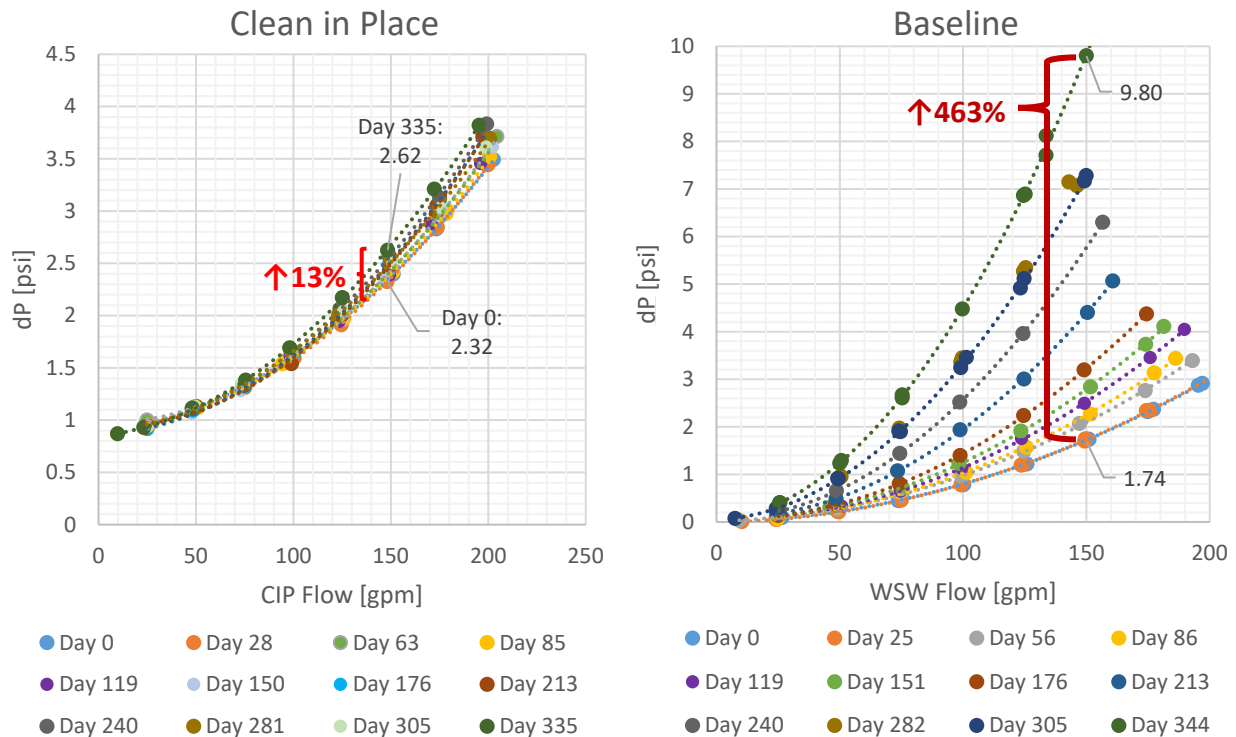
After one year of operation, the automated clean-in-place prototype (ACIP) experienced only 13% increase in pressure drop compared to the baseline (no cleaning) test which had over 400% increase in pressure drop (Figure 27). A portion of the increase in pressure drop in the ACIP is attributed to the surfaces that are not cleaned. Based on visual inspection, the plates were generally clean. There was soft and hard fouling on edges of the plates; hard fouling was predominantly at the leading and trailing edge seal welds.

Figure 27. Baseline test shows >400% increase in pressure drop after almost 1 year. The clean-in-place sample has ~13% increase in pressure drop over the same period.

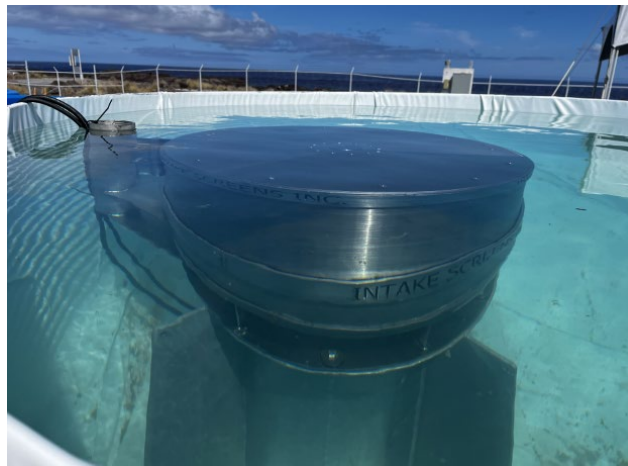
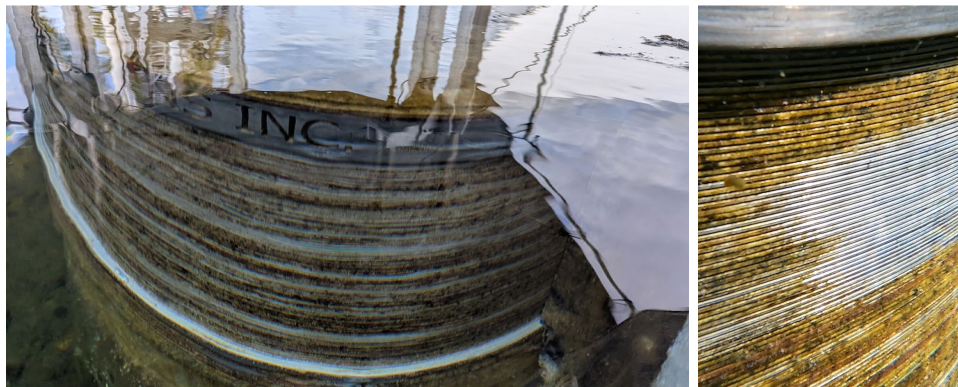
As observed during evaporator testing, the compact channels of the TFHX are susceptible to clogging from debris. Makai has been testing a self-cleaning intake screen by ISI, Inc (Figure 28) for one year. The test is to determine the efficacy of the cleaning mechanism, understand the required maintenance cycles, and evaluate the durability of the components in order to understand where improvements are needed for long-term deployment.

The discoloration on the screen is fouling that is easily removed with a brush. Makai has observed that the screen is not perfectly round and the screen bristles do not evenly make contact across the entire surface of the screen. There has been no corrosion observed on the screen. The anode surface was cleaned twice, at about 3 and 6 months after installation and replaced at 10 months (Figure 29).

Figure 28. (top) Intake screen upon installation. (bottom) Intake screen after one year.

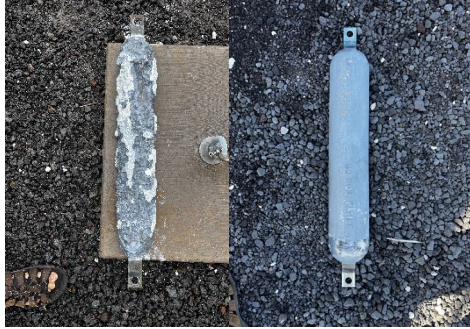
Figure 29. Old (left) and new (right) anode.
