Hawaii National Marine Renewable Energy Center (HINMREC)

Task 4: Environmental Impact Monitoring at WETS

Sediment Transport Analysis Reports, 3A-3D

Prepared by:
Sea Engineering, Inc.

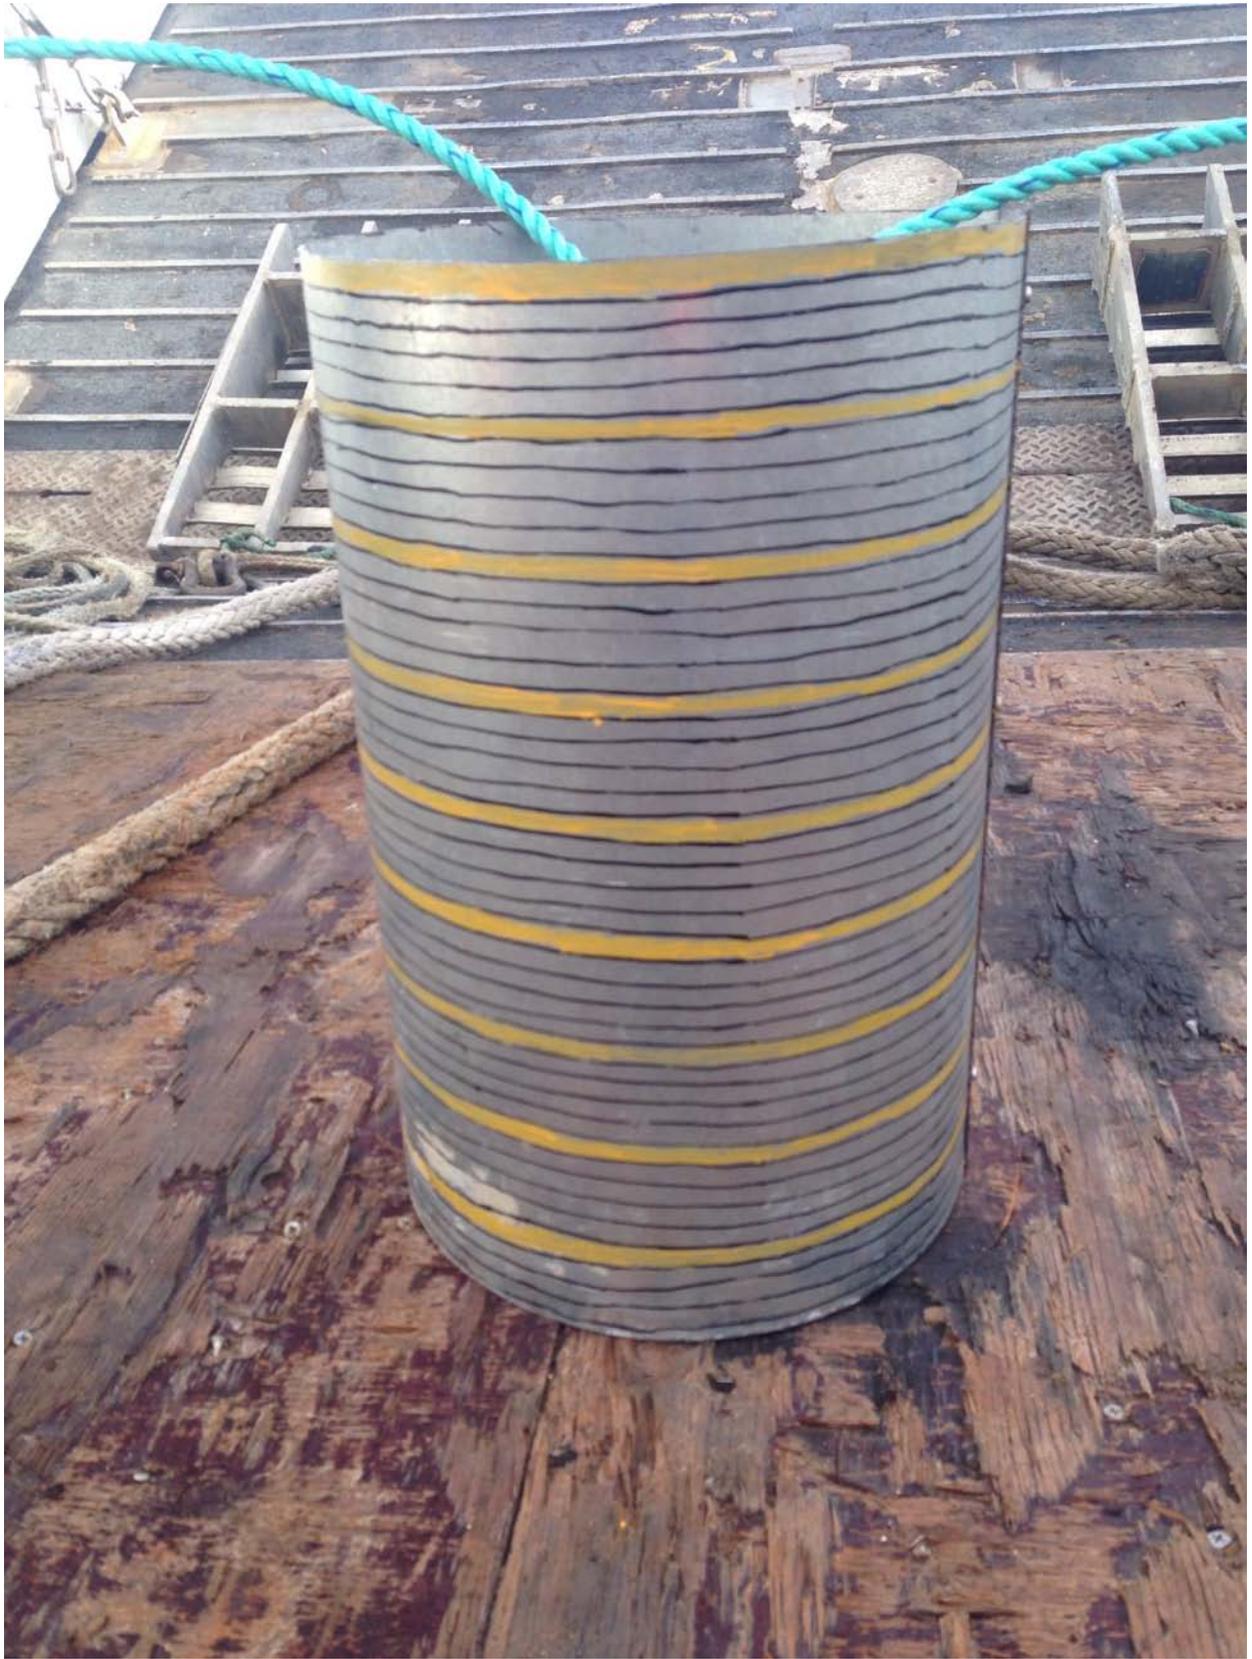
Two scour measurement cylinders have been also been fabricated. These consist of thin walled sheet metal cylinders approximately 12" in diameter, and 16" high. The cylinders are partially filled with concrete from 4" to 10" from the bottom of the cylinder. When placed on the seafloor, the cylinders will sink into the sediment to the level of the concrete, and will allow observation of scour. The cylinder is marked in centimeter graduations. Figure 2 is a photograph of the scour cylinder prior to deployment.

Figure 2. Scour cylinder

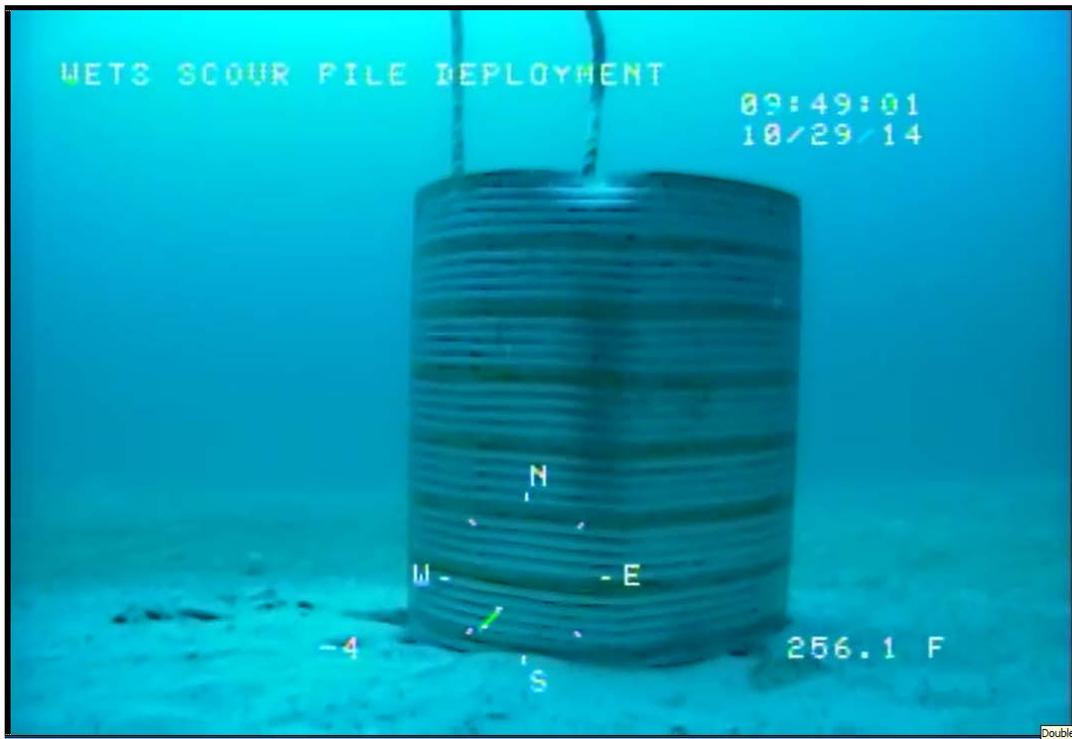
Figure 3. Scour pile deployed at anchor base B

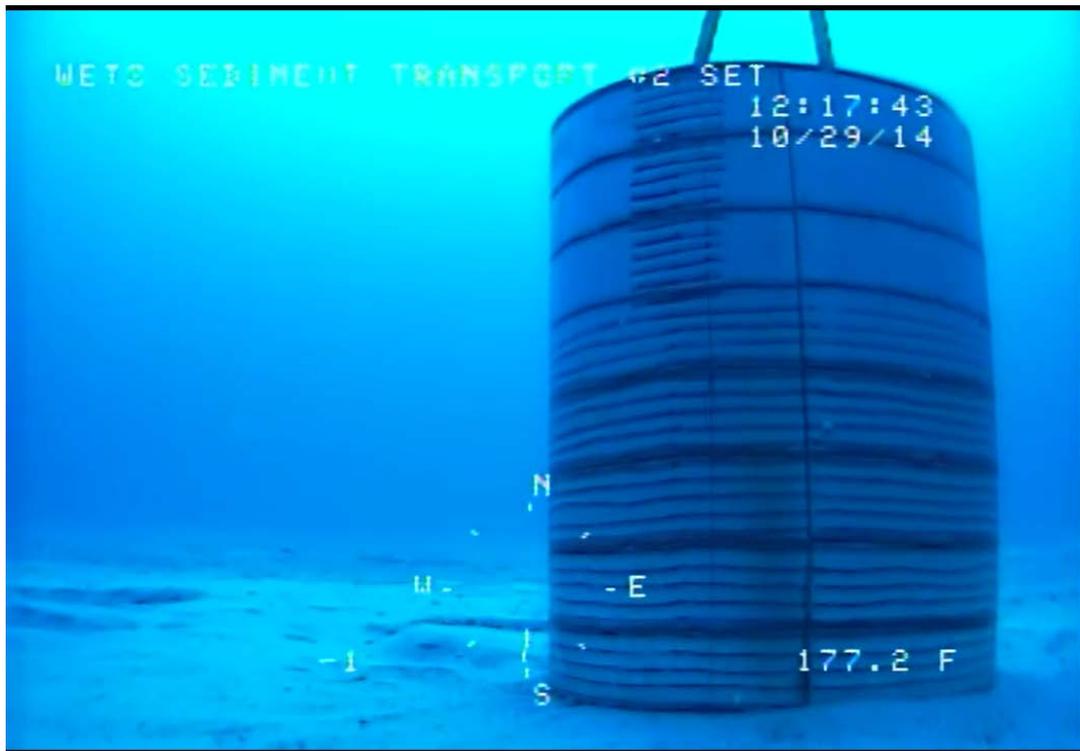
Figure 5. Scour cylinder deployed at anchor base A

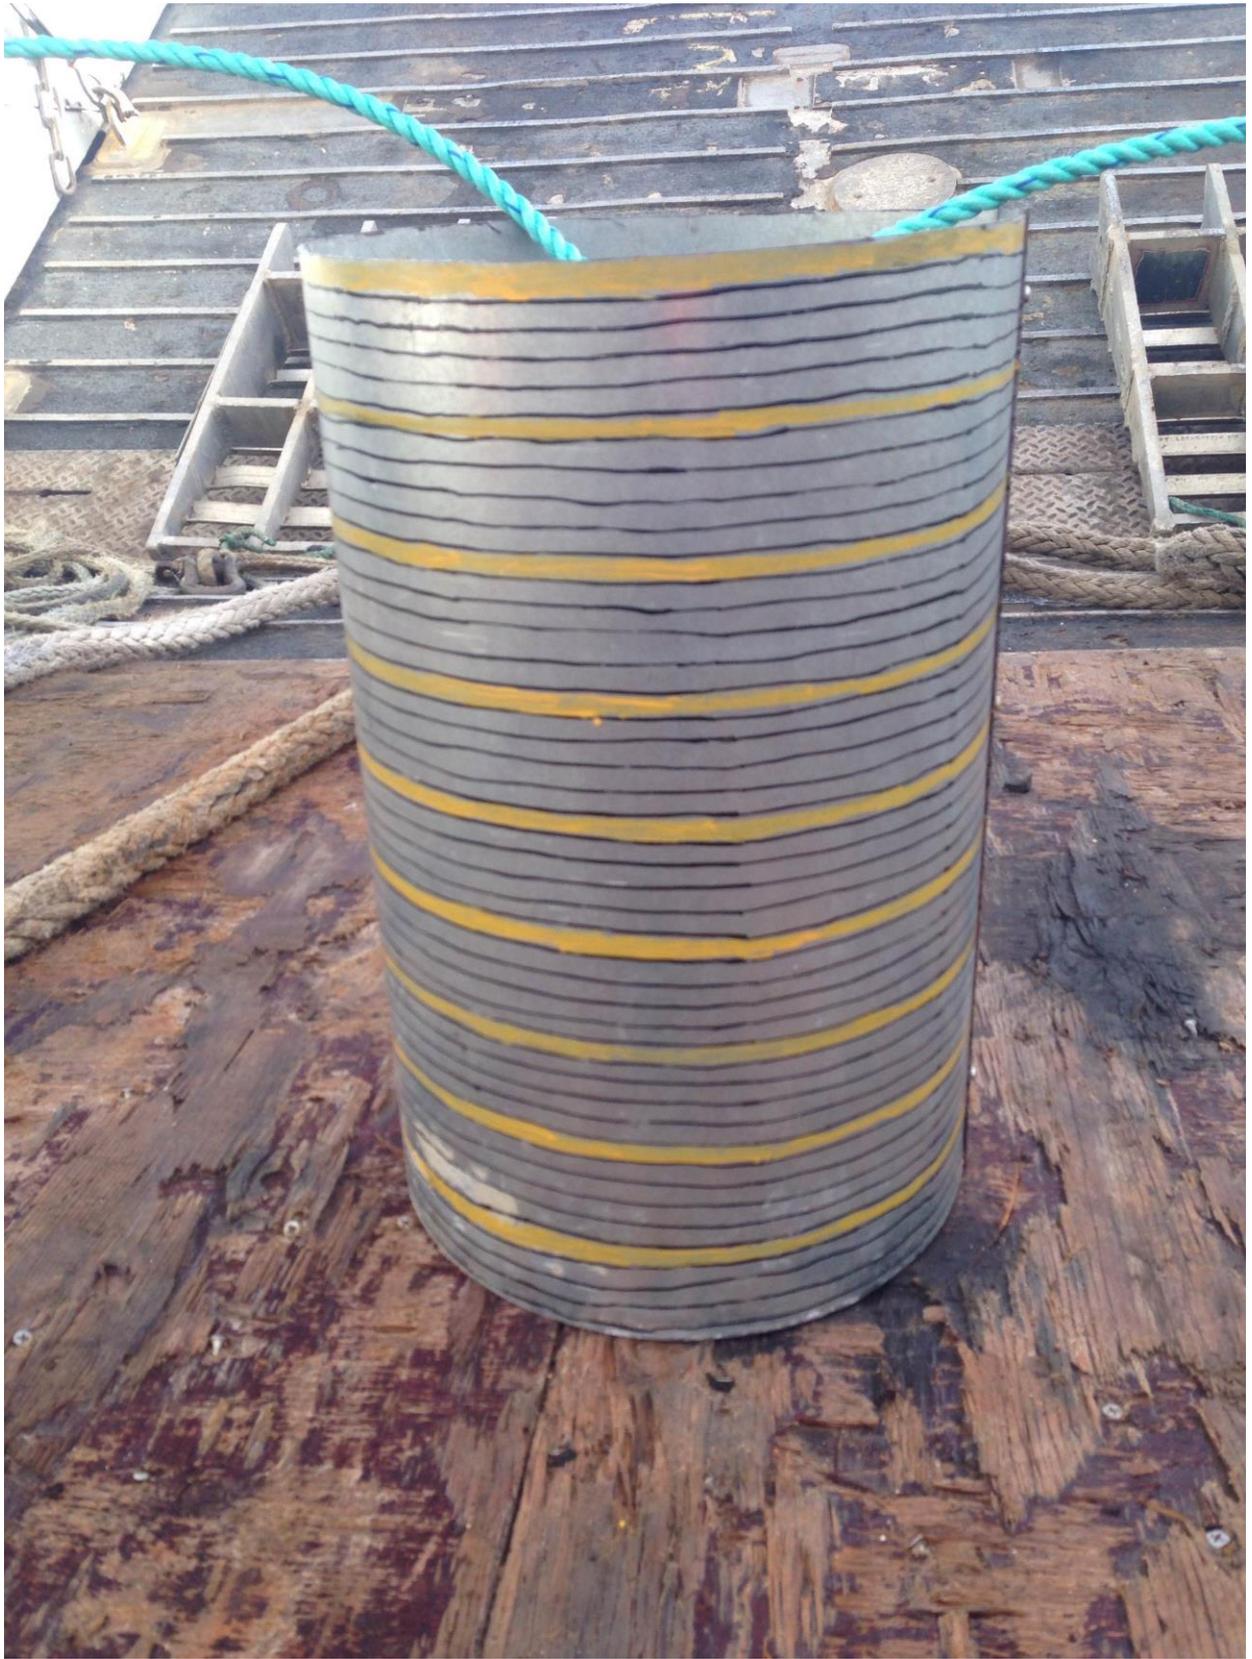
Figure 2. Scour cylinder

Scour Cylinders: Both scour cylinders are marked every centimeter with a black line, have a highlight every 5cm and have a total height of approximately 44.5cm.

Two scour measurement cylinders, were also been fabricated. These consist of thin walled sheet metal cylinders approximately 30.48 cm [12 in] diameter, and 40.64 cm [16 in] high. The cylinders are partially filled with concrete from 10.16 cm [4 in] to 25.4 cm [10 in] from the bottom of the cylinder. When placed on the seafloor, the cylinders will sink into the sediment to the level of the concrete, and will allow observation of scour. The scour cylinder is marked in centimeter graduations. Figure 2 is a photograph of a scour cylinder prior to deployment.

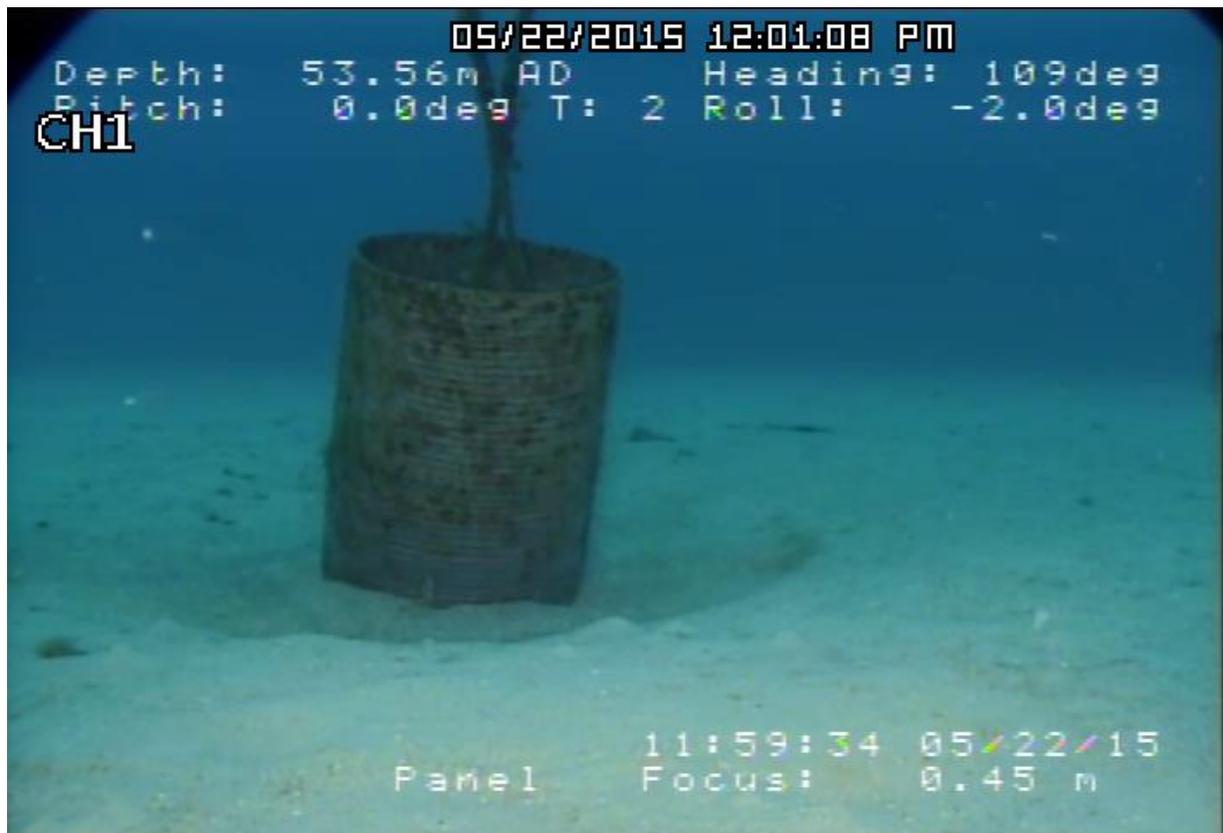
The seafloor around the scour cylinder located near Mooring A had observable scour in a semicircle around the West-Southwest side of the scour cylinder. The diameter of the scour was approximately 82 cm, and was roughly 4 cm deep. The cylinder was also leaning in the West-

Southwest direction. Due to the fact that the cylinder was leaning or tilting, a range of heights were observed from 44 cm to 36 cm.

Figure 3. Scour cylinder deployed at anchor base A

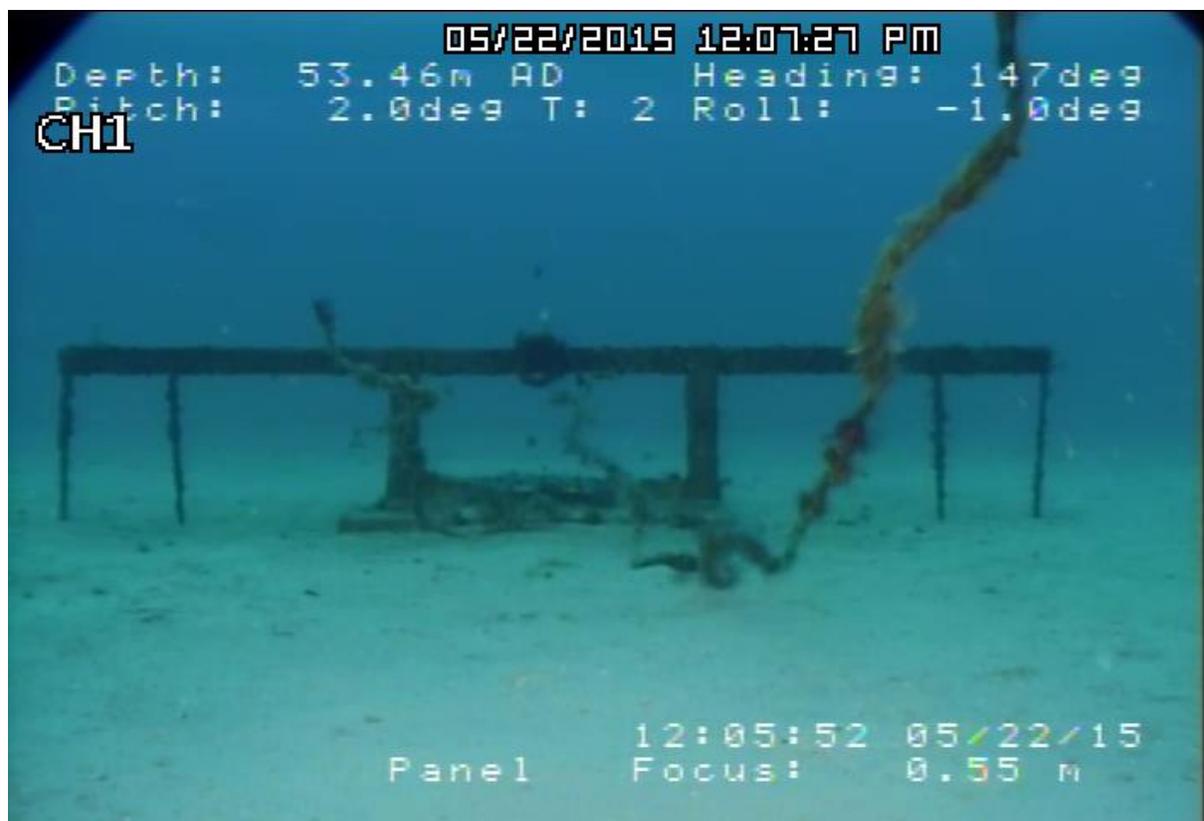
Figure 4. Sediment staffs deployed at anchor base A

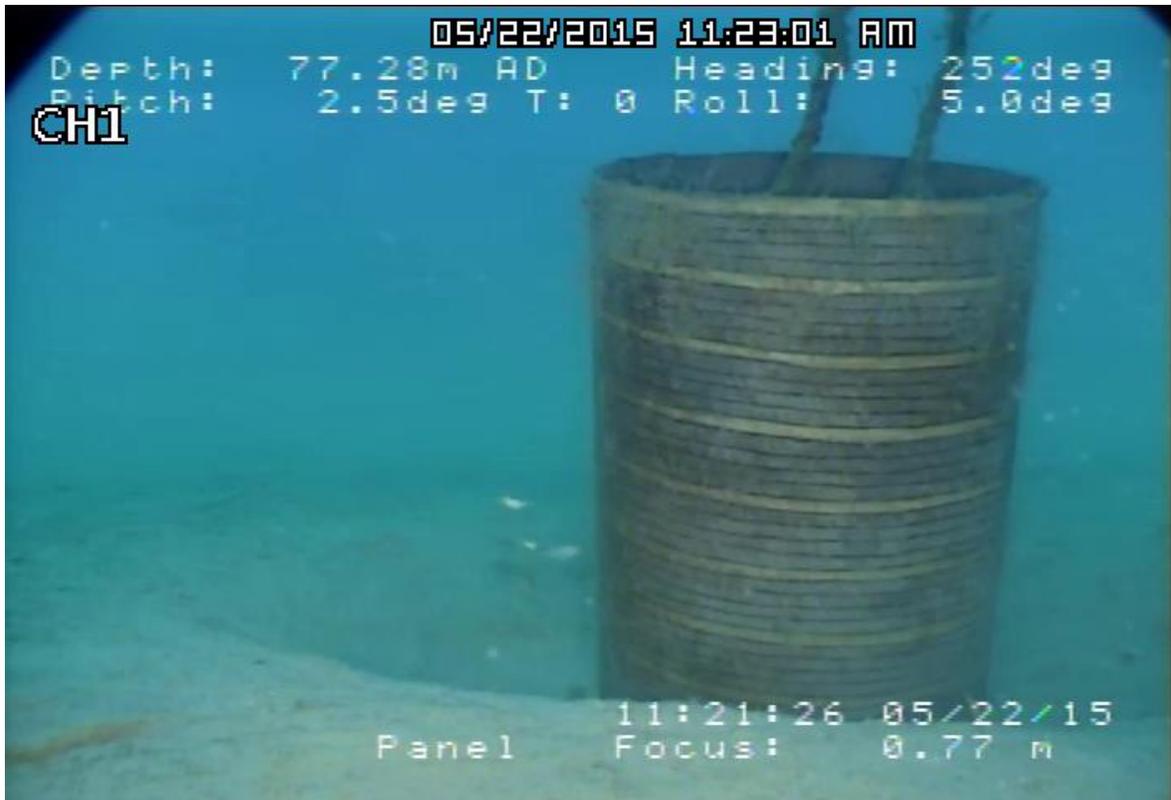
The seafloor around the scour cylinder located near Mooring B had observable scour in a full circle around the cylinder. The diameter of the scour was approximately 77 cm, and was roughly 12 cm deep. The scour cylinder had an observed height of approximately 44 cm. Photographs of the scour cylinders for Mooring A and Mooring B are shown in Figure 3 and Figure 5.

Figure 5. Scour cylinder deployed at anchor base B

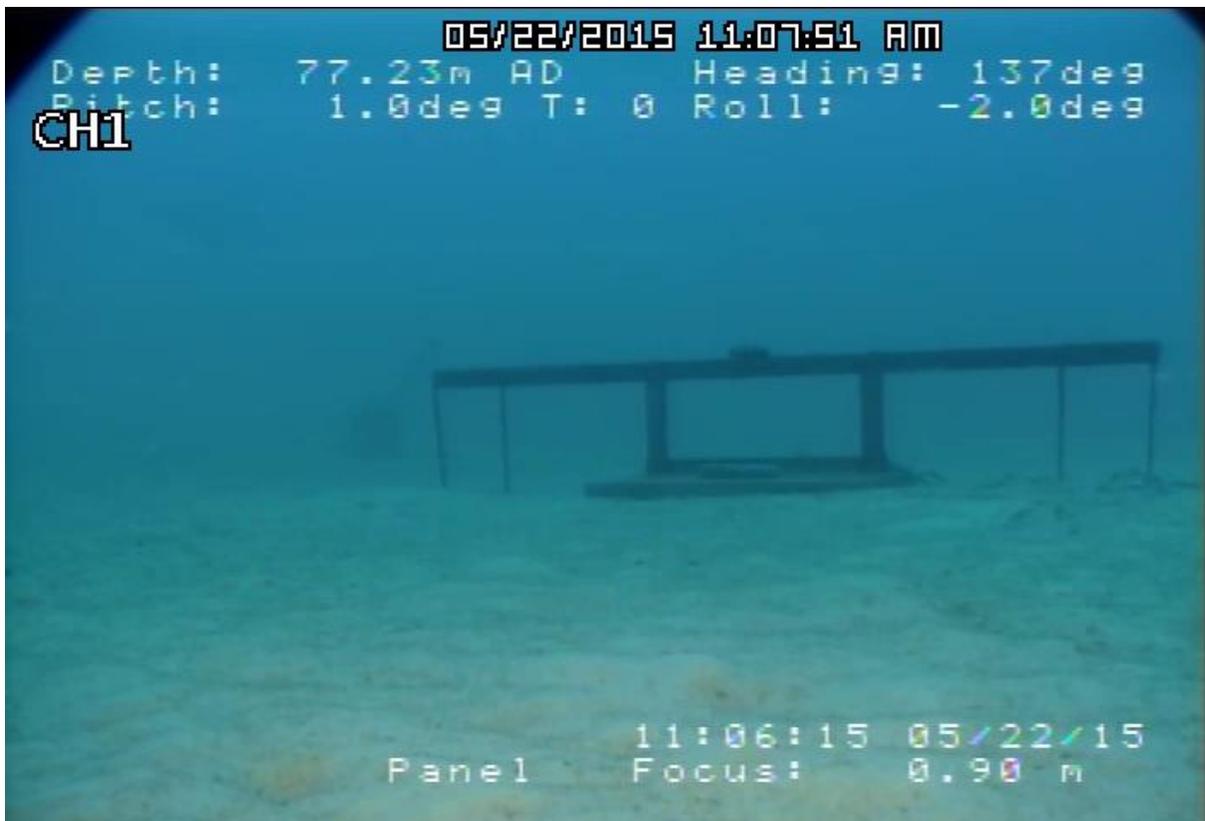
Figure 6. Sediment staffs deployed at anchor base B

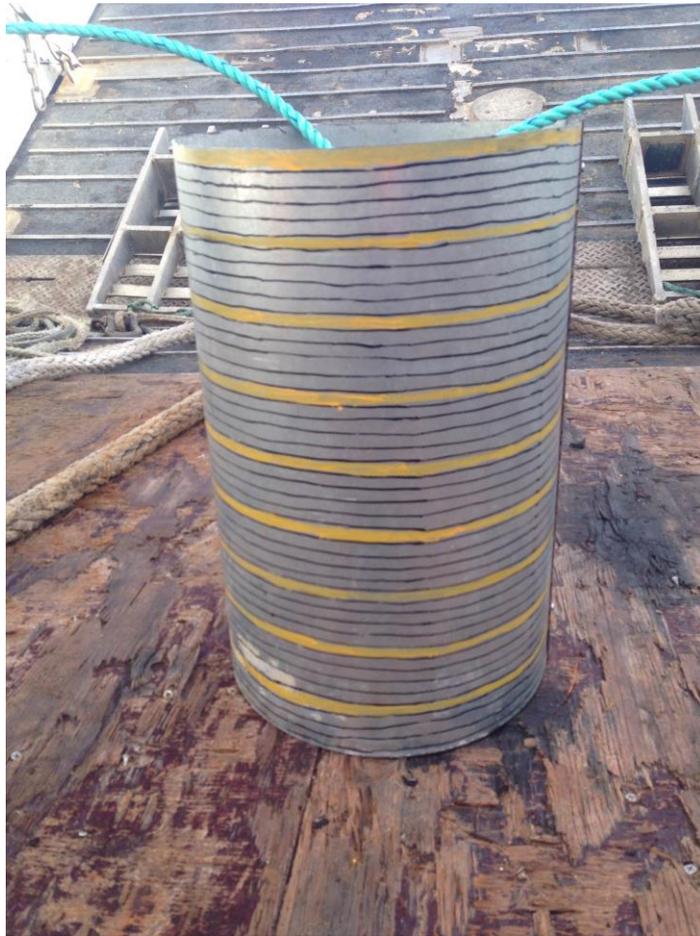
Figure 2. Scour cylinder

Two scour measurement cylinders, were also fabricated. These consist of thin walled sheet metal cylinders approximately 30.48 cm [12 in] diameter, and 40.64 cm [16 in] high. The cylinders are partially filled with concrete from 10.16 cm [4 in] to 25.4 cm [10 in] from the bottom of the cylinder. When placed on the seafloor, the cylinders will sink into the sediment to the level of the concrete, and will allow observation of scour. The scour cylinder is marked in centimeter graduations. Figure 2 is a photograph of a scour cylinder prior to deployment.

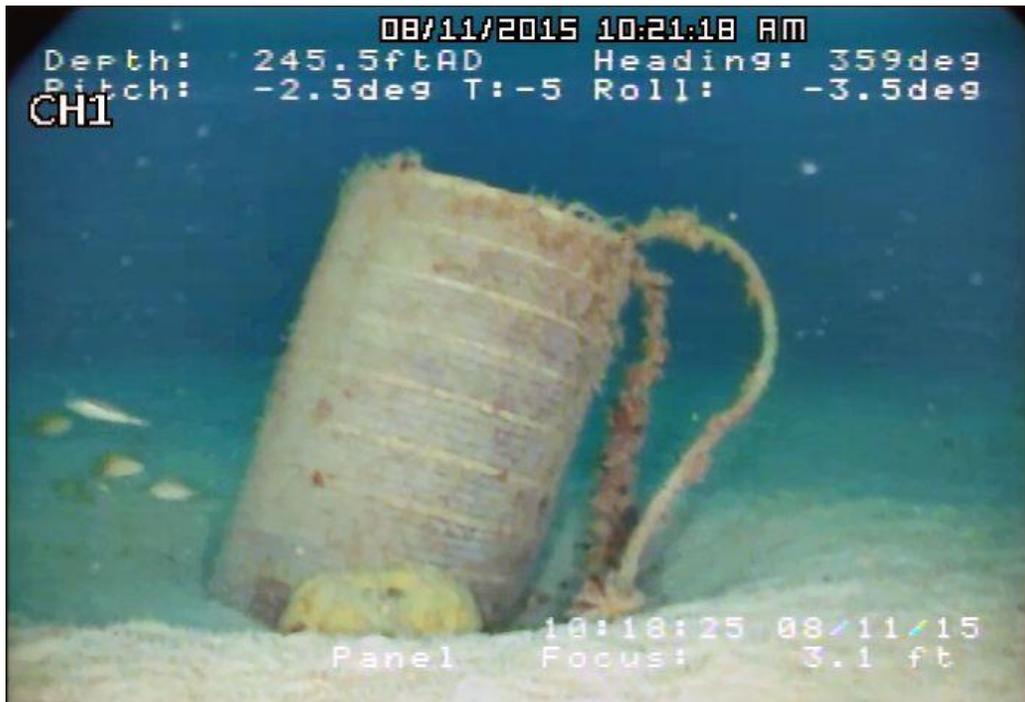
The scour cylinder located at the 80m site (Mooring A) also had extensive marine growth. The markings were still visible and measurements were possible. The seafloor around the cylinder has scoured all around all sides of the cylinder. Again the most defined observable scour is on the West-Southwest side of the scour cylinder. The diameter of the scour area has enlarged from approximately 82 cm to 89 cm. The scour depth has also increased from roughly 4 cm deep to 10 cm. The cylinder was still leaning in the West-Southwest direction. Due to the fact that the cylinder was leaning or tilting, a range of heights were observed from 45 cm to 38 cm.

Figure 3. Scour cylinder deployed at anchor base A

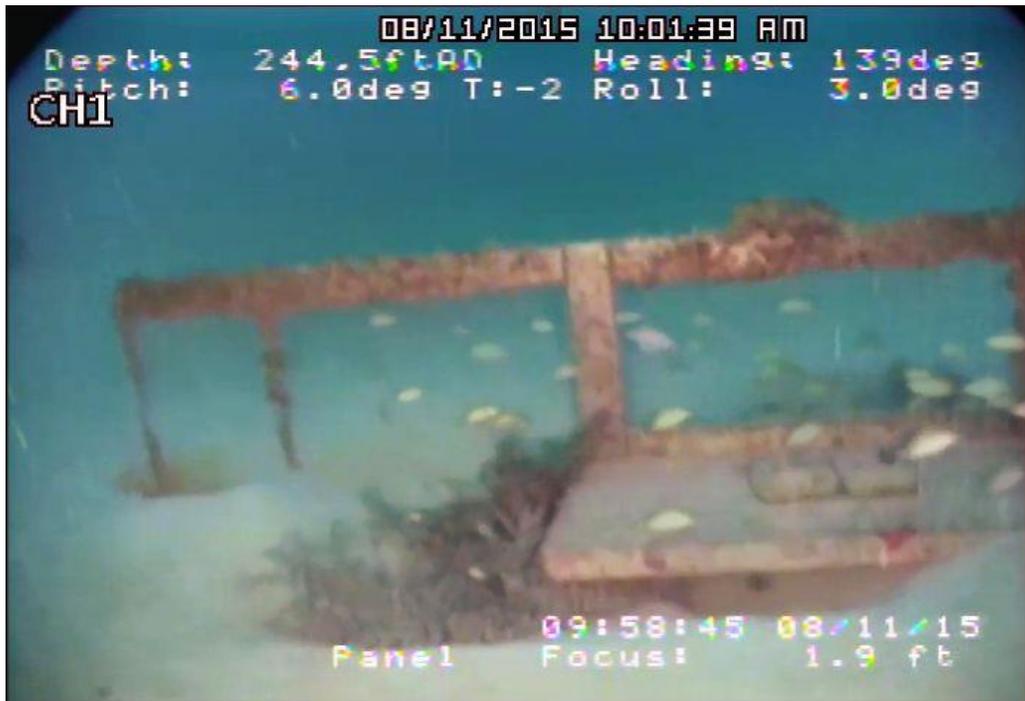
The August 11th ROV observations indicate that the base of the staff at the 80m site (Mooring A) is undermined. The loss of sediment is likely due to marine animals. This undermining appears to have caused the base to shift or tilt and thus the measurements have lost their reference. Furthermore, seagrass is growing in the voids created by the undermining. Also burrow holes are evident around both the northeast staffs. These holes do not seem to be formed by any sedimentation process but by marine animal activity. Measurements of the staffs indicate 3.9 to 8.6cm of sedimentation. However, the differences are likely due to the base settling into the undermined void and also due to the inaccuracies of the scaling used rather than actual sediment transport processes

Figure 4. Sediment staffs deployed at anchor base A

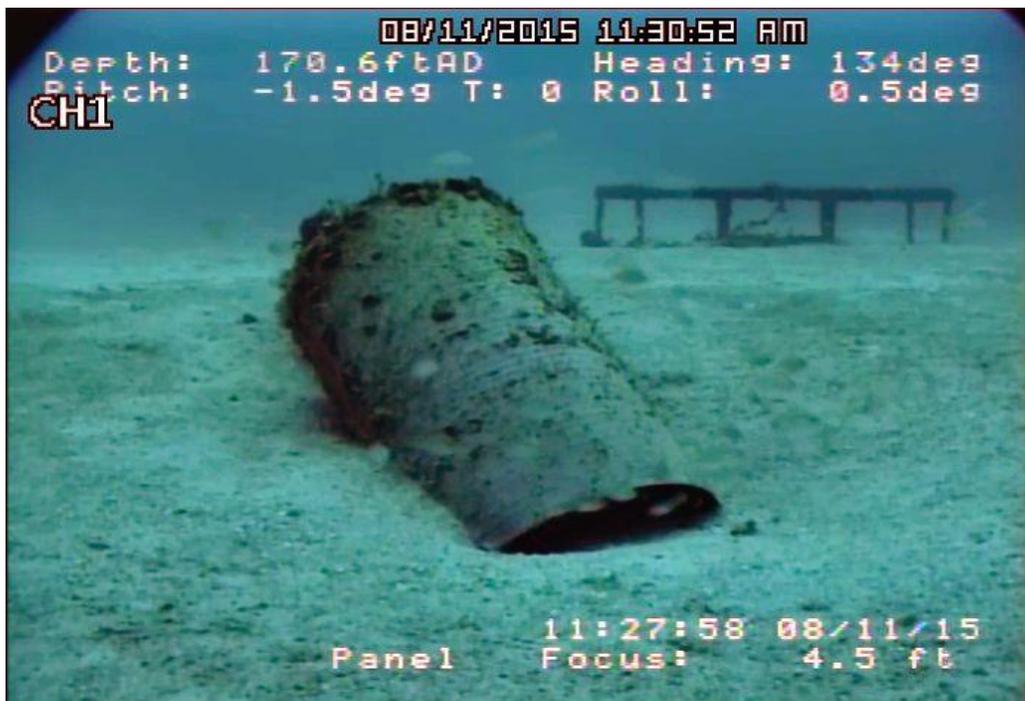
The scour cylinder located near Mooring B has toppled over. There appears to be a shallow scour depression (about 3-4cm) around the North side of the overturned cylinder. Seagrass has started to grow in the void at the top of the cylinder. Photographs of the scour cylinders for Mooring A and Mooring B are shown in Figure 3 and Figure 5. Table 4 shows the sediment scour cylinder measurements for both Mooring A and Mooring B.

Figure 5. Scour cylinder deployed at anchor base B

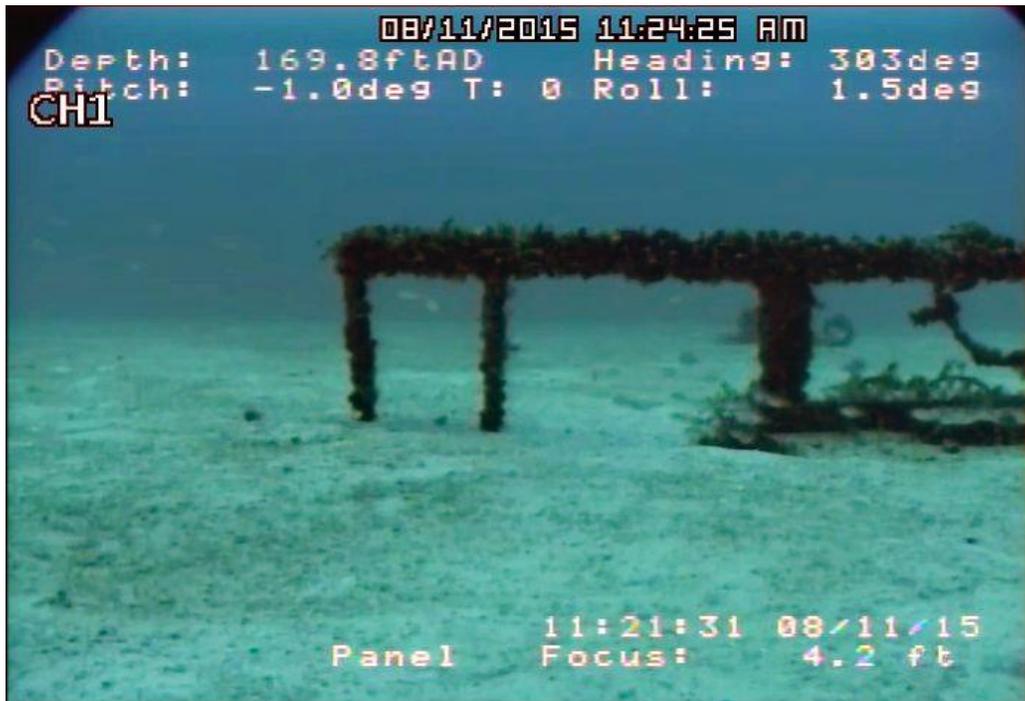
The sediment staffs at the 60m site (Mooring B) also have substantial growth that has obscured the markings. However, there was no evidence of burrowing or scouring around the base of the staffs. The measurements are shown in Table 3. The larger variation in the measurements for the August 11th readings is due to the inaccuracies of scaling a known dimension and not any sediment transport process.

Figure 6. Sediment staffs deployed at anchor base B

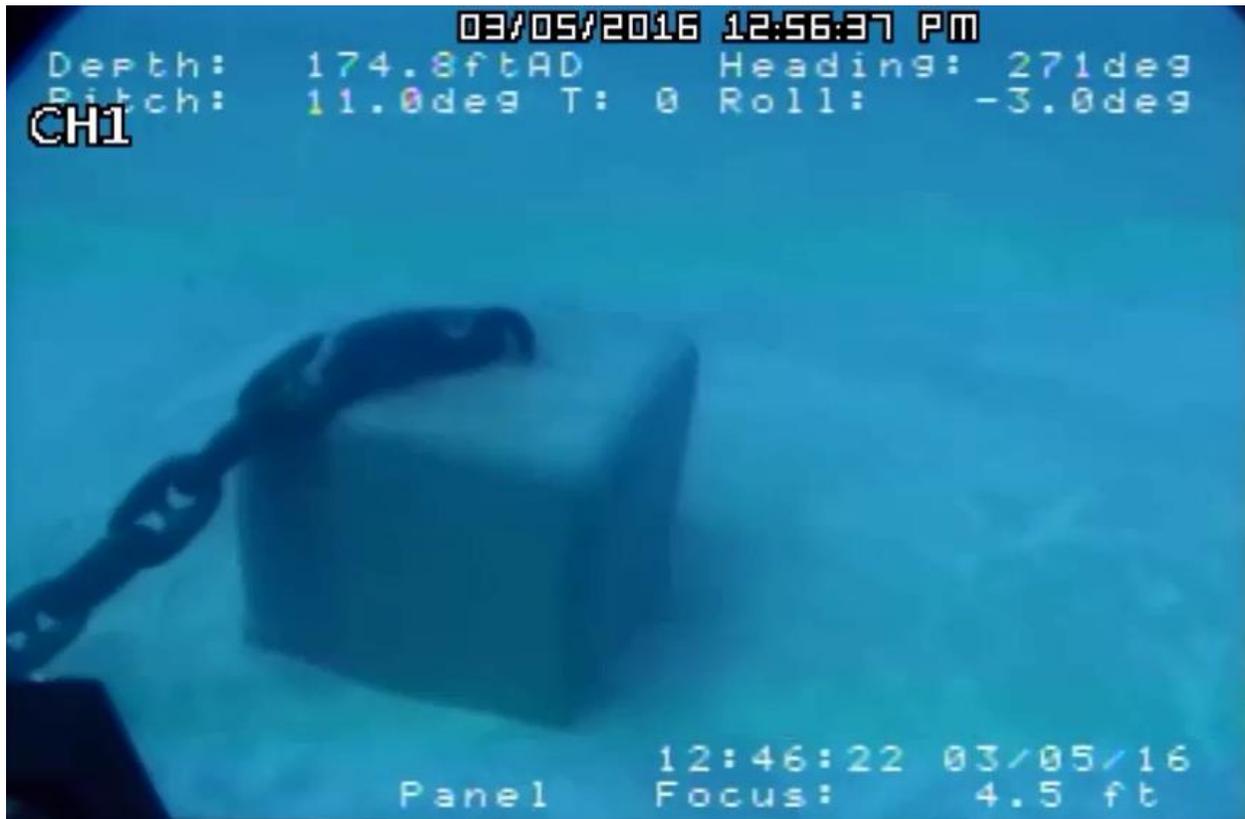
- Figure 2 shows mooring leg A1 recorded on March 5, 2016. There is no noticeable scour or sediment accumulation around the sinkers; however, there is considerable rounding of the top corners of the sinker weight and no marine growth. This was attributed to the motion of the chain and first sinker weight. The studs in the chain links that are impacting the seafloor (and piling up on the chain below) had been displaced or were completely missing. The first sinker weight on the A2 mooring leg had disconnected from the mooring leg.

Figure 2 First Concrete Block Sinker on Mooring Leg A1, March 5, 2016

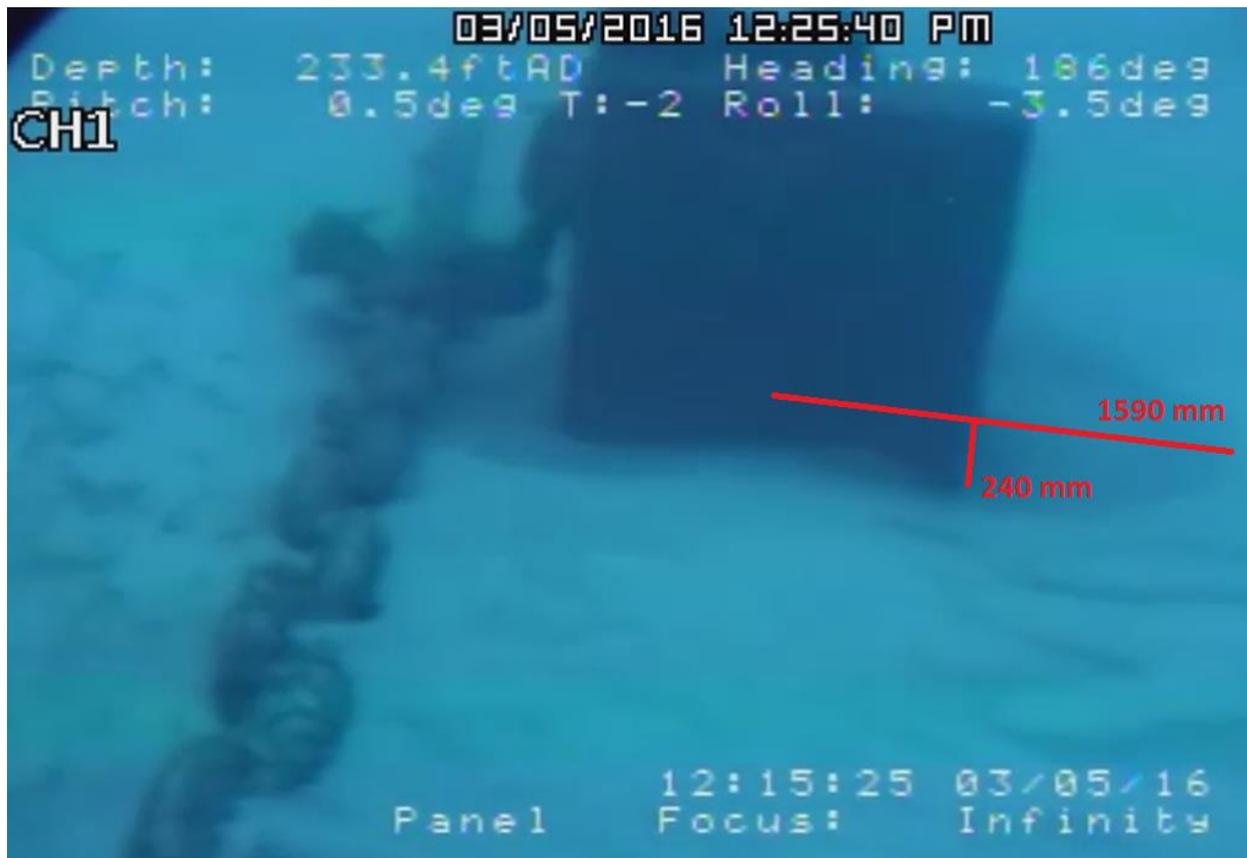
- Scour erosion around the fifth sinker (1194 mm wide) can be seen in Figure 3 on mooring leg A2 recorded on March 5, 2016. The radius of the scour is estimated to be 1590 mm and the depth 240 mm. Erosion is more intense on the right (west) side of the structure indicating that the current flows towards the west.

Figure 3 Scour Erosion around Fifth Sinker on Mooring Leg A2, March 5, 2016

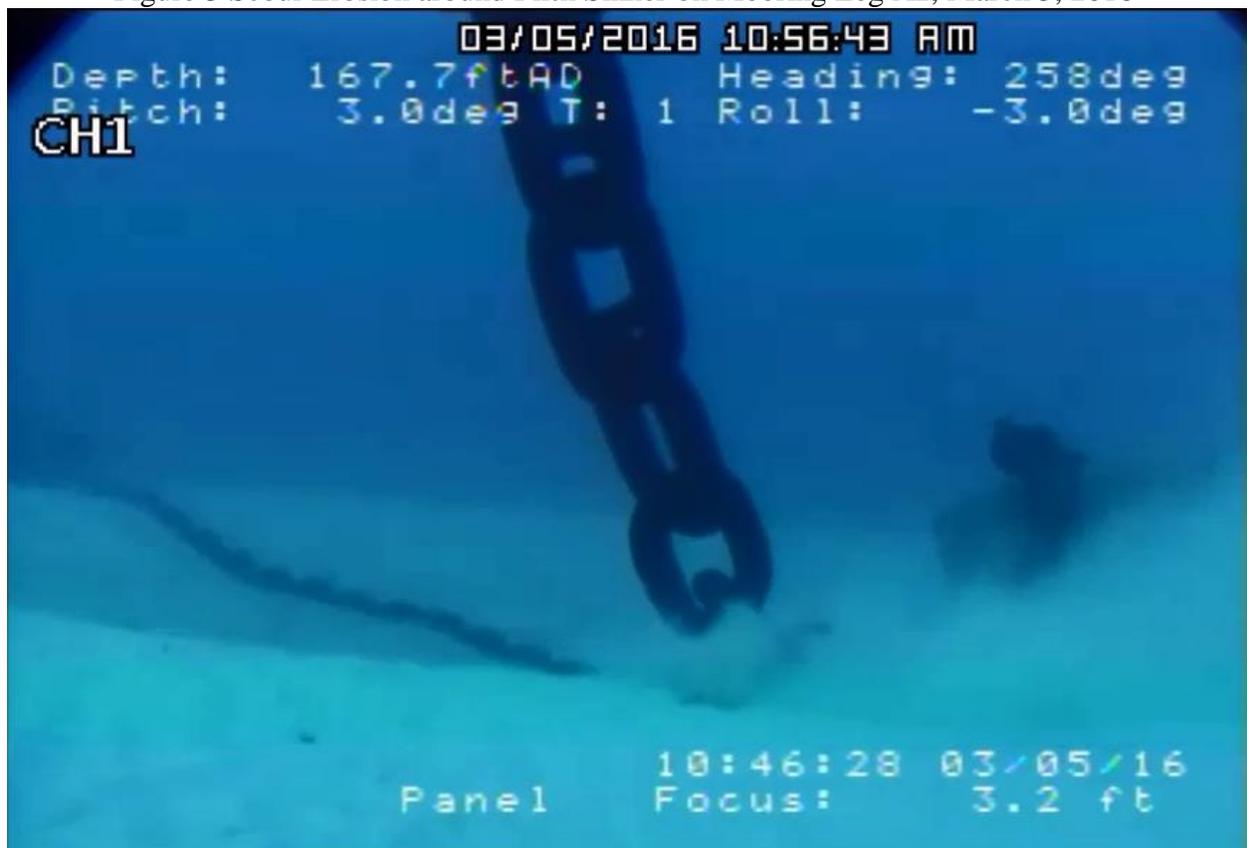
- Figure 4, recorded on March 5, 2016, shows the sediment being suspended by the up and down movement of the chain on mooring leg A3. The constant up and down motion is caused by the mooring buoy A3 rising and falling with the swell and the chain

Figure 4 Sediment Lifted by the Heave Movement of Mooring Leg A3, March 5, 2016

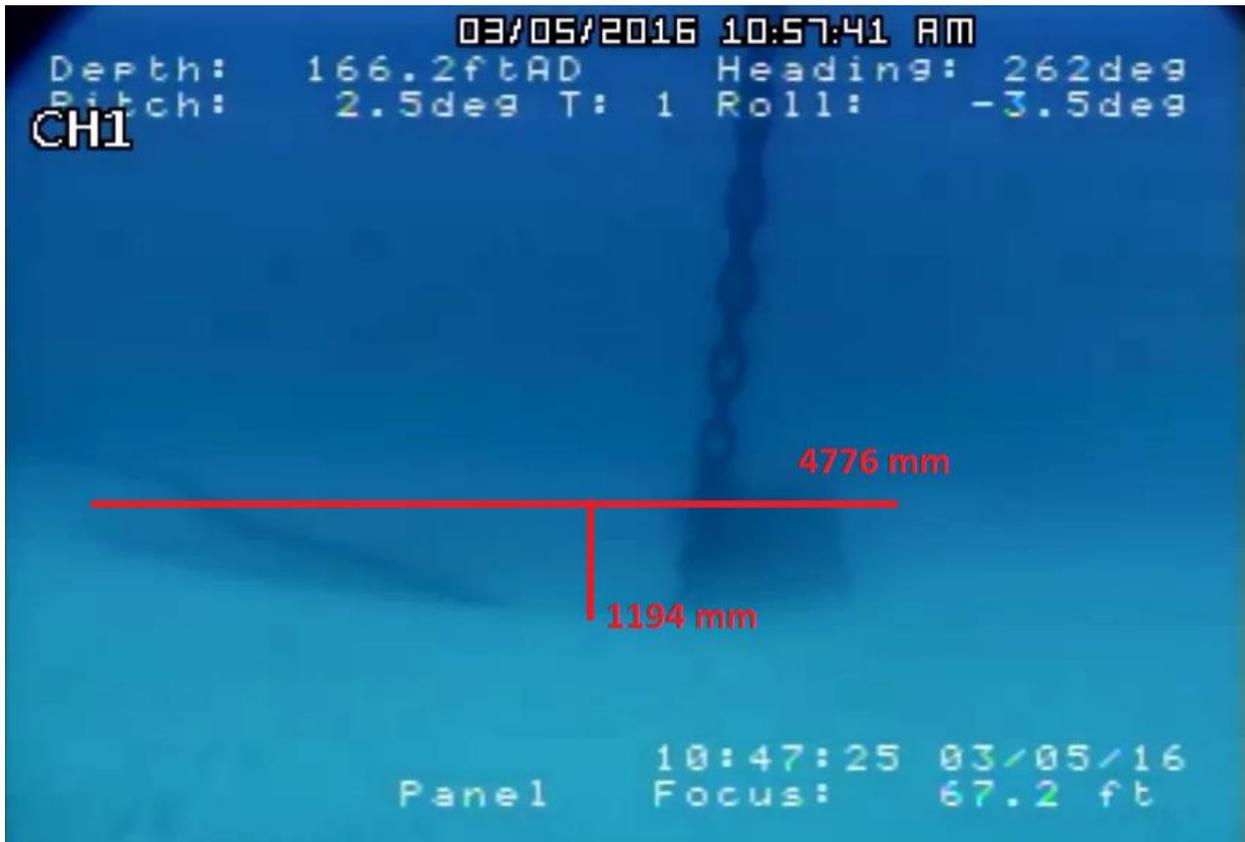
subsequently following. This continuous rising and dropping of the chain is the suspected reason for the formation of a large depression around the first sinker of the A3 mooring leg, as seen in Figure 5.

Figure 5 Depression around a Sinker on Mooring Leg A2, March 5, 2016

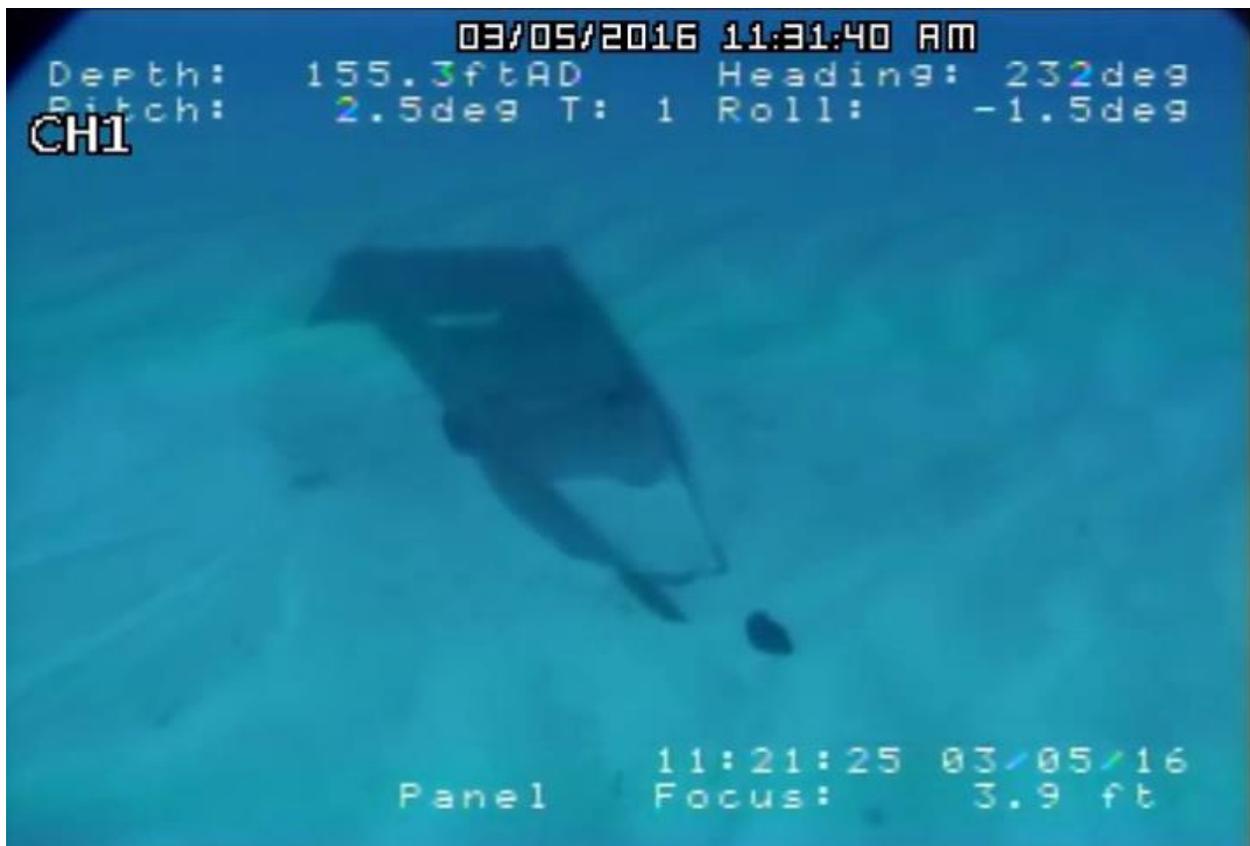
- The anchor of mooring leg A3 has significant sediment accumulation on its left (east) side, as shown Figure 6, recorded on March 5, 2016, and Figure 7, recorded November 13, 2015. This indicates that current flow and sediment transport is from east to west. Sand deposited on the on top of the cross bracing of the anchor is also shown in Figure 6.

Figure 6 Anchor on Mooring Leg A3, March 5, 2016

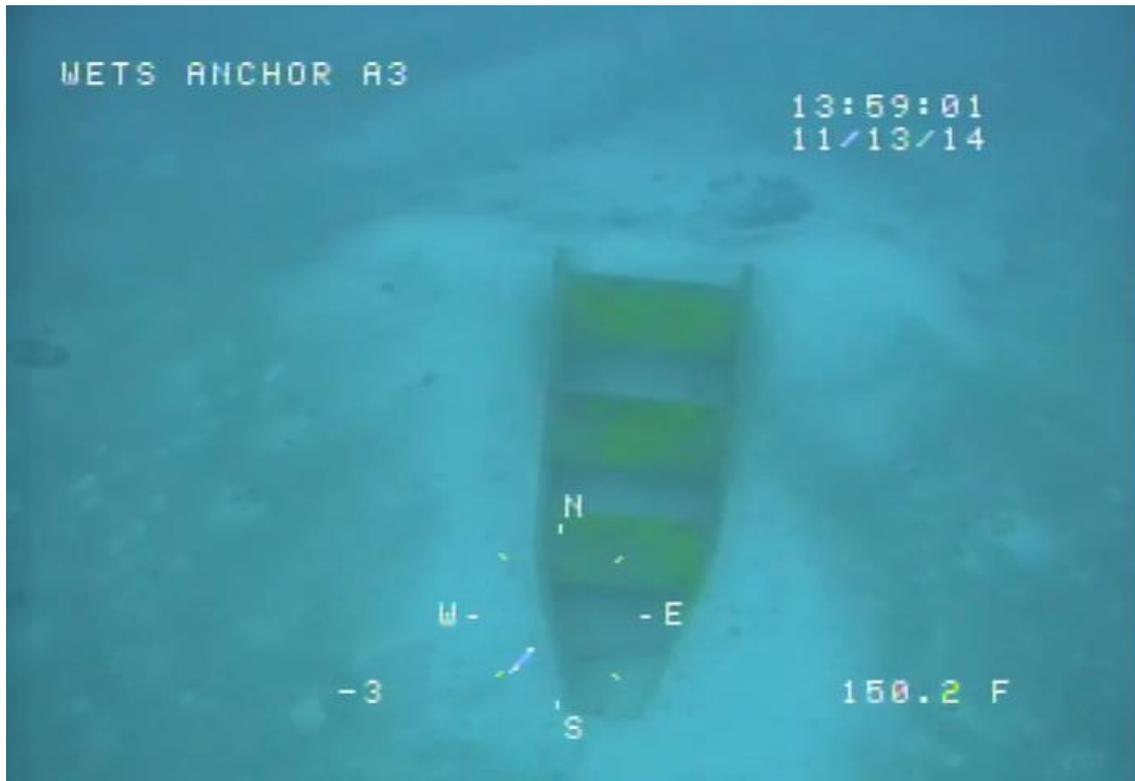
Figure 7 Anchor on Mooring A3, November 13, 2015

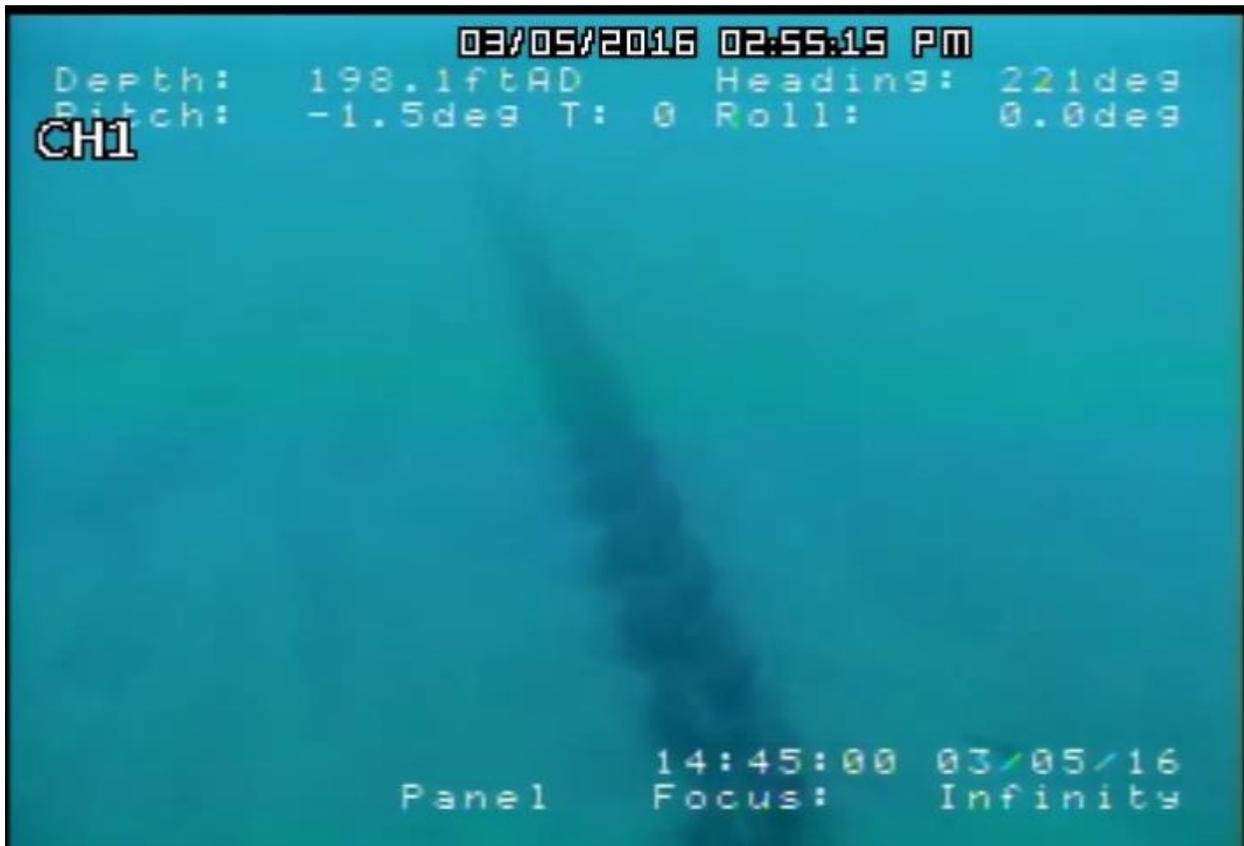
- Figure 8 recorded on March 5, 2016, shows the B3 mooring leg chain and that there is no significant deposition or erosion on the chain.
- Figure 9 recorded on March 5, 2016, on mooring leg B2 there is no significant scour erosion, although some sediment deposition can be seen on the chains near the sinker.

Figure 8: Mooring 3B chain, March 5, 2016
