Hawaii National Marine Renewable Energy Center (HINMREC)

Task 4: Environmental Impact Monitoring at WETS

Sediment Transport Analysis Reports, 3A-3D

Prepared by:
Sea Engineering, Inc.

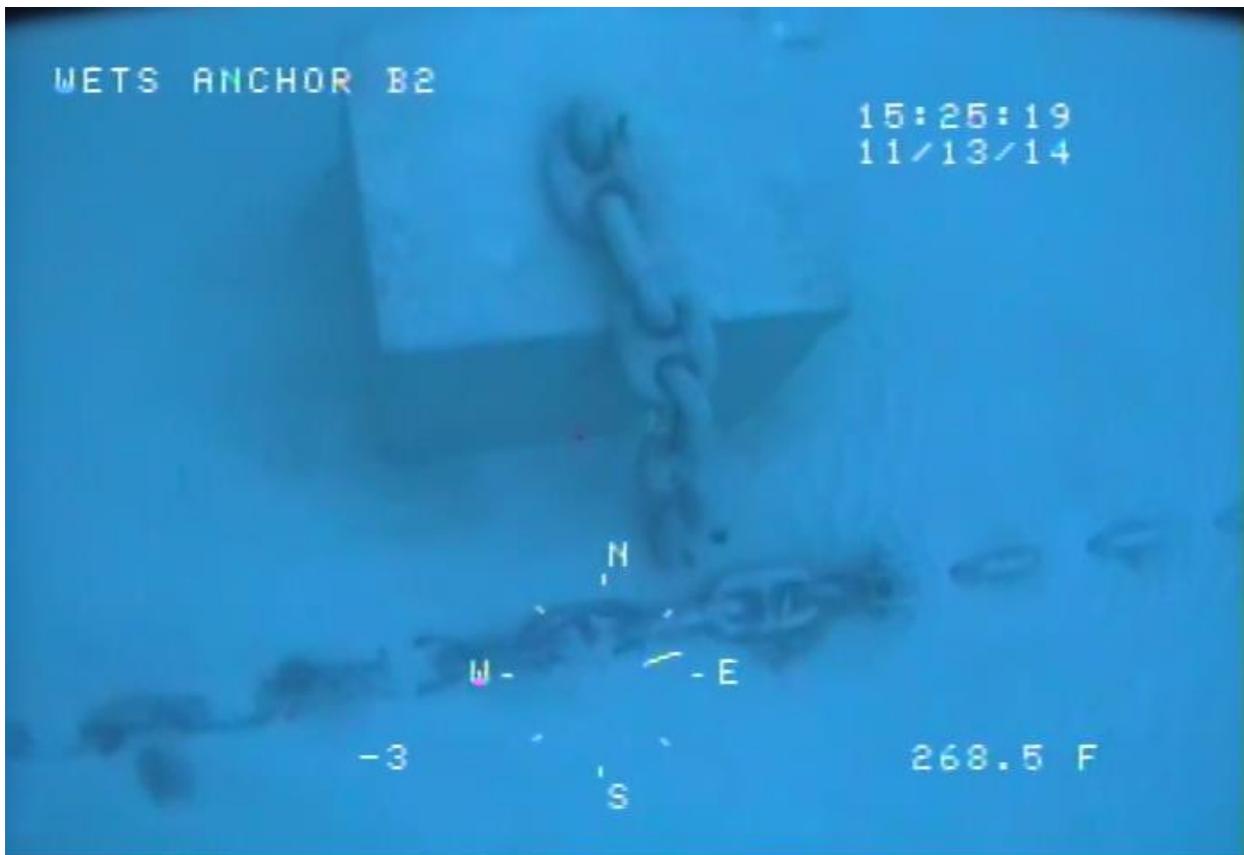
- Figure 8 recorded on March 5, 2016, shows the B3 mooring leg chain and that there is no significant deposition or erosion on the chain.
- Figure 9 recorded on March 5, 2016, on mooring leg B2 there is no significant scour erosion, although some sediment deposition can be seen on the chains near the sinker.

Figure 9 Sinkers on mooring leg B2, November 13, 2015

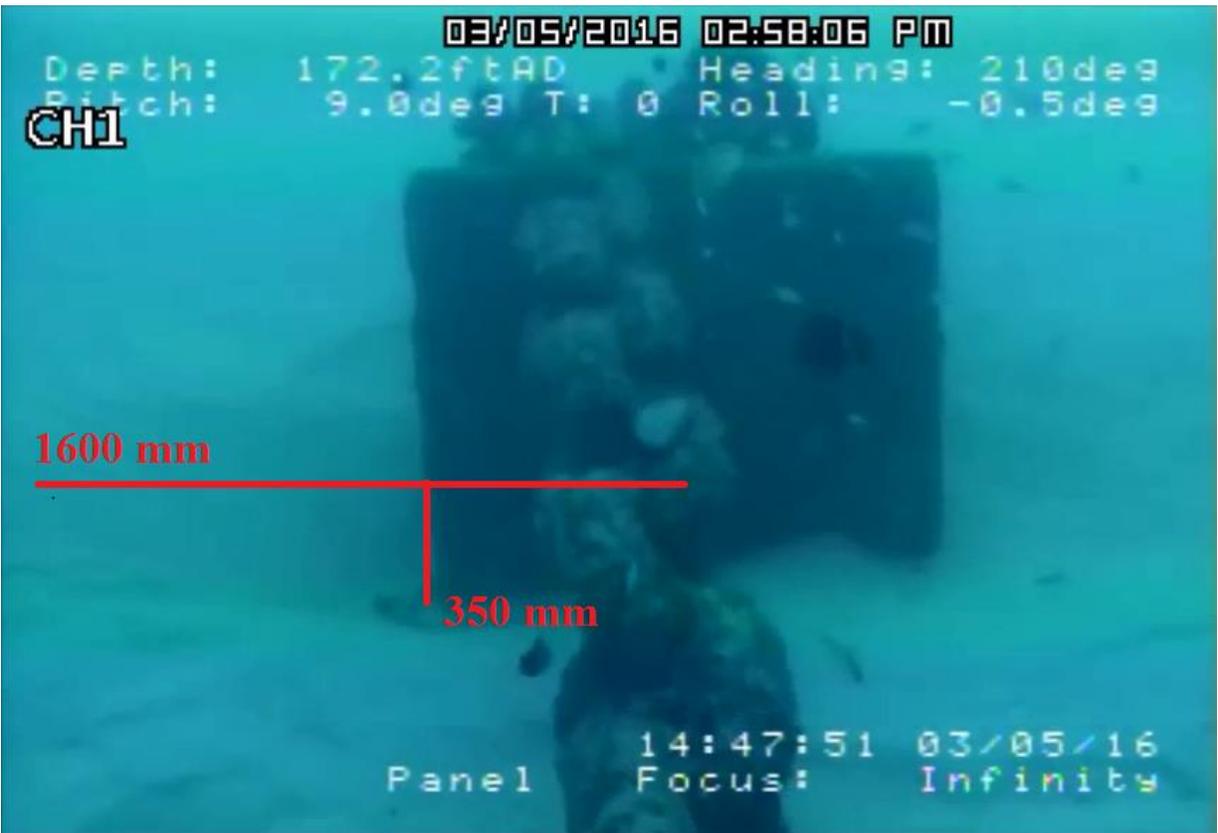
- Figure 10 recorded on March 5, 2016, shows scour erosion around a sinker which on mooring leg B3. The radius of the scour is estimated to be 1600 mm and the depth 350 mm. The shape and dimensions of the scour erosion on mooring B are very similar to the ones observed on mooring A. Scour appears to be on the East side suggesting a west to east flow opposite of which is different with that noted at mooring A.

Figure 10 Scour erosion around sinker on mooring leg B3

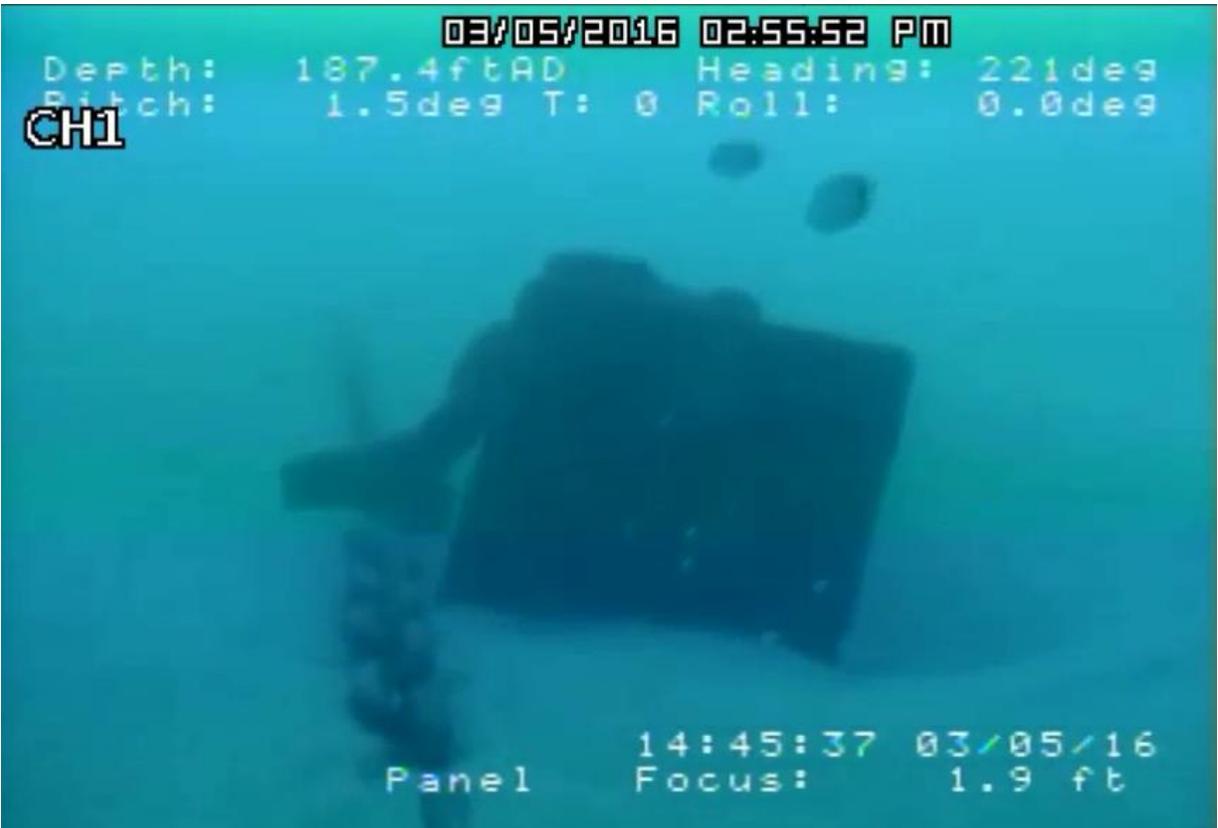
- Figure 11 recorded on March 5, 2016, shows more intense scour erosion on the right (west) side of the sinker, causing differential settlement of the block.

Figure 11 Sinker with differential settlement due to scour erosion

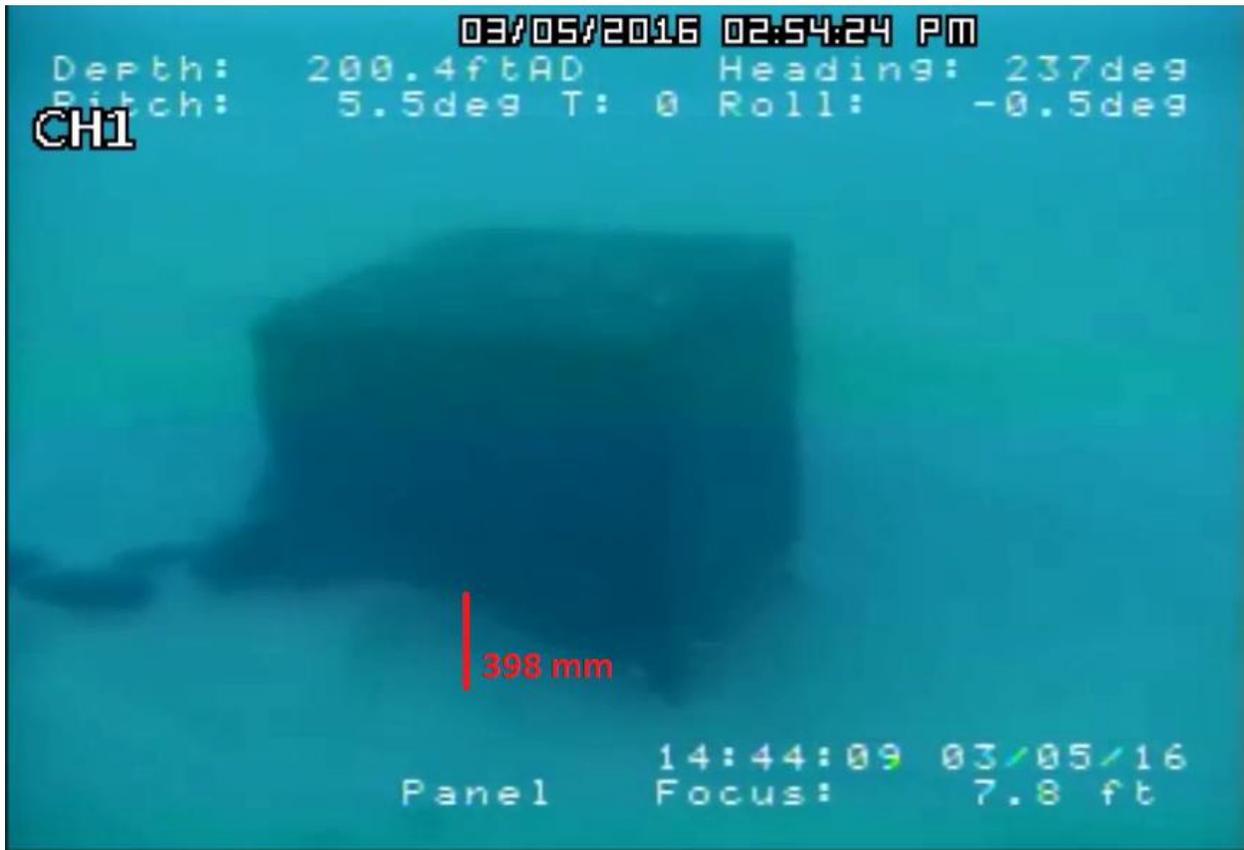
- It is possible to see deposition of sediment on the front left (east) side of the sinker in Figure 12. The height of the sand accumulation is estimated to be 398 mm, covering around one third of the block. Again, the sediment transport seems to be in the east-west direction.

Figure 12 Sediment deposition at sinker on mooring 3B

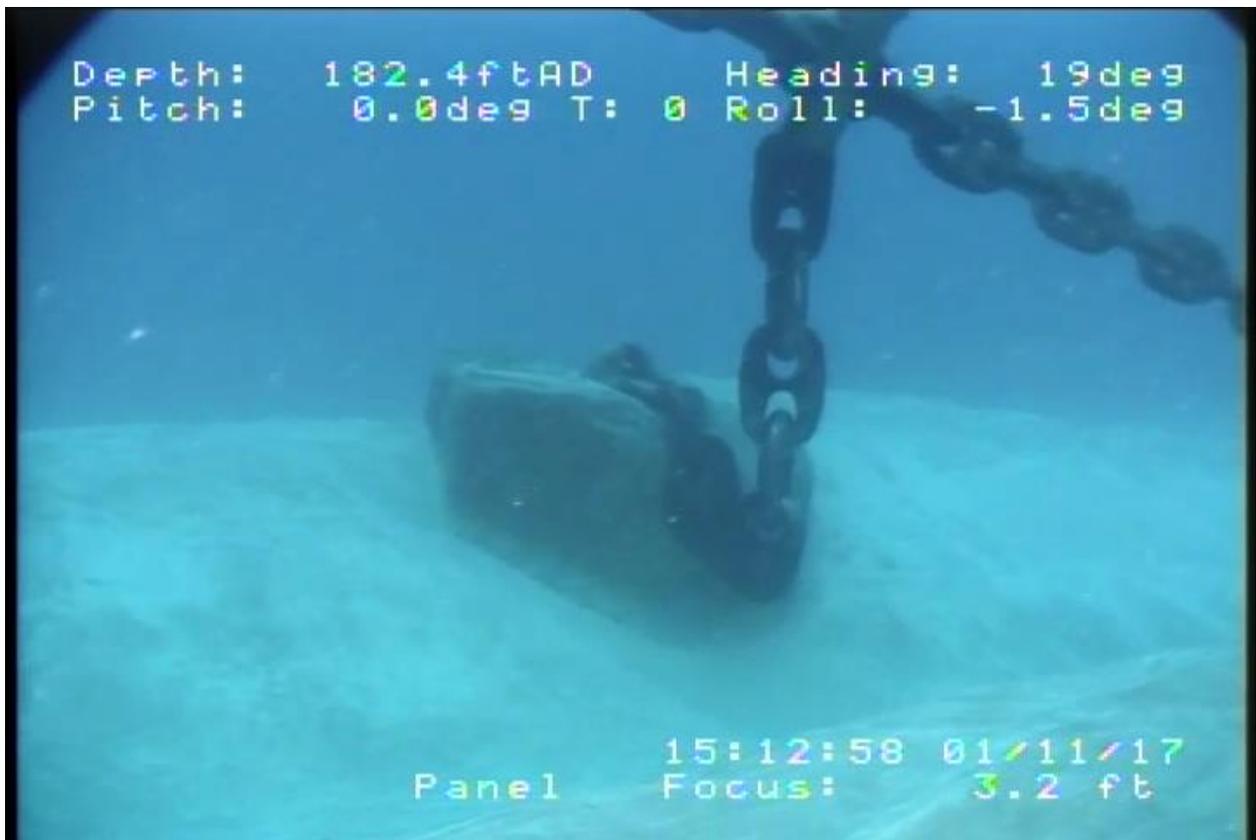
- The Fred Olsen Lifesaver was installed on March 25, 2016. When installed the hawsers pulled the mooring legs towards the center of the mooring arrangement. The mooring legs then had larger dip section of chain in intermittent contact with the seafloor. This larger dip section resulted in sediment displacement in the form of trenches in the seafloor sediments that centered on the dip section of each leg. This can be seen in Figure 13, Figure 14, and Figure 15.

Figure 13 A1 Dip Section of Chain

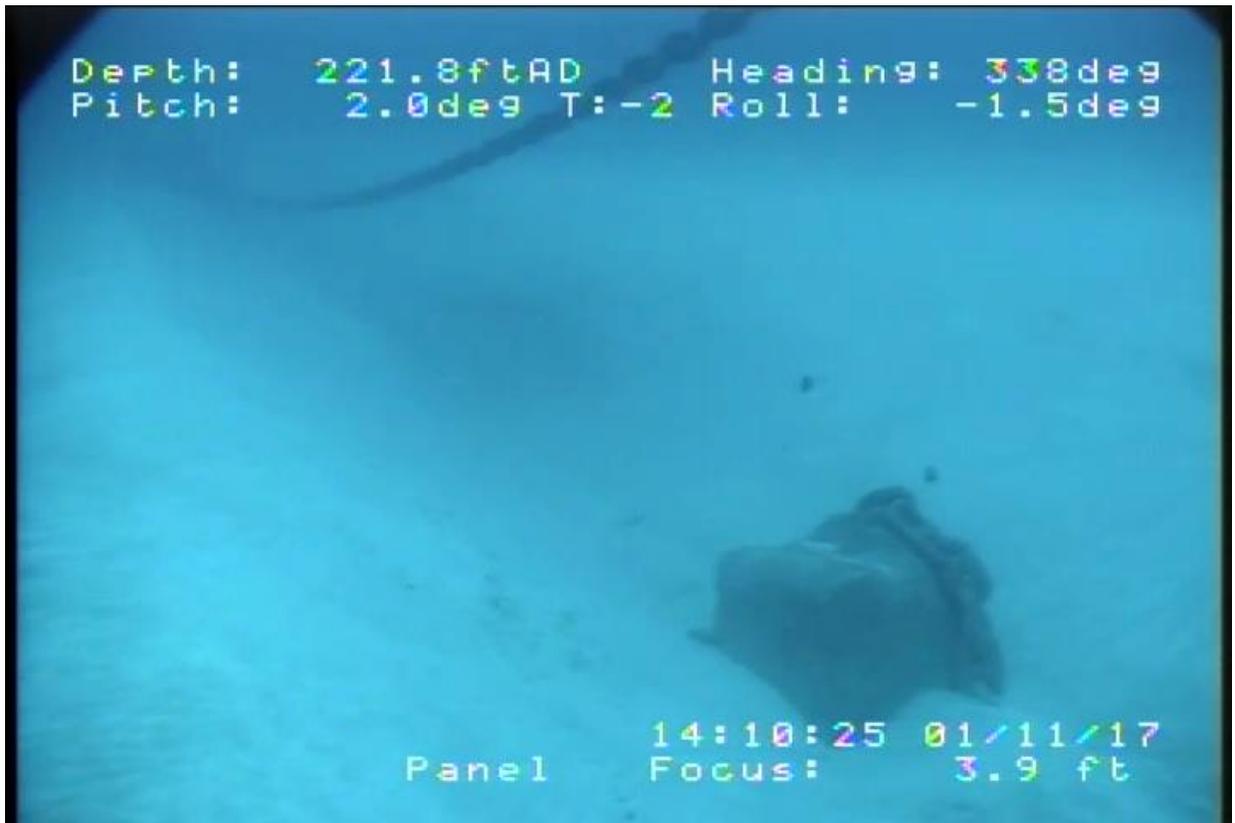
Figure 14 A2 Dip Section of Chain

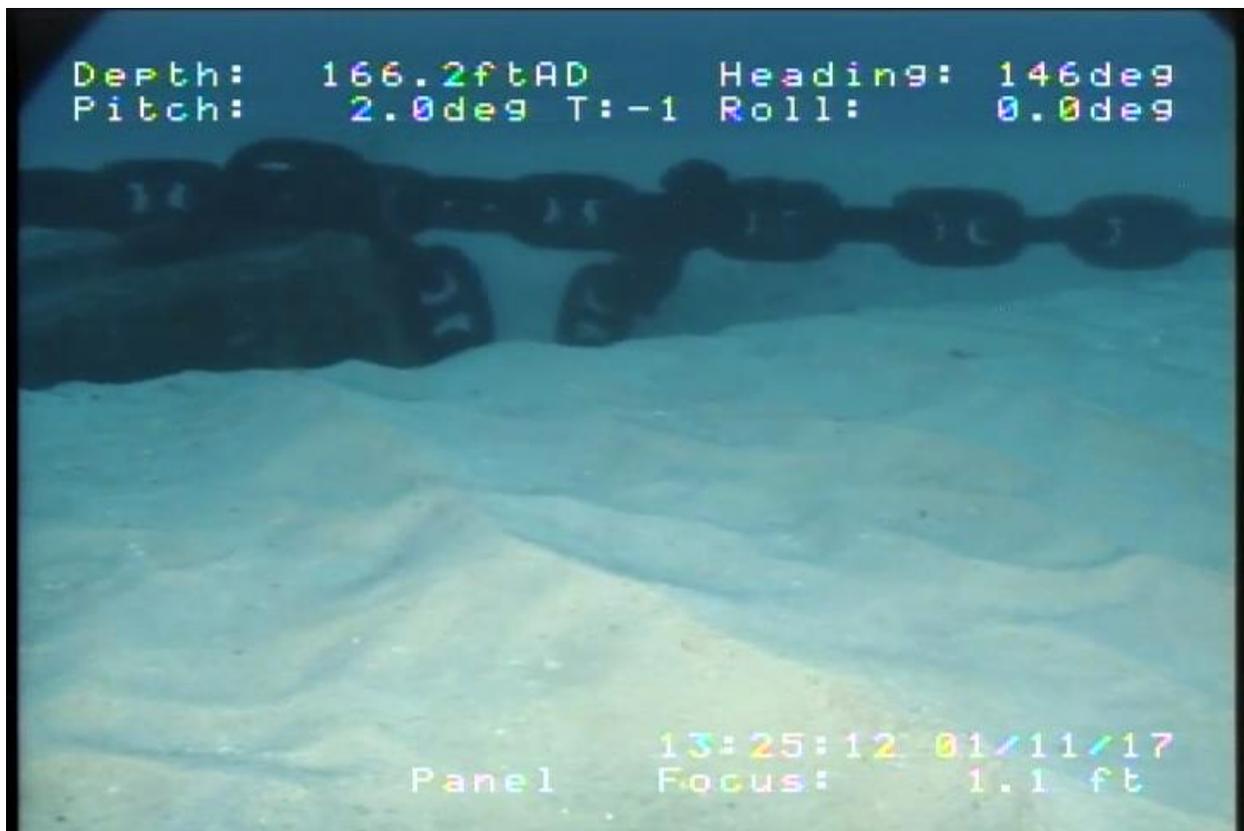
Figure 15 A3 Dip Section of Chain (third sinker weight in trench)
