Hawaii National Marine Renewable Energy Center (HINMREC)

Kāneʻohe Wave Energy Test Site: Dive Survey Report

Prepared by:
Sea Engineering, Inc.

December 2013

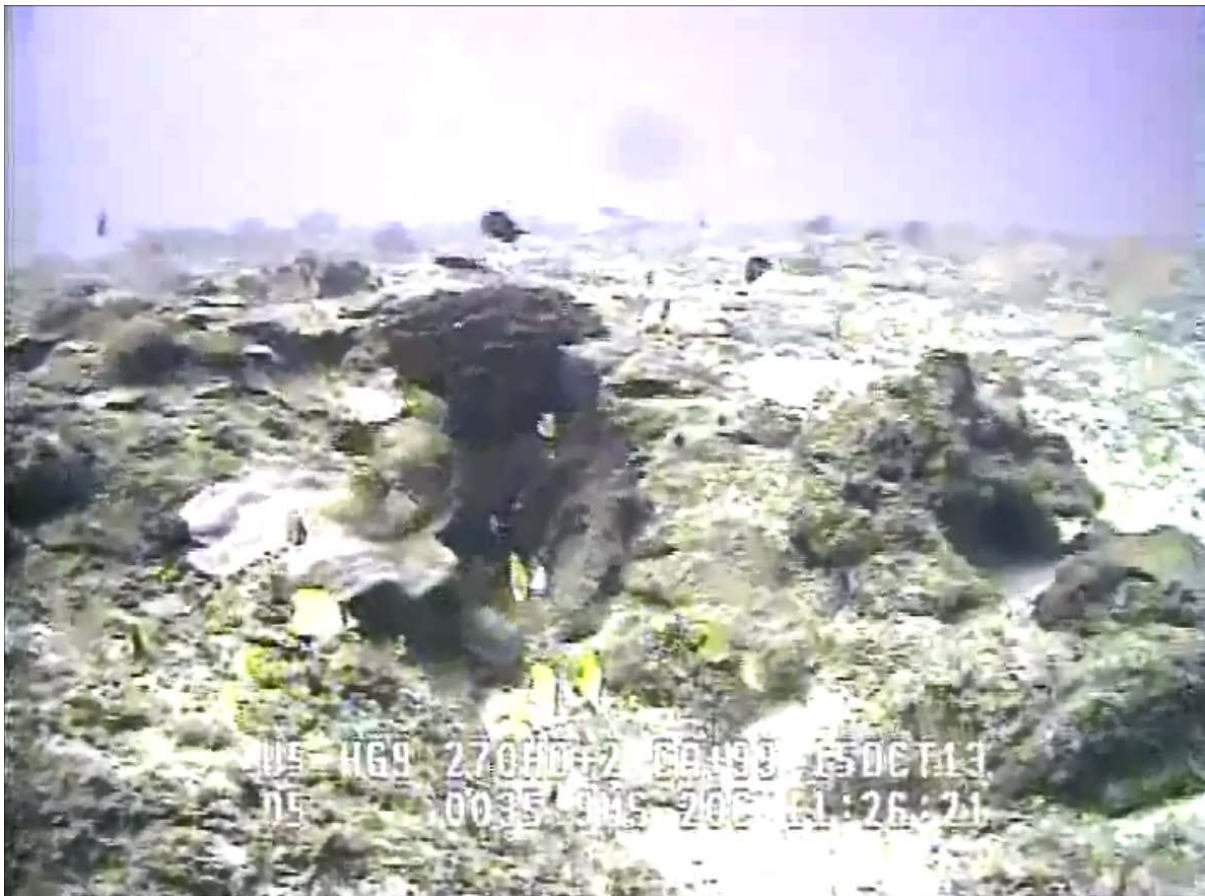
| TARGETS | | | |
|---|---|---|---|
| A-1 | N 21 28' 13.48" | W 157 45' 20.77" | SMALL CORAL CHUNK |

Figure 3-3: Target A-1 Coral

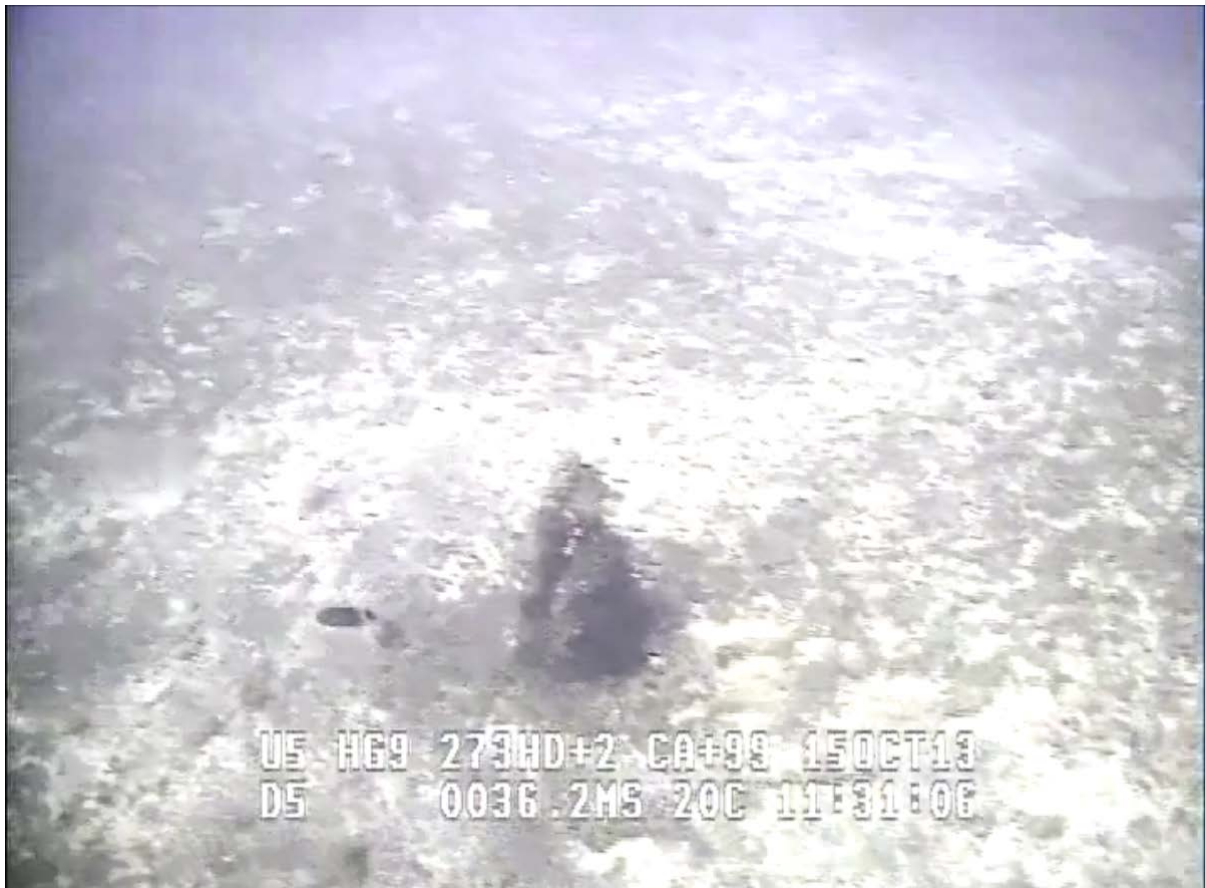
| TARGETS | | | |
|---|---|---|---|
| A-2 | N 21 25' 15.75" | W 157 45' 22.28" | ROCK PINNACLE |

The dive along Cable Route A began at point 10A at a water depth of 10-15 meters and progressed seaward passing through points 10A-32A in numerical order (Figure 3-2). The dive along Route A terminated at point 32A at a water depth of 60-65 meters. Previous geophysical surveys conducted at the WETS site indicated that the seafloor in this area was hard bottom with irregular relief closer to shore, transitioning to a sand field near points 24A and 25A. The ROV survey confirmed these findings, and revealed hard bottom, with irregular relief and a spur and groove morphology on the inshore section. Sand was visible in the grooves while the spurs were barren, hard bottom with some algae. As the ROV survey progressed seaward, a 0.5 meter ledge was observed at targets A-5 and A-6 separating the inshore hard bottom from the broad sand field mapped in previous surveys (Figure 3-2, Figure 3-7, Figure 3-8). In addition to the ledge, three small coral heads and a rock pinnacle were discovered along Cable Route A (Figure 3-2, Figures 3-3 to 3-6). All coral heads were less than 30 cm in diameter, and the pinnacle was less than 0.5 meters tall with an estimated diameter of 20 centimeters.

Figure 3-4: Target A-2 Rock Pinnacle

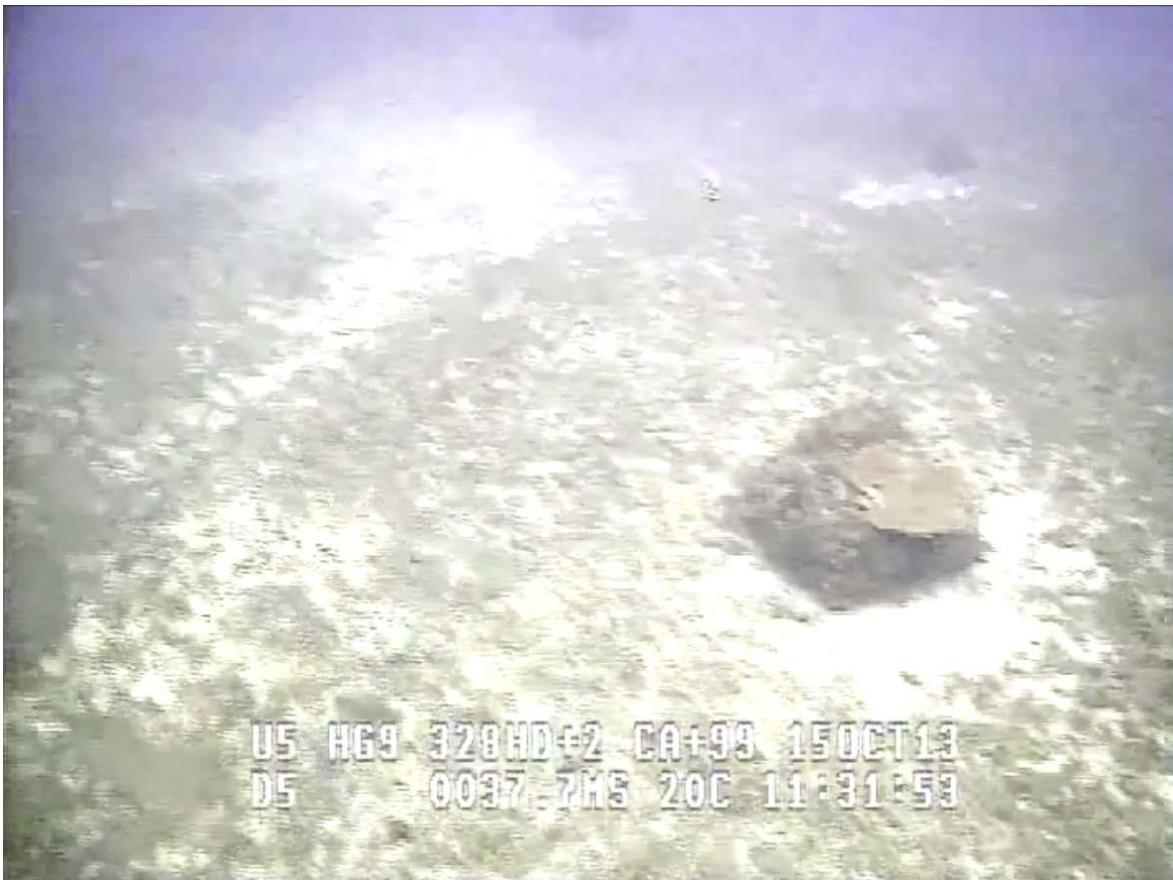
| TARGETS | | | |
|---|---|---|---|
| A-3 | N 21 28' 16.43" | W 157 45' 22.32" | SMALL CORAL CHUNK |

Figure 3-5: Target A-3 Coral

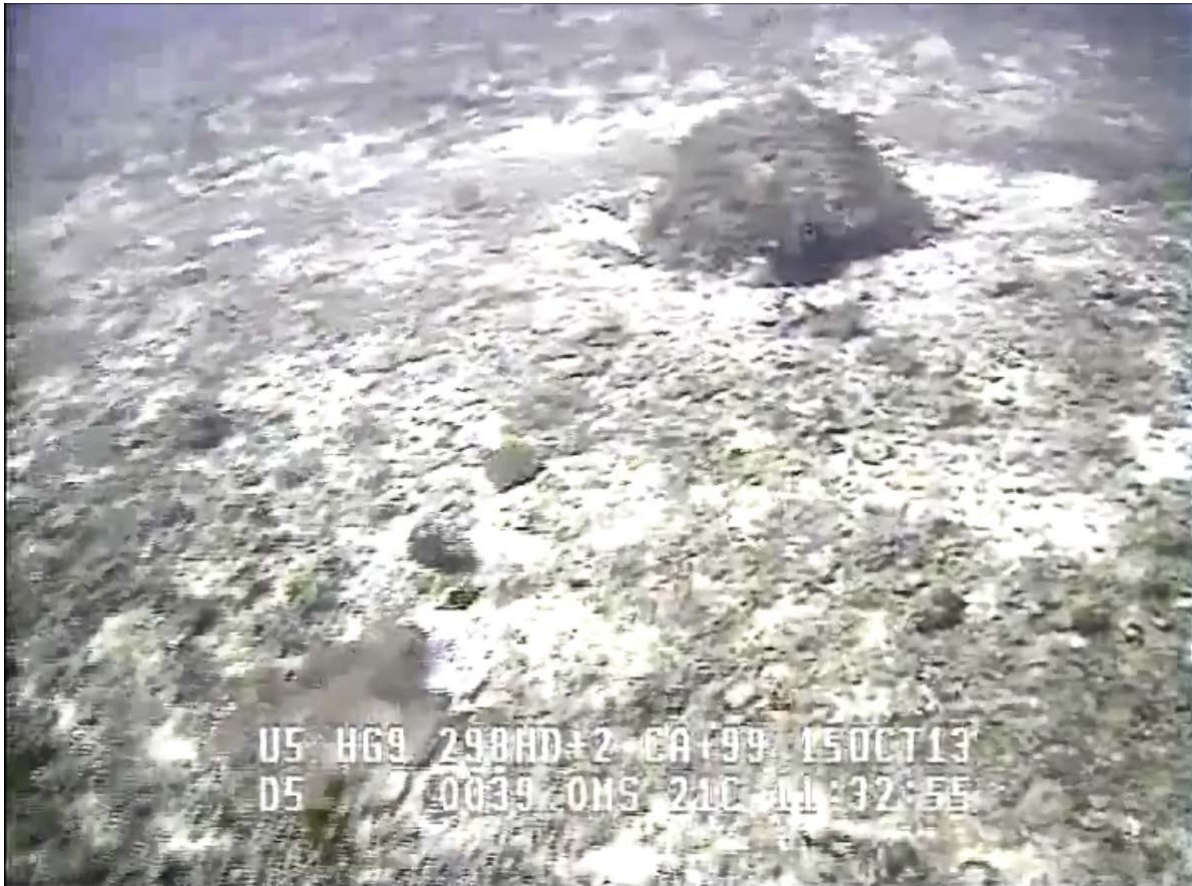
| TARGETS | | | |
|---|---|---|---|
| A-4 | N 21 28' 16.90" | W 157 45' 22.85" | SMALL CORAL CHUNK |

Figure 3-6: Target A-4 Coral

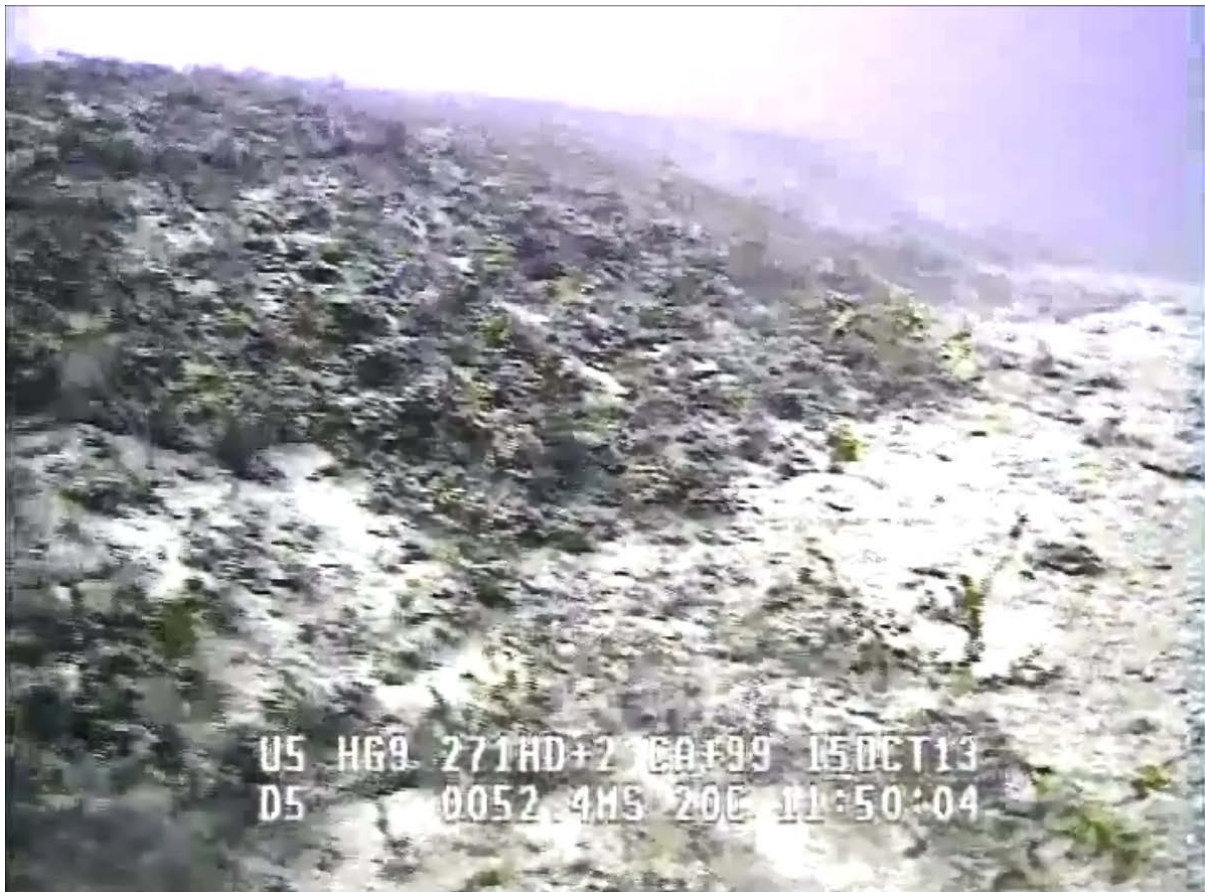
| TARGETS | | | |
|---|---|---|---|
| A-5 | N 21 28' 22.54" | W 157 45' 26.28" | LEDGE |

Figure 3-7: Target A-5 Ledge

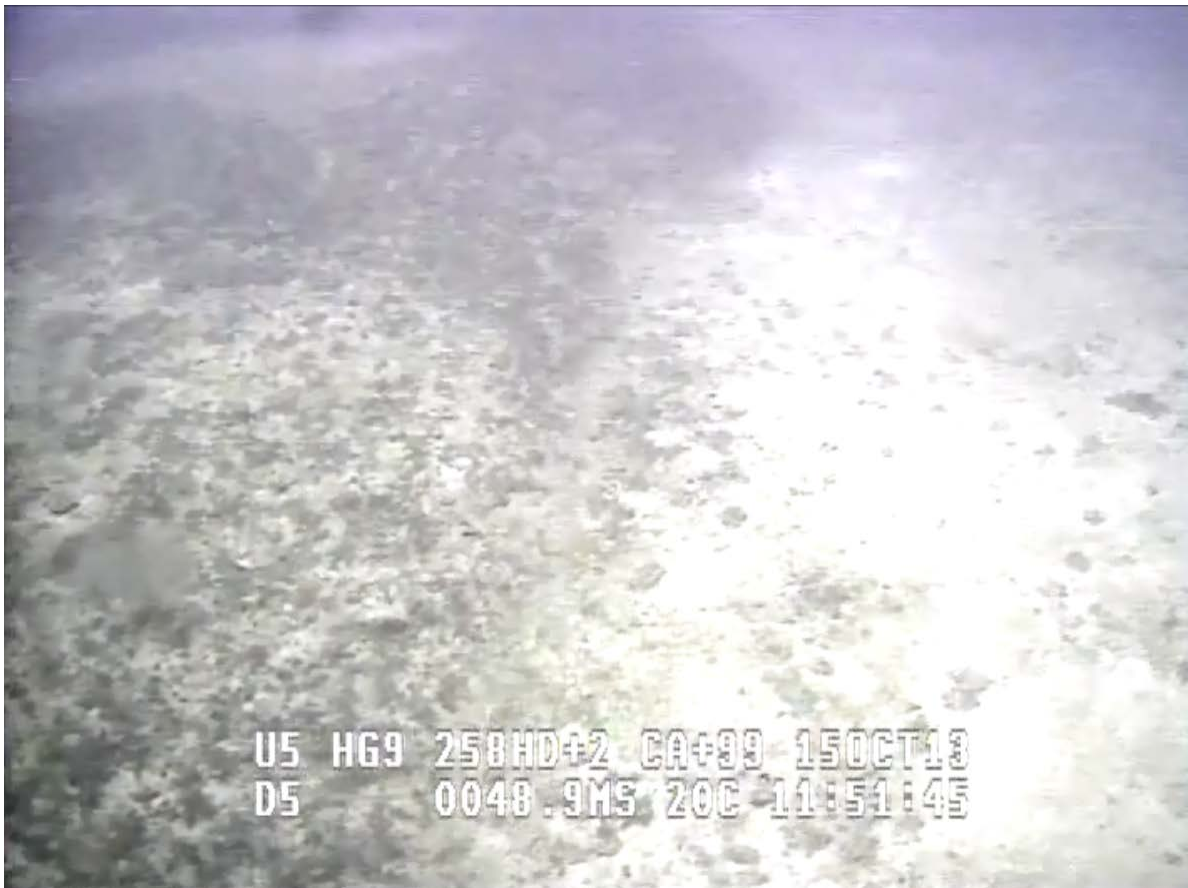
| TARGETS | | | |
|---|---|---|---|
| A-6 | N 21 28' 22.88" | W 157 45' 27.47" | LEDGE |

Figure 3-8 : Target A-6 Ledge

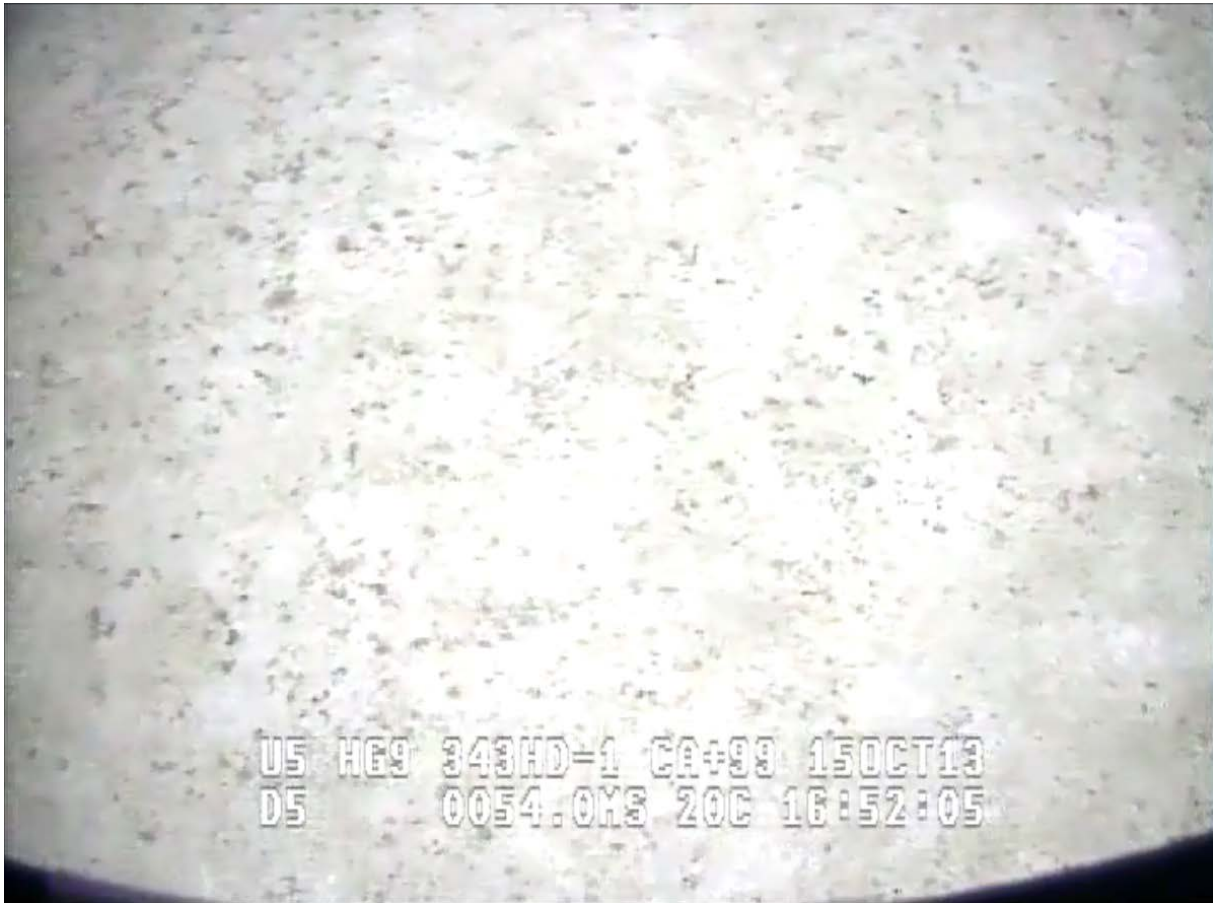
The ROV was lowered and surveyed the ocean floor at anchor locations A1-001, A2-001 and A3-001 to provide a visual verification of bottom characteristics. The water depths at locations A1-001, A2-001 and A3-001 are 55-60 meters, 75-80 meters and 50-55 meters, respectively. Based on the previous geophysical surveys and vibracore data these locations are within the sand field with an estimated sand thickness of 5 meters or more. ROV video footage confirmed that the bottom was sandy with scattered patches of algae. Figures 3-11 through 3-13 depict general bottom conditions at the anchor locations. Figure 3-14 shows the anchor dive locations and targets along Cable Routes A and B.

Figure 3-11: Sand Bottom at Anchor Location A1-001

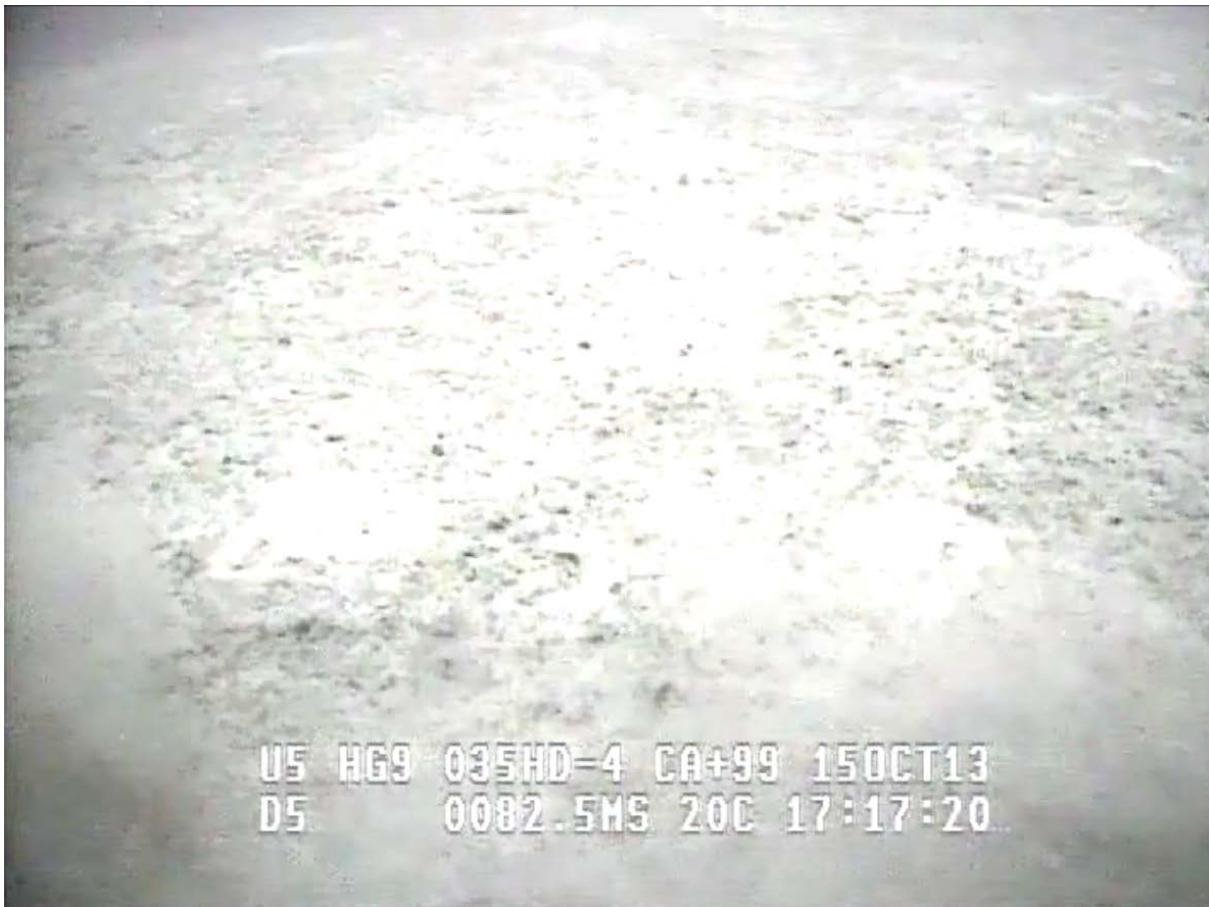
Figure 3-12: Sand Bottom at Anchor Location A2-001

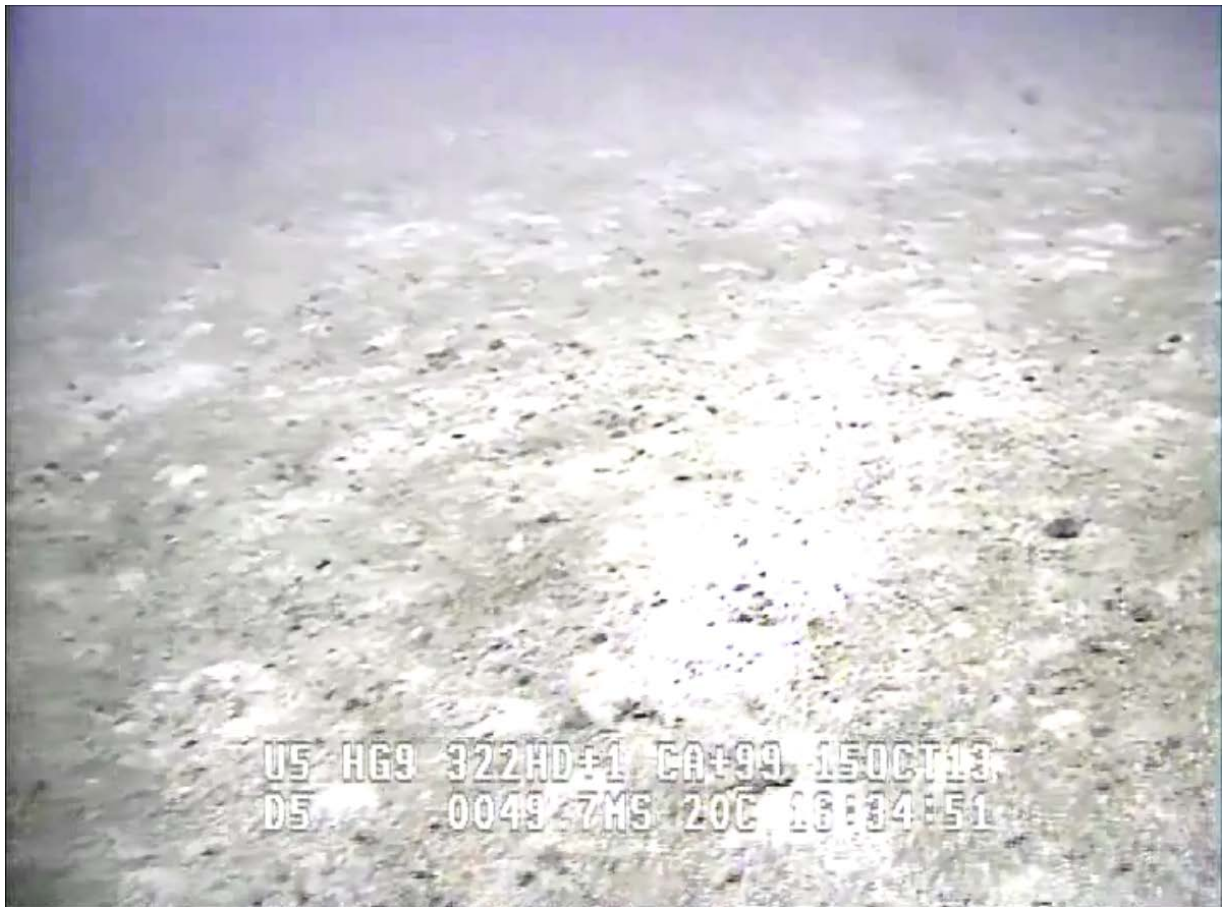
Figure 3-13: Sand Bottom at Anchor Location A3-001
