4.5 Energy Test Platforms: Crissy Field Center Wind Power Study: Wind Turbine Commissioning and Interconnection

**Prepared by:
Golden Gate National Parks Conservancy**

Wind Turbine Commissioning and Interconnection

Crissy Field Center Wind Power Study

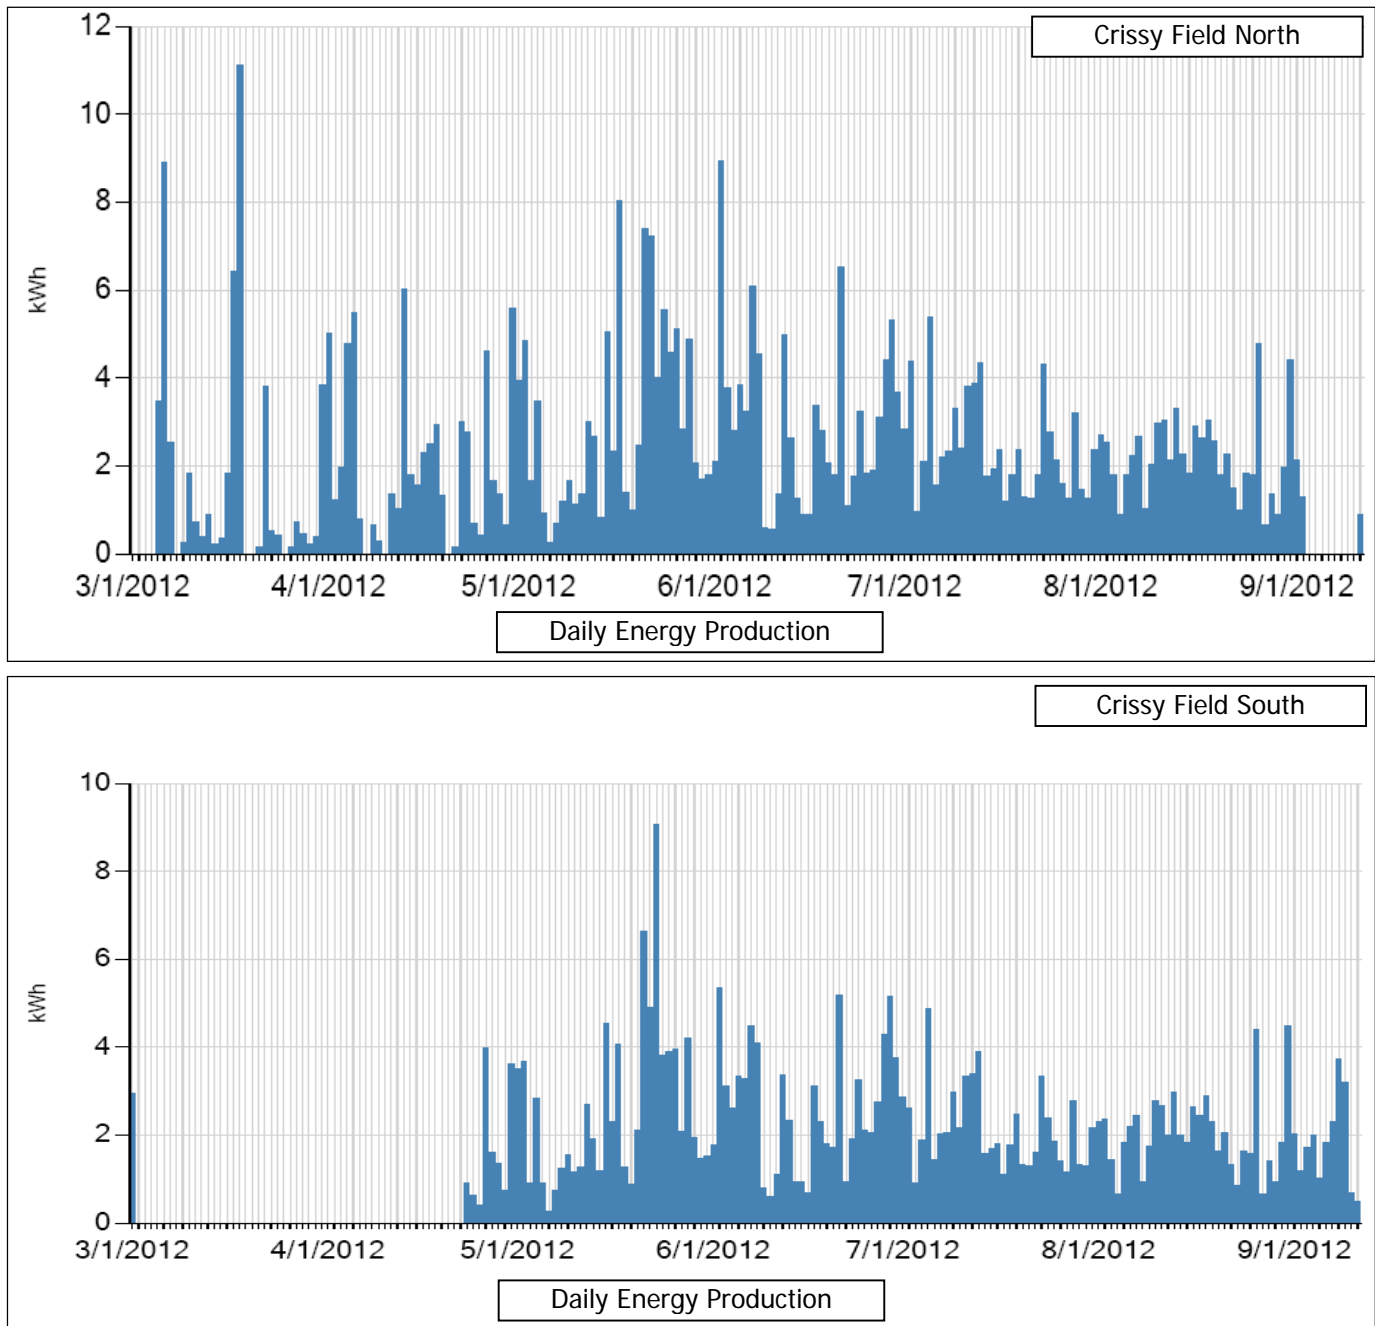
Trying to glean from these charts which turbine is producing more power is quite difficult. At a glance it would appear that the North turbine is producing more than the South turbine. However, this inference is contradictory to the data collected and presented on page 1, where in the North Therefore, the important inference to draw from comparing these graphs is that on a day-to-day basis, the two turbines seem to be operating consistently with one another.

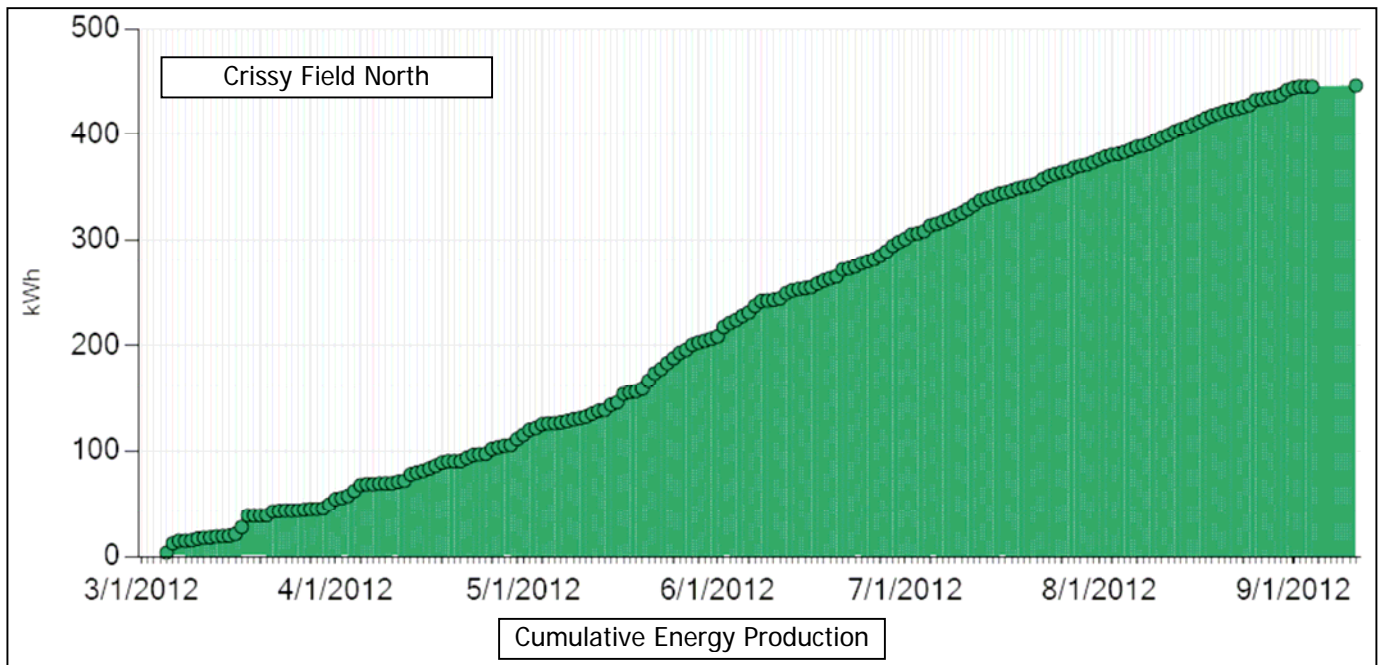
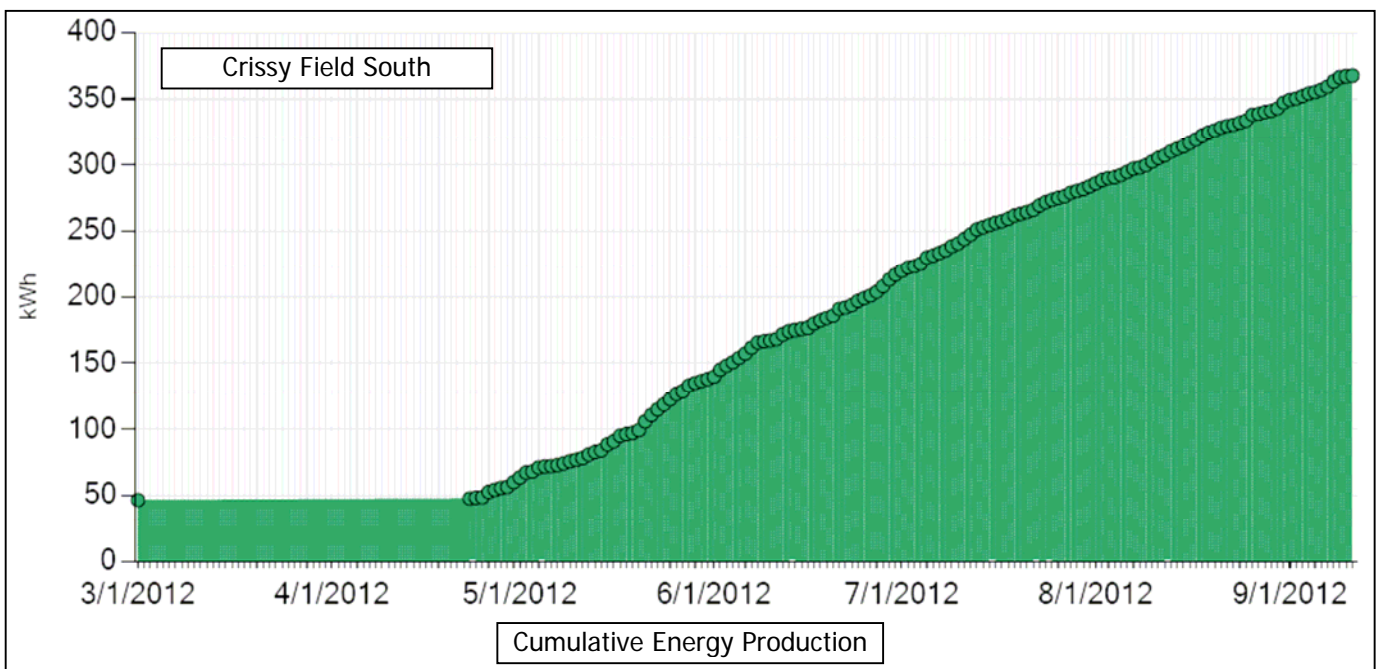
The steadily increasing slope of these two graphs suggests that each turbine is operating consistently as data is collected over time. A sharp change up or down in the slope would suggest that something significant has change, affecting the turbine performance.

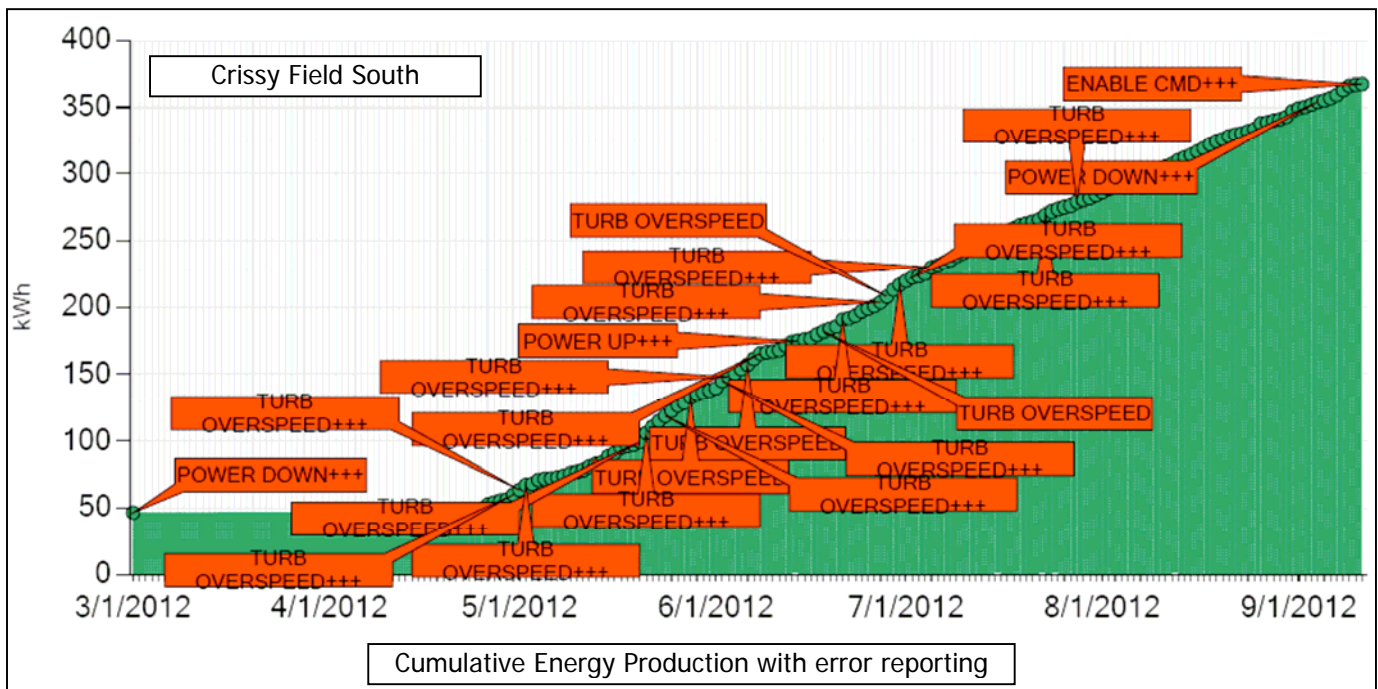
Again, because the average daily production is so close between the two turbines, this does not appear to have had a significant impact on energy production.

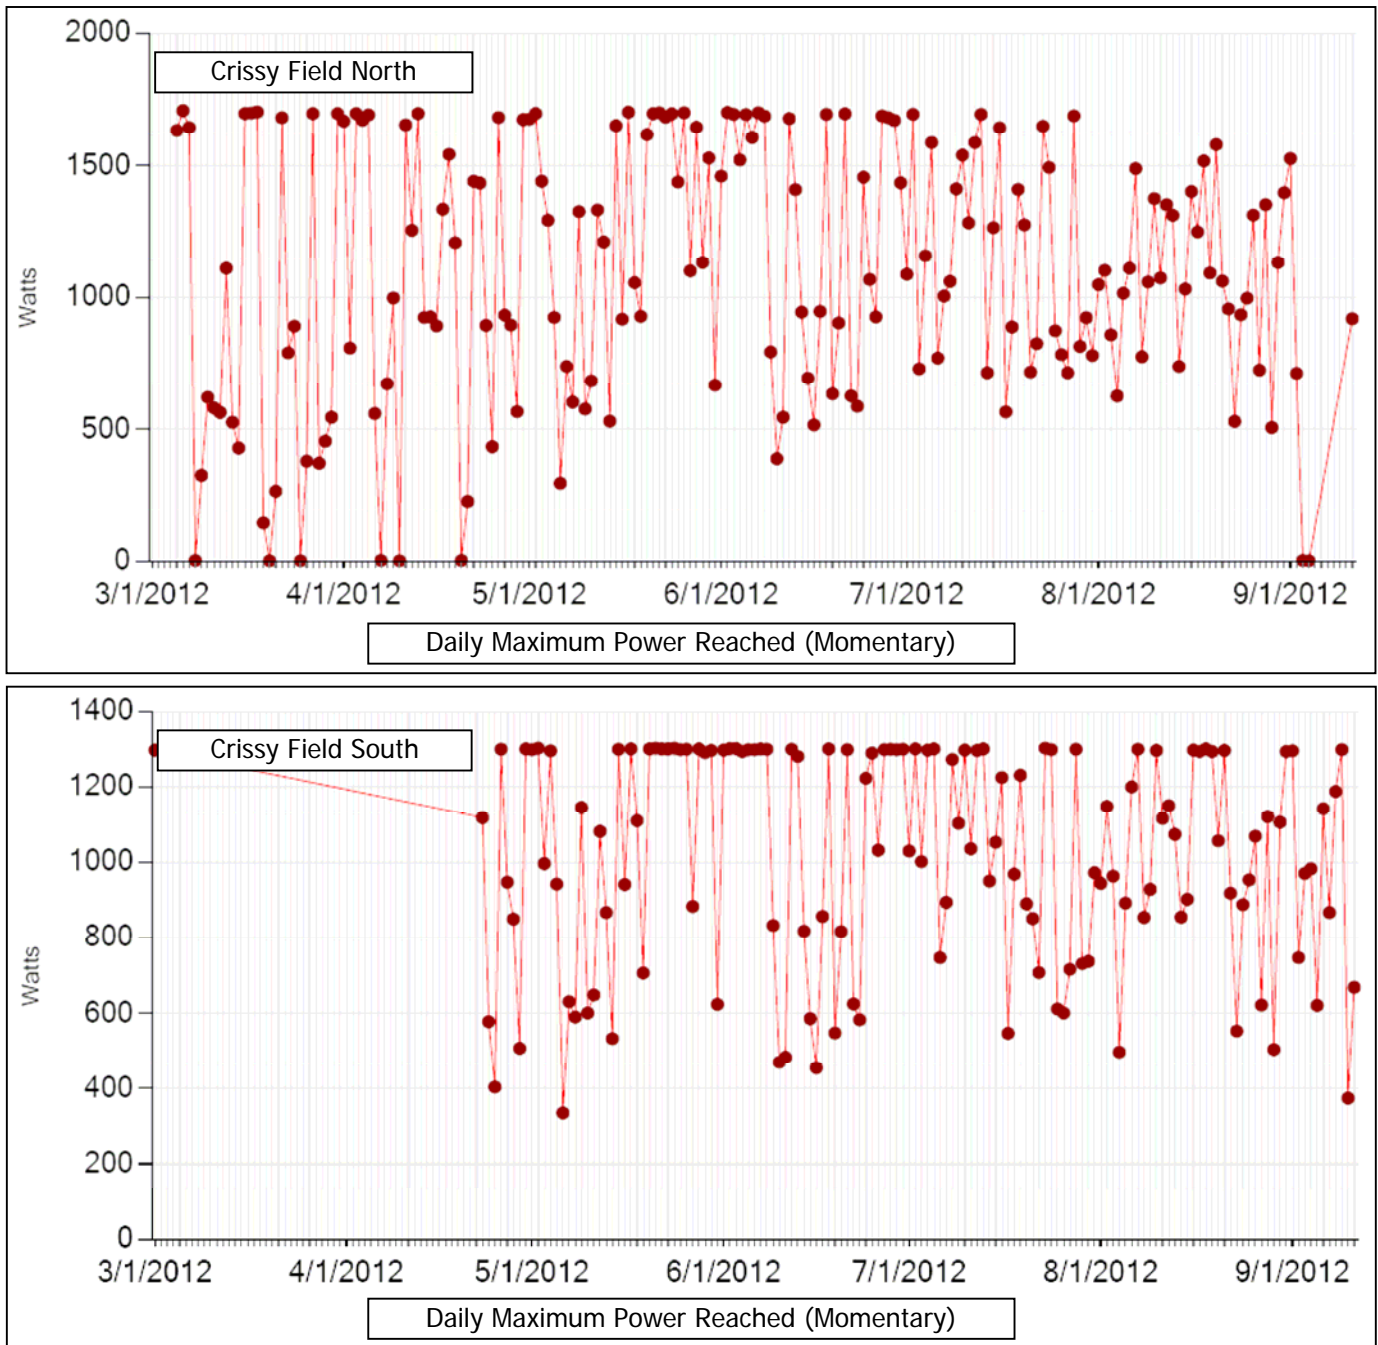
These graphs confirm that the Max Power limit as discussed on page 1 have been set to 1700 W North turbine and 1300 W on the South turbine for the entire period over which this data was collected.

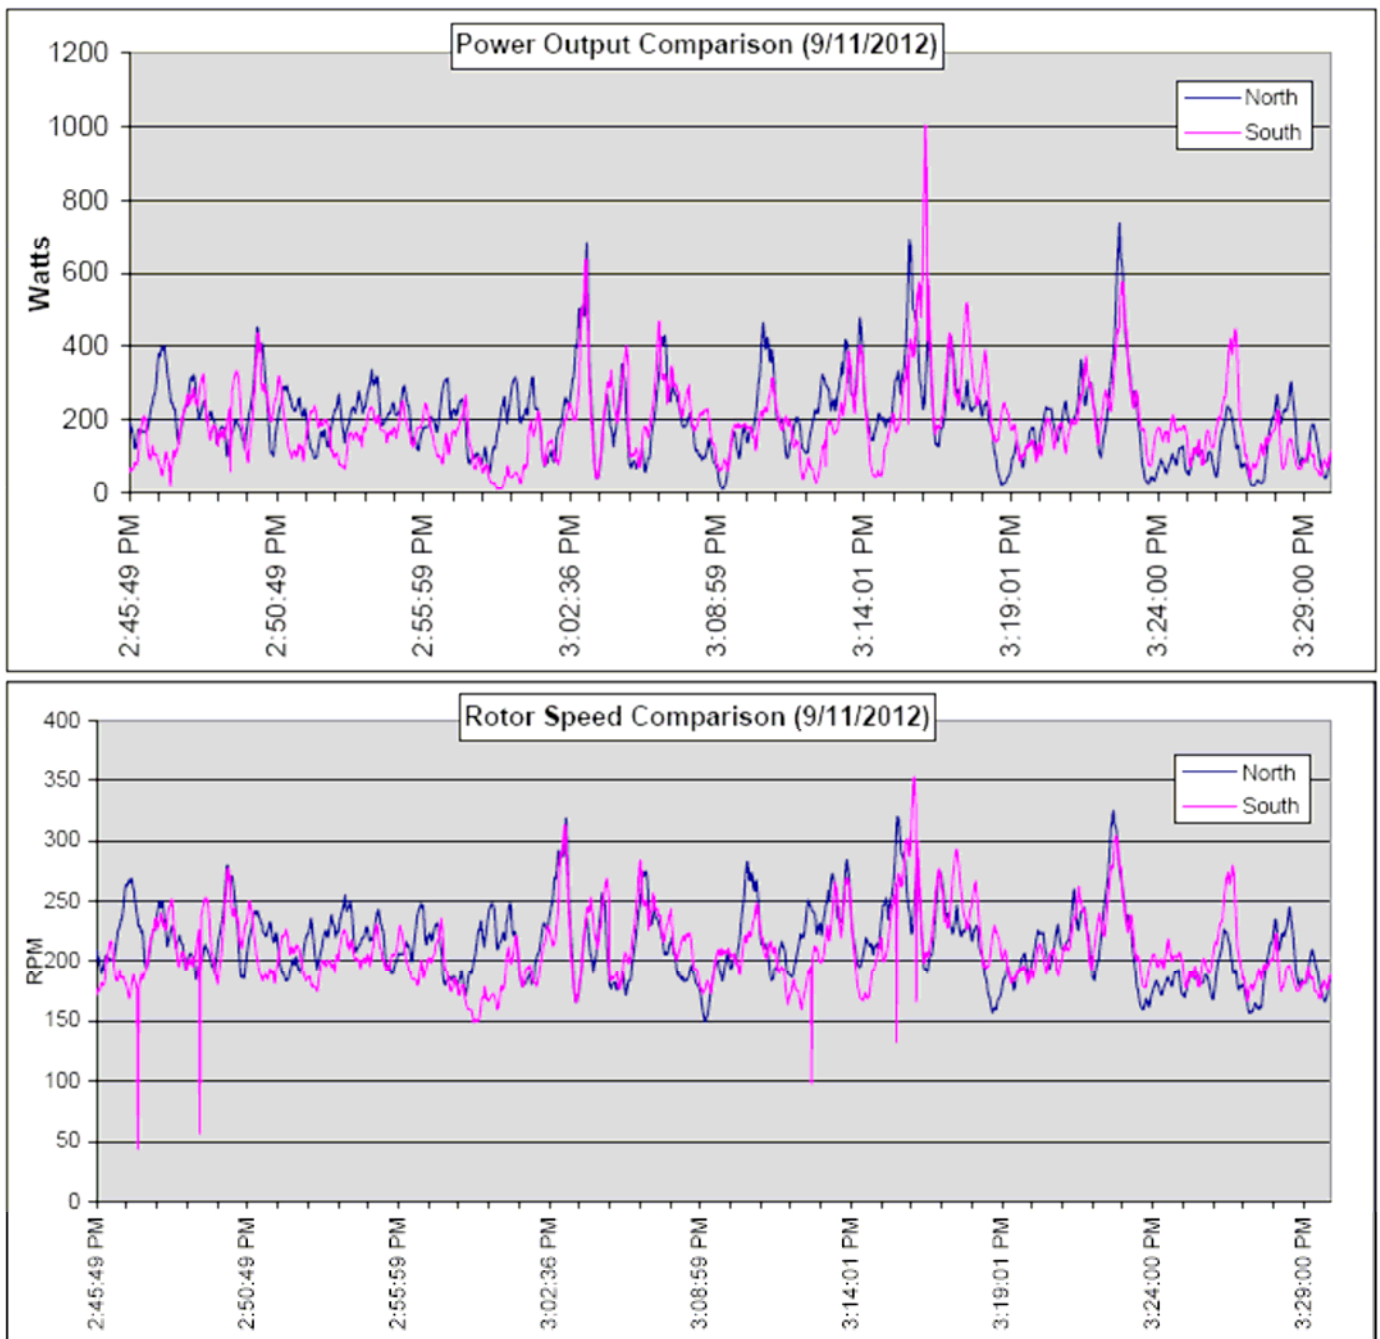
These graphs are a turbine versus turbine comparison of the data collected over a 45 minute period on September 11, 2012. The parameters displayed are power output in watts (top) and rotor speed in RPM (bottom). During this 45 minute period, the turbines were most often trending the same way and about the same measurements, but not exactly matching one another. At other moments the two turbines seem to be operating quite differently from one another.

This is normal operation and has been observed at other multi-unit installations. Slight aberrations in the wind flow have been observed to leave one turbine barely turning while another turbine as close as 15 feet away spins quite rapidly. This phenomenon can be observed by watching the way the wind blows the
