Crissy Field Center Wind Power Study Phase II: Commissioning of the Wind Turbines and Data Acquisition System

Crissy Field Center Wind Power Study Phase II, Report 3: Commissioning of the Wind Turbines and Data Acquisition System

MEMORANDUM

DATE	21 June, 2017
то	Tom Odgers Golden Gate National Parks Conservancy
	Jim Maskrey Hawaii Natural Energy Institute
FROM	Nathan Brown, Associate
RE	Crissy Monitoring Software Update and Commissioning Report

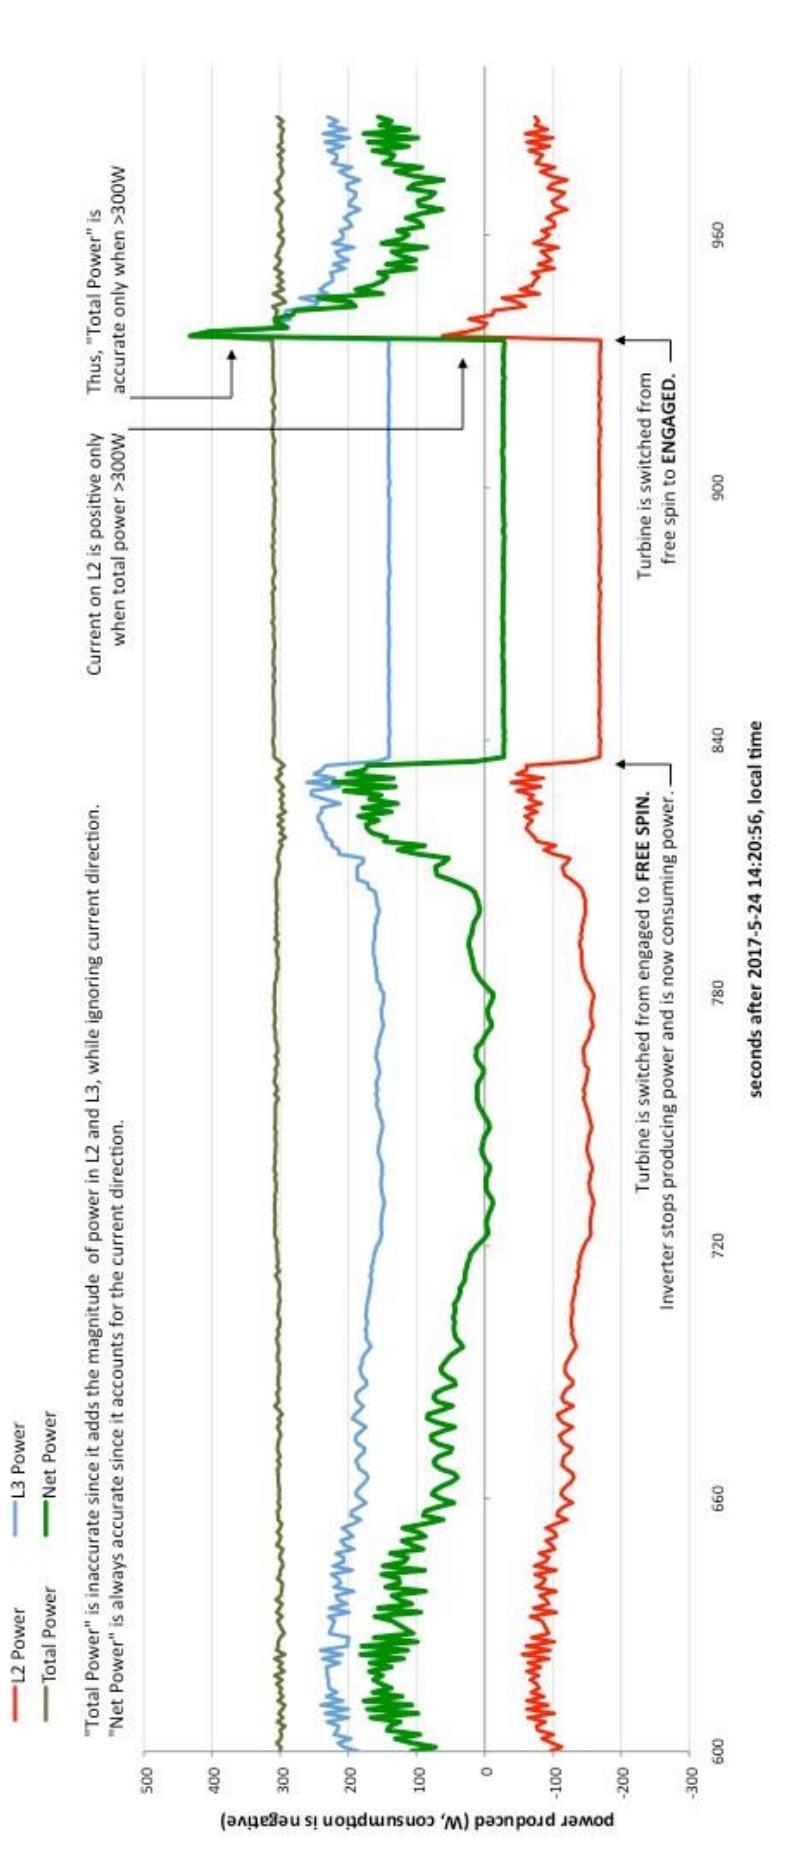
In the process of commissioning the UGE power monitoring, we discovered an unexpected and unusual issue. The UGE inverters are connected to the electrical panel using 2-pole breakers. We discovered that during lower levels (<280W) of power output, the direction of current in each wire is opposite, and the total power produced or used is the difference between the readings. This required a change to explicitly monitor net positive power and net negative power (as is reflected in the registers described above). The former method measured total power – or the sum of the absolute values for power on each phase. This showed a near constant 300 W of power produced, even though the totals were much lower. For example, we performed a test on site where the UGE North turbine was switched from power production to "free spin" mode, and then back to power production mode (see graph on following page). This shows the variation in power logged in each wire (L2 and L3), in the calculated Net Power, and in the calculated Total (absolute) Power. This graph further demonstrates why Net Power needs to be calculated rather than using the Total Power.

Luminalt and Loisos + Ubbelohde researched the issue and discussed these observations with Ginlong, the turbine manufacturer, and with Dent Instruments, the manufacturer of the Powerscout meters. The team identified low power factors as a likely cause of these observations, as described in more detail in this document, posted by Continental Control Systems, another power meter manufacturer:

While this issue presents further monitoring challenges for the dashboard data collection (see below), for purposes of the high frequency monitoring, it confirms that our monitoring of net power will accurately capture total power production or use at any given moment in time.

- 2. Due to the observed behavior of the current flowing from the inverter, it appears that a calculation could be applied to estimate power produced by the UGE turbines. In the graph above, note that L3 power is always positive, and that L2 power switches to positive when L3 power is above approximately 280W (although this limit is inconsistent). In order to infer the sign of L2 power, we can test to see if L3 power is above or below 280W, and assign a negative number to L2 if L3 is below 280W.

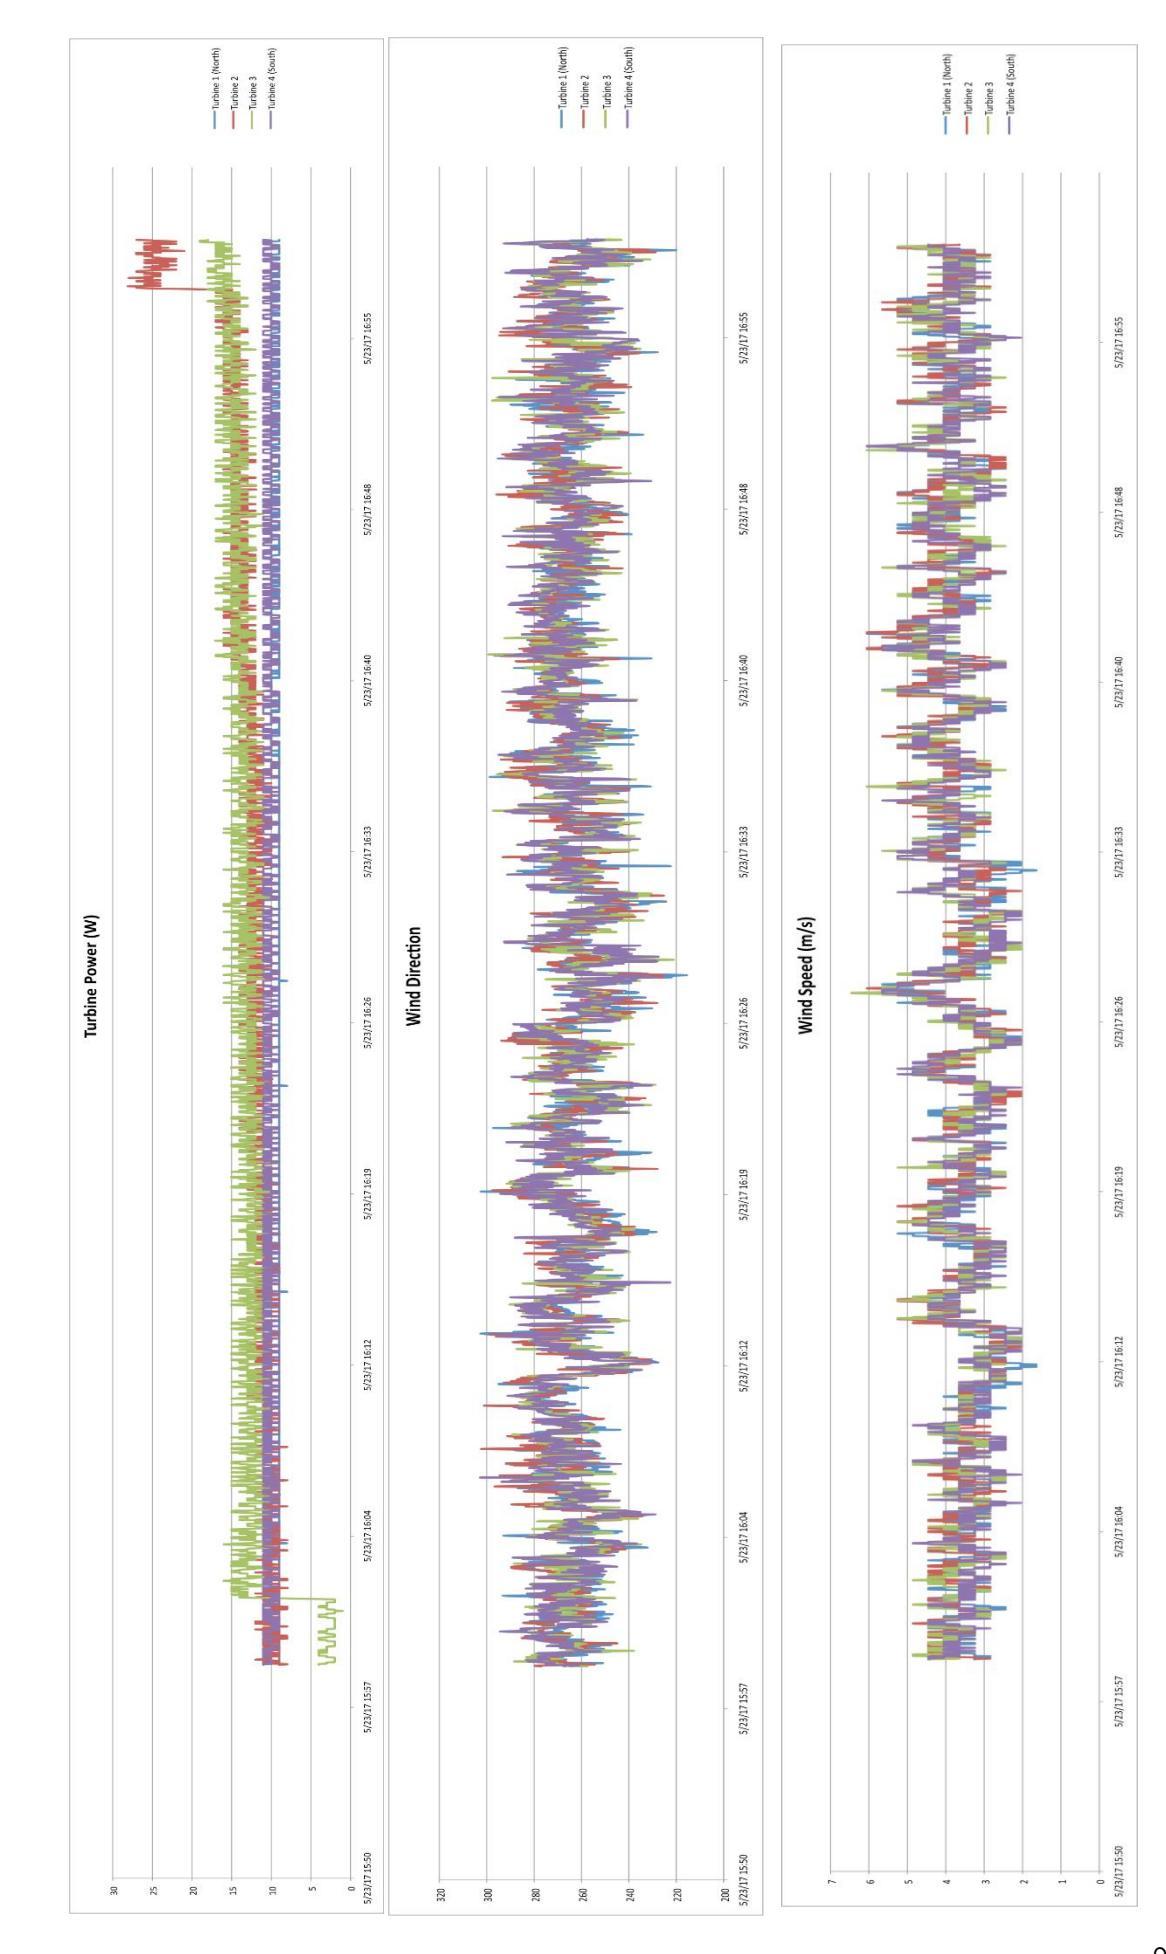
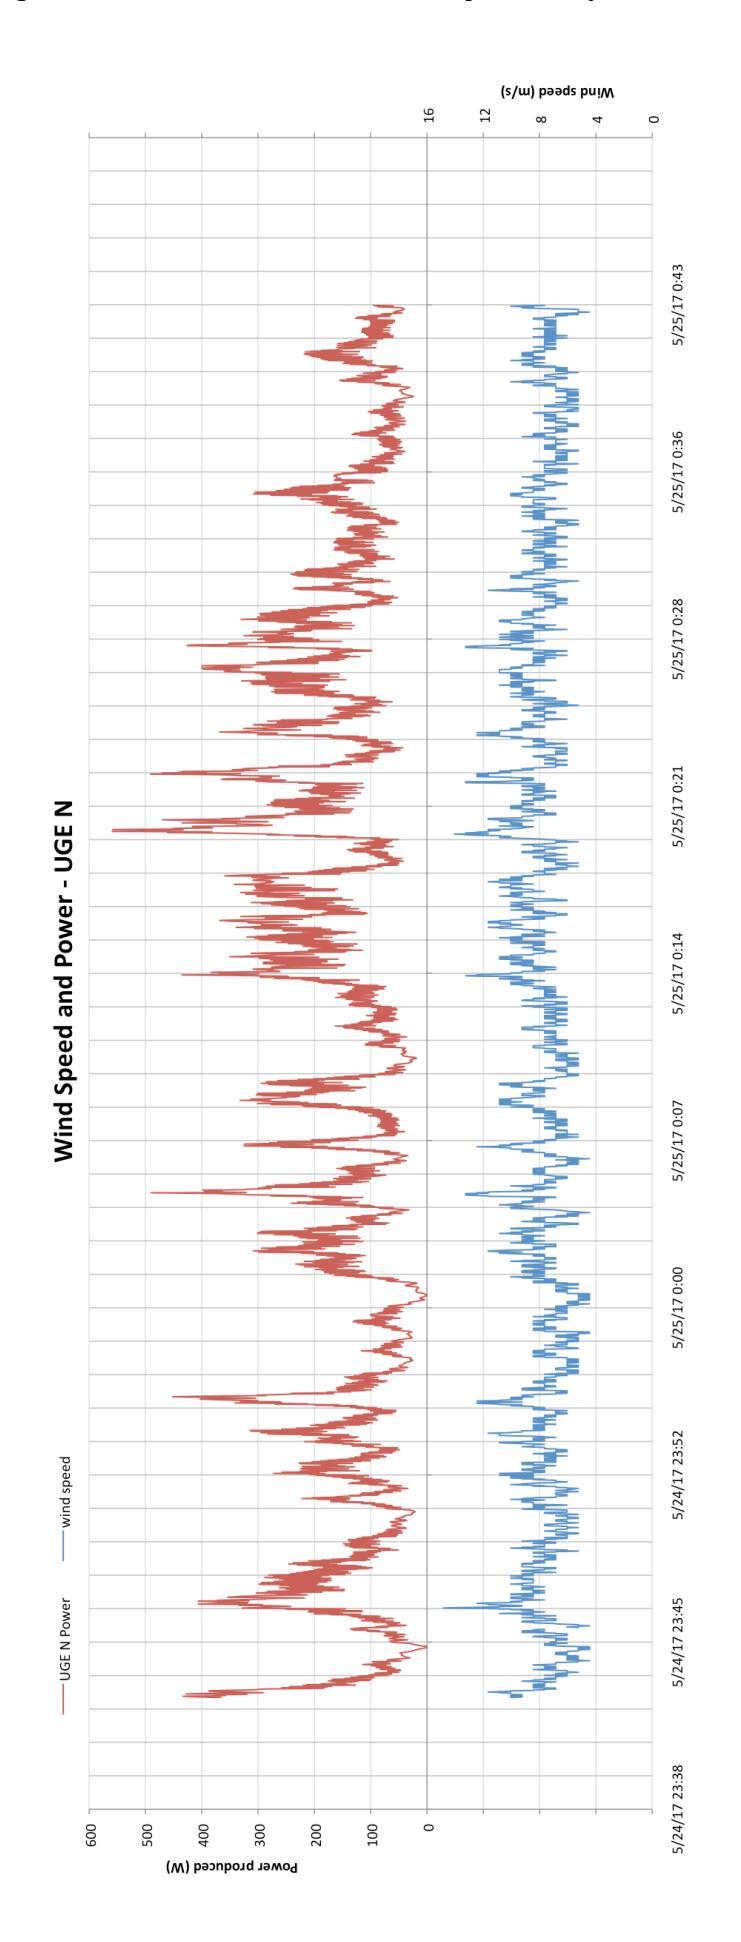
A data file (the converted data file 1495555161_data.csv) was downloaded and checked for potential errors. Wind speed, wind direction, and power were plotted for each wind turbine, using a 2-second average to enhance readability. At the time of this initial check, the UGE wind turbines had not yet been fully commissioned. A second data file (1495669392_data.csv) was downloaded to examine UGE data. The data check of each of these files showed data range and variation consistent with expectations (see graphs below). In particular, we note:

- Wind speed and direction vary, but patterns are consistent across sensors.
- Power monitoring of the Omniflow turbines shows increases that seem to correspond to increasing PV output.
- Wind speed resolution is somewhat coarse this is unavoidable since the execution interval of data collection is so small. The sensor uses a pulse signal with each full rotation of the anemometer, so there is no way to measure a fraction of a rotation.
- UGE North turbine and wind data for wind speed and power generated show very similar patterns of variation.
- UGE North turbine shows high frequency variation in performance that is different from the UGE South turbine – see detailed discussion in below.

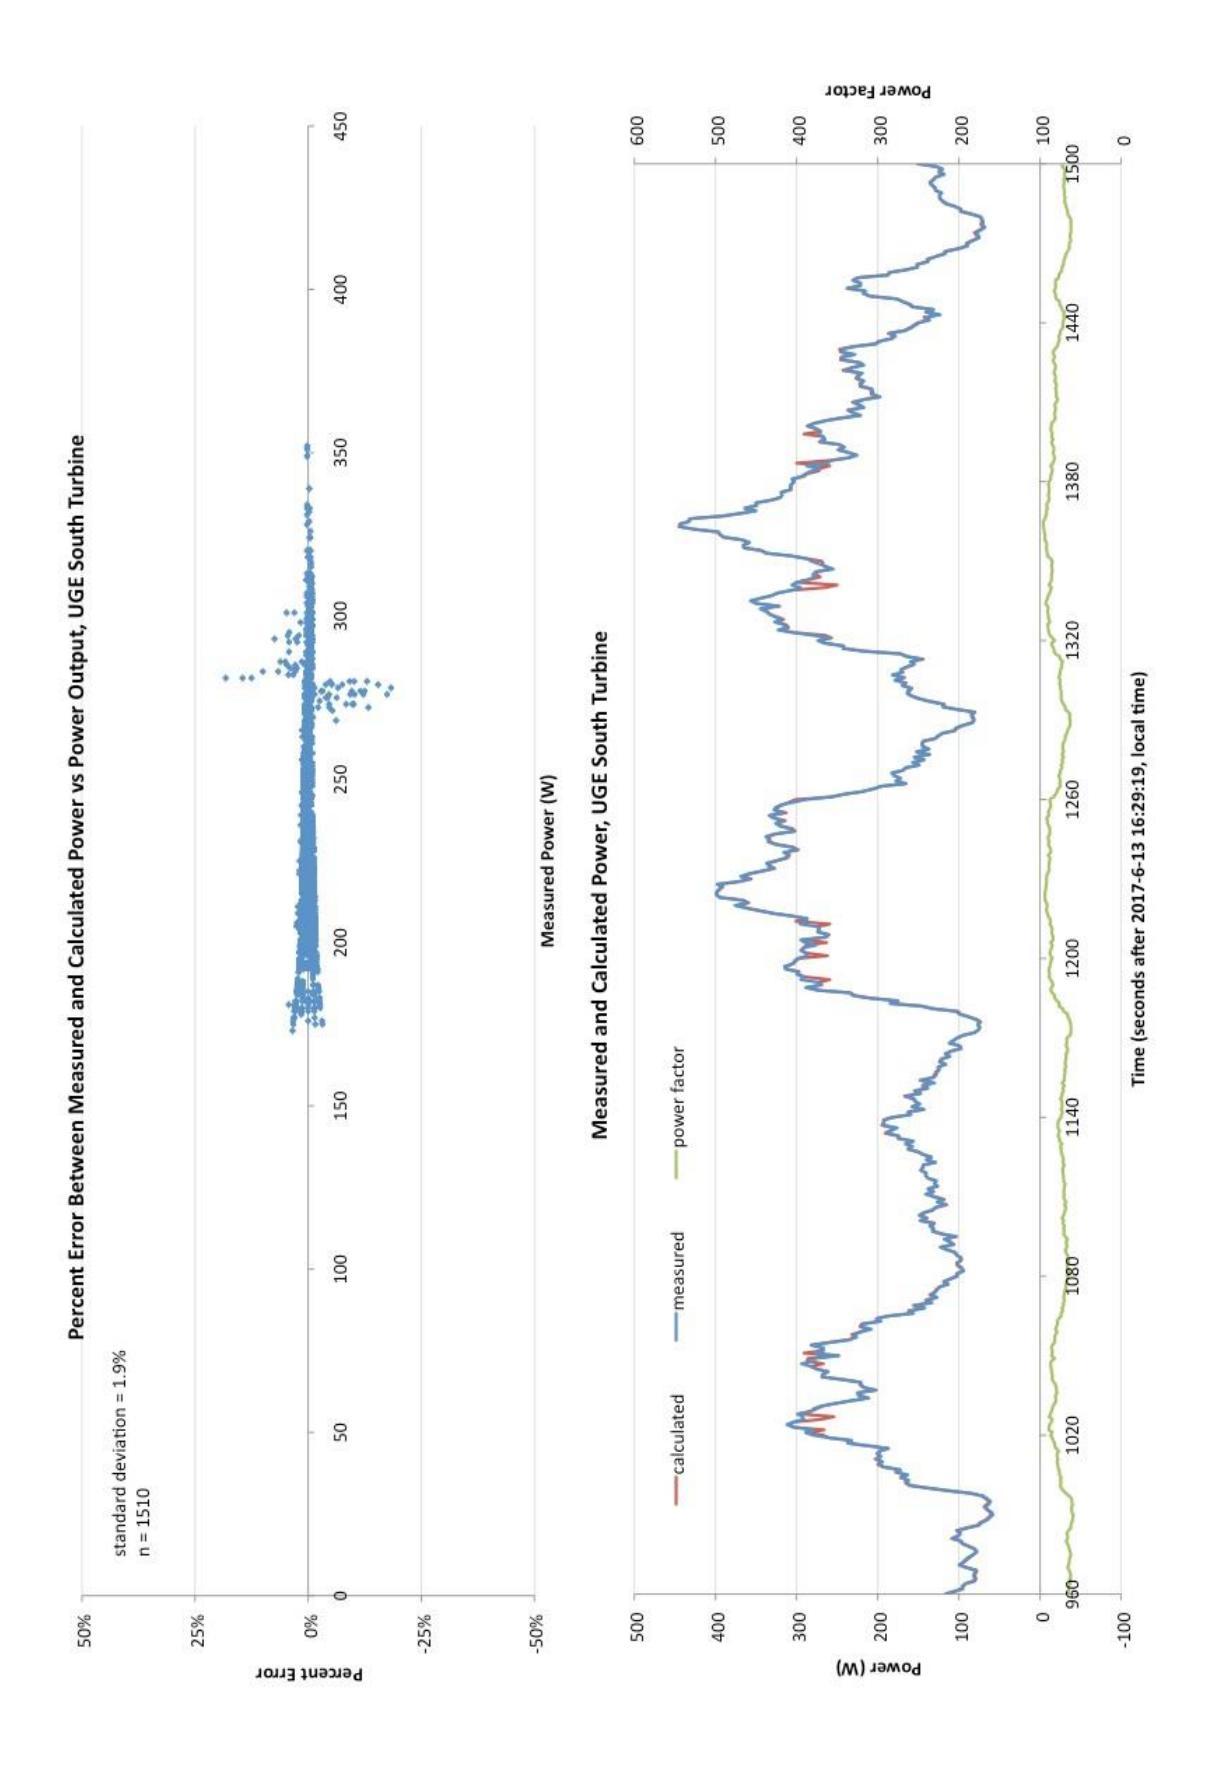
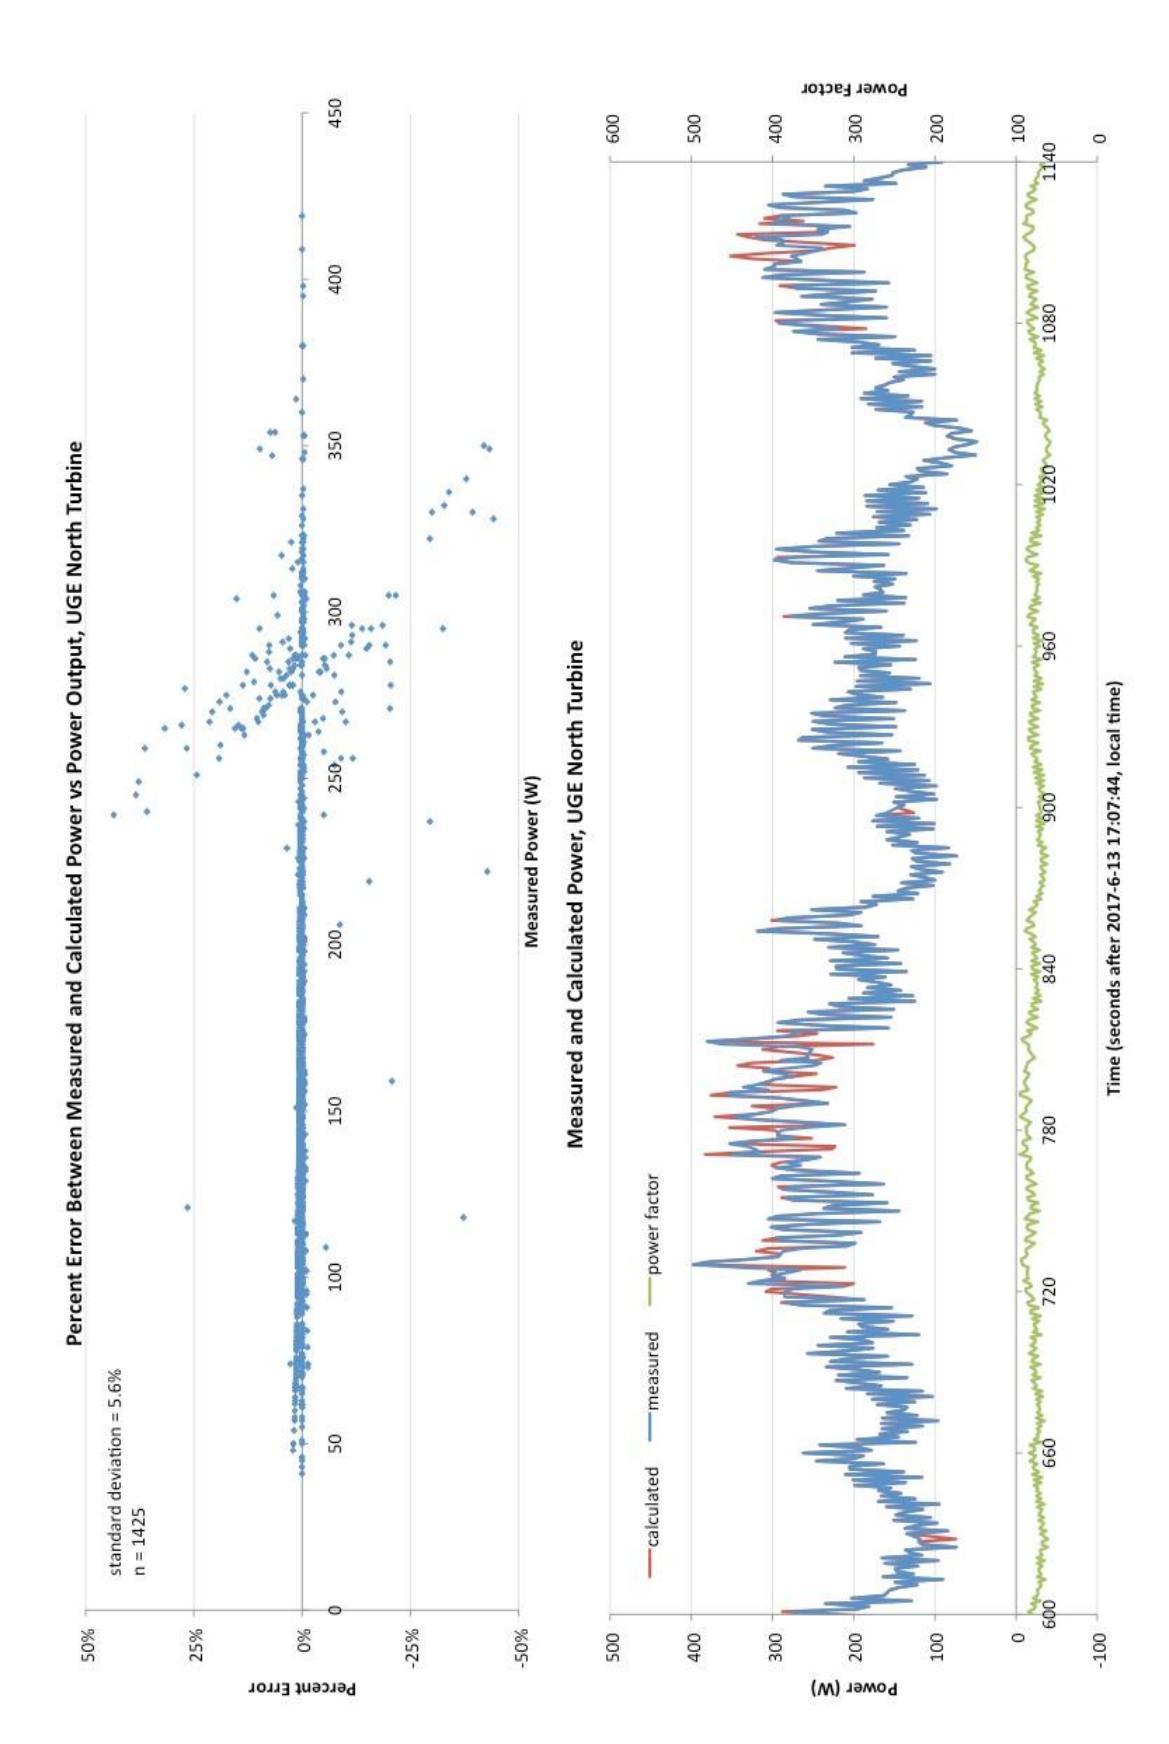
We further investigated the second and third solutions by recording detailed data for each UGE turbine using the Powerscout 24 to both simulate data collected by the Powerscout 18 and to measure net power. We were thus able to test each potential calculation method. We found that calculating total power using the 280W threshold was slightly more accurate than calculating the total using data from a single CT, and it was also easier. Based on our test of using the 280W threshold, we found this would produce accurate results for small or large power values, and an occasional error up to \pm 50% when total power is around 280W. We found that this error was larger for the UGE North turbine, which exhibits a high frequency pattern of variation in its output, than for the UGE South turbine. See figures below for the percent error vs measured power for each turbine. We also plotted the measured and calculated values over time, and we note that when taken as a whole, the calculated values tend to show a similar overall pattern (ie, when measured power is high, calculated power tends to be high as well).

This may be a "good enough" solution for the dashboard, since this interface is meant to indicate performance rather than precisely track performance. Dashboard data collection for UGE turbine power production was suspended when we identified this as an issue, pending a solution. Given cost considerations and the general purposes of the dashboard, our recommended solution is to apply calculation method 2, above. This solution was implemented on June 16, 2017, as reflected in the data shown in the dashboard (see second image on Page 14 below).

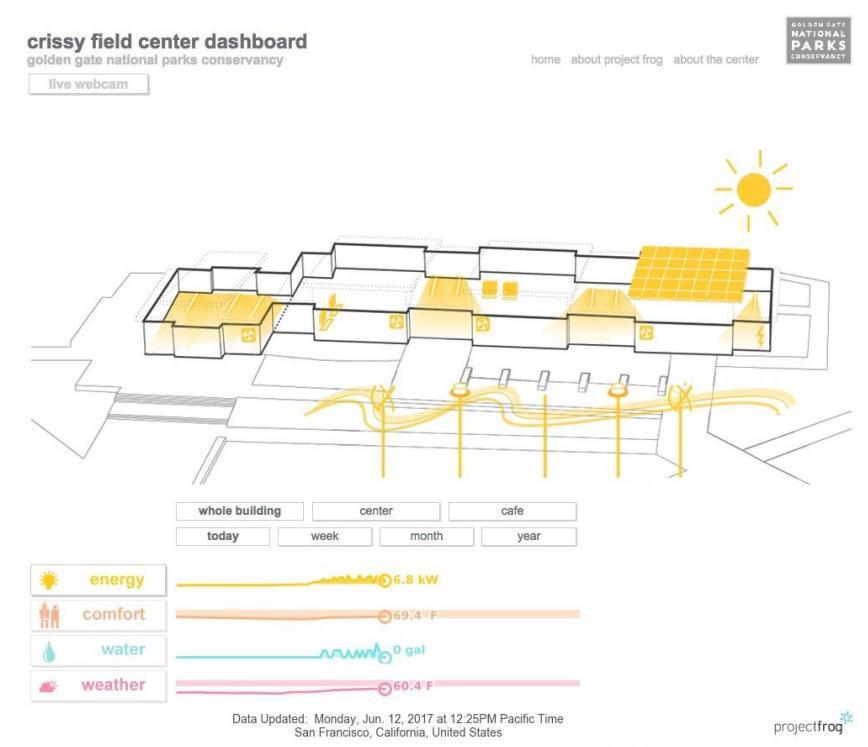
The dashboard interface was updated to include images and graphs to match the new installation. This involved reducing the number of graphs shown in the "per turbine" page and updating the legend to show images of the new turbines. While the intent was to represent the solar power and wind power produced by the Omniflow turbines separately, these values could not be disaggregated as planned (see memo titled 161025_omniflow_monitoring for further discussion). See screen shot of updated interface below.
