Energy Consumption Data Analysis Phase I Final Report

Under Cooperative Agreement No. DE-FC26-06NT42847 Hawai'i Distributed Energy Resource Technologies for Energy Security

UH Watt Watcher: Energy Consumption Data Analysis Phase I Final Report

Prepared for: Forest City Military Communities Hawaii

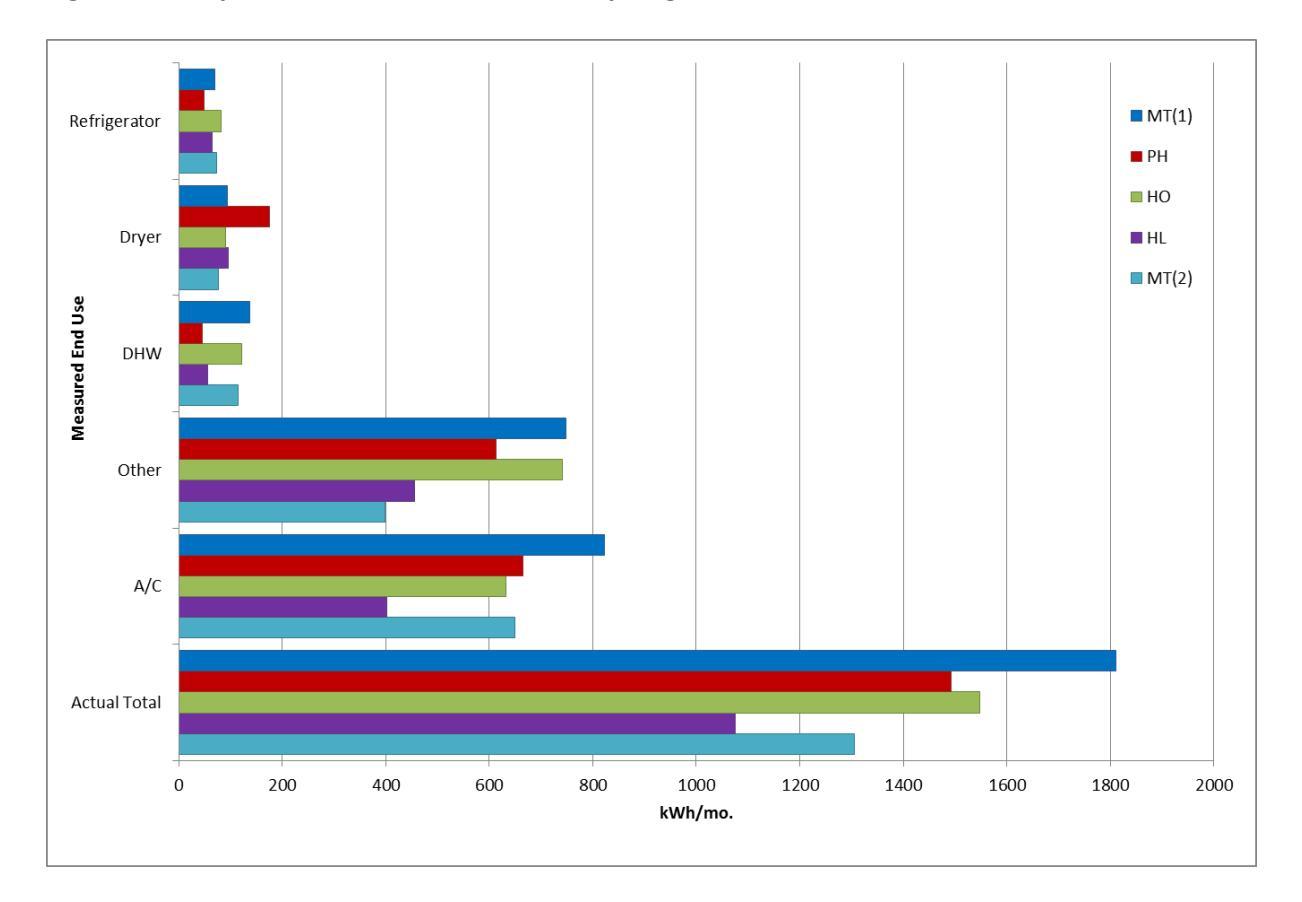
Figure 1 compares the monitored energy consumption over a 30 day period for the 4 measured enduses. The total energy consumption per home was monitored and plotted to determine the magnitude of the "other" end-uses, which include entertainment (TV, VCR/DVD, stereo, game consoles), lighting, fans, cooking, dish washing, computer, and phantom loads. These "other" end uses were not monitored. Air conditioning is the dominant load for these homes. The water heater, dryer and refrigerator use only a fraction of the energy that air conditioning consumes.

Figure 1. Comparison of measured end uses by neighborhood.

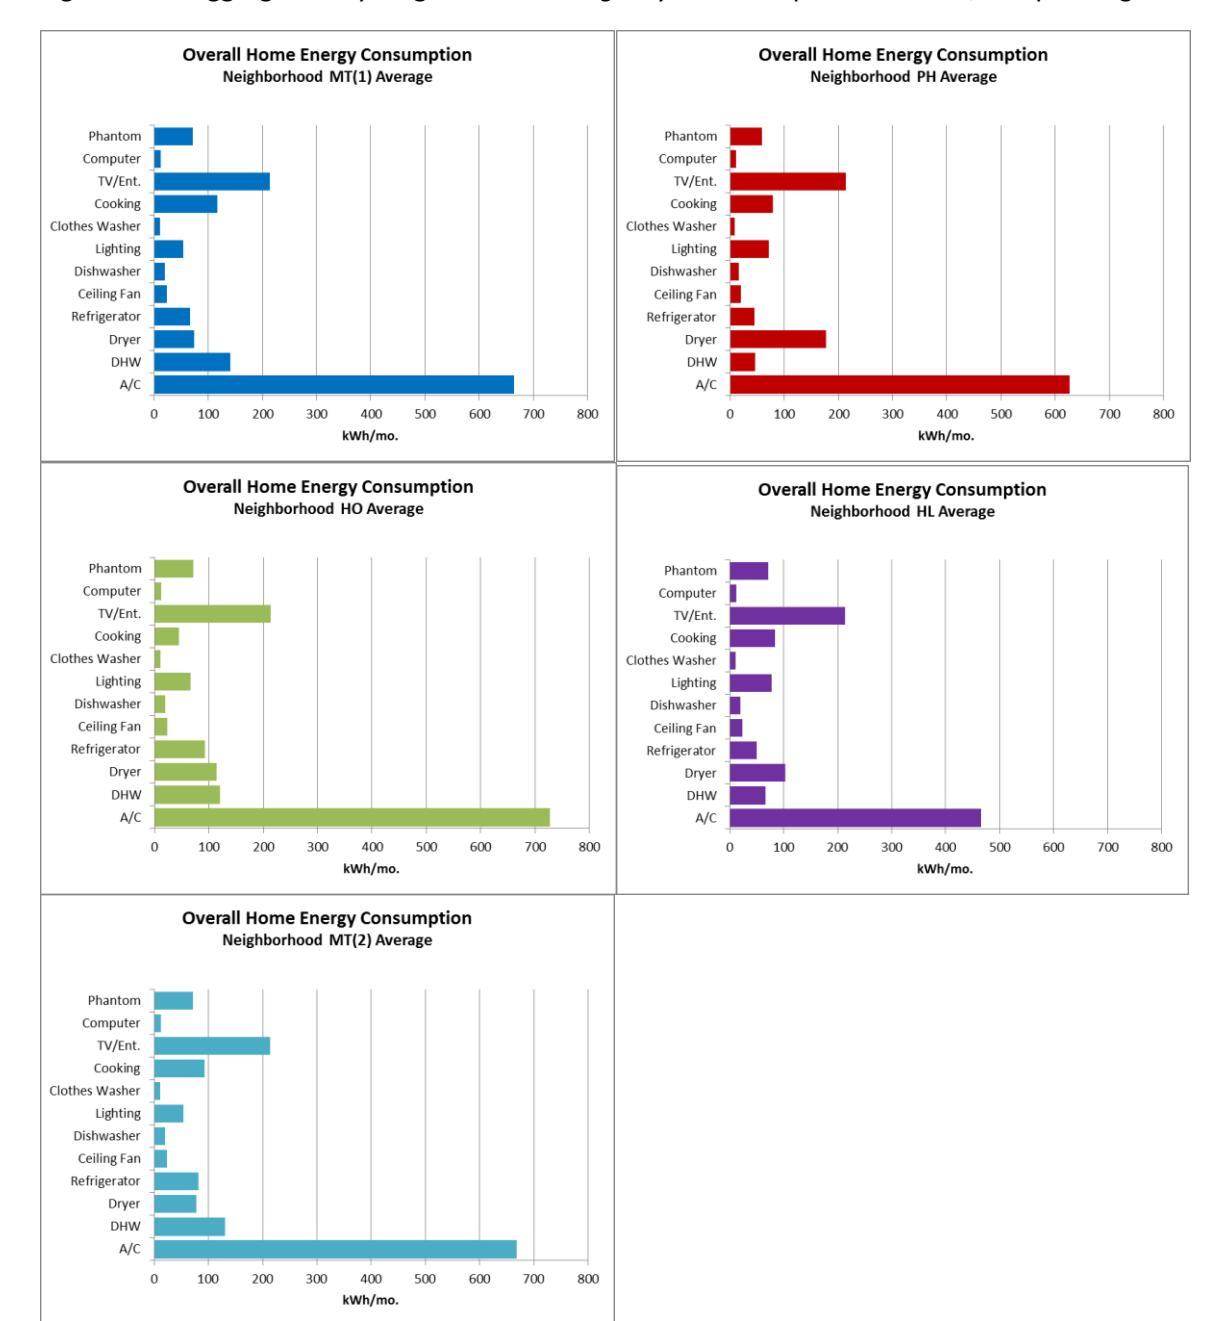
Figure 2 compares the relative energy consumption of common energy-consuming devices. While the data for the four monitored end-uses was measured (air conditioner, water heater, dryer, refrigerator), the remaining end-uses are approximations based on available research. Estimates are based on a variety of sources, including Hawaiian Electric Company, the National energy labs, and private research organizations.

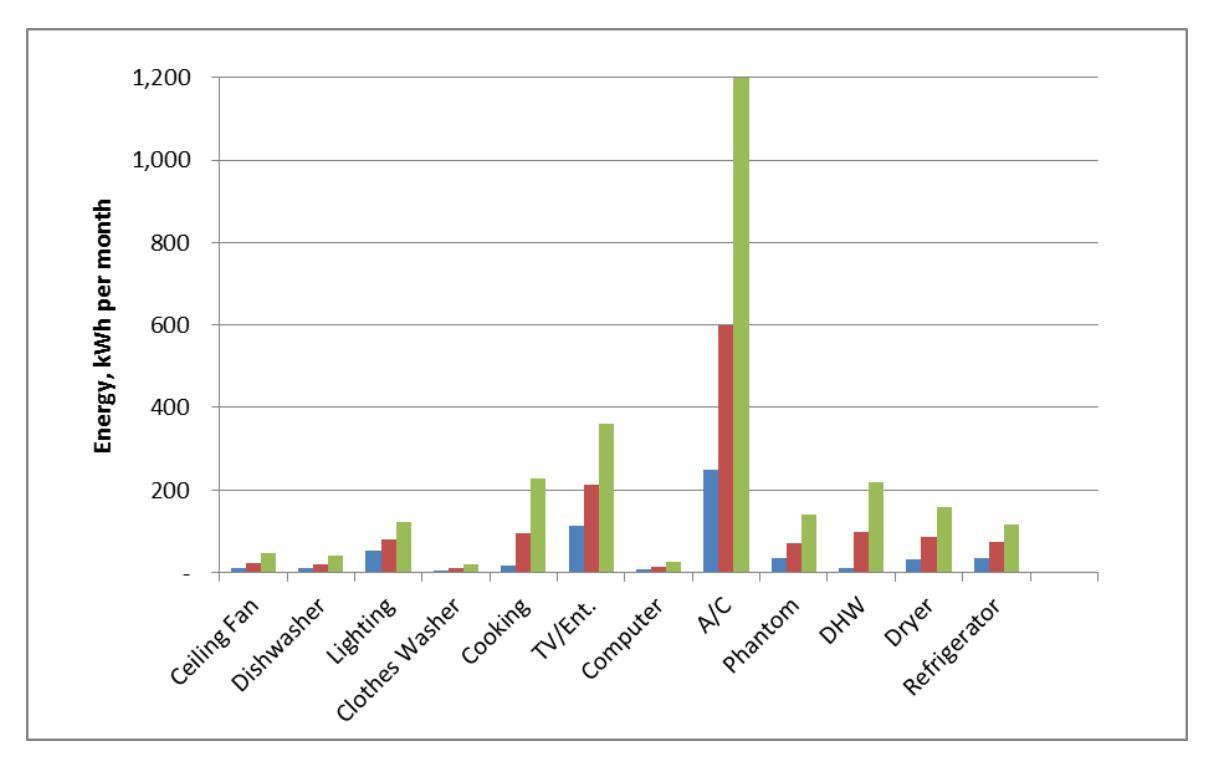
While several end-uses in the homes are not measured, their individual impact on overall consumption may be relatively small. Figure 3 shows the estimated relative impact of low, medium and high use of several of these end uses in Forest City neighborhoods. As indicated throughout this report, air conditioning is the major energy consumer in a household. Domestic hot water, lighting, TV/entertainment are all high consumers, but pale in comparison to the AC load.

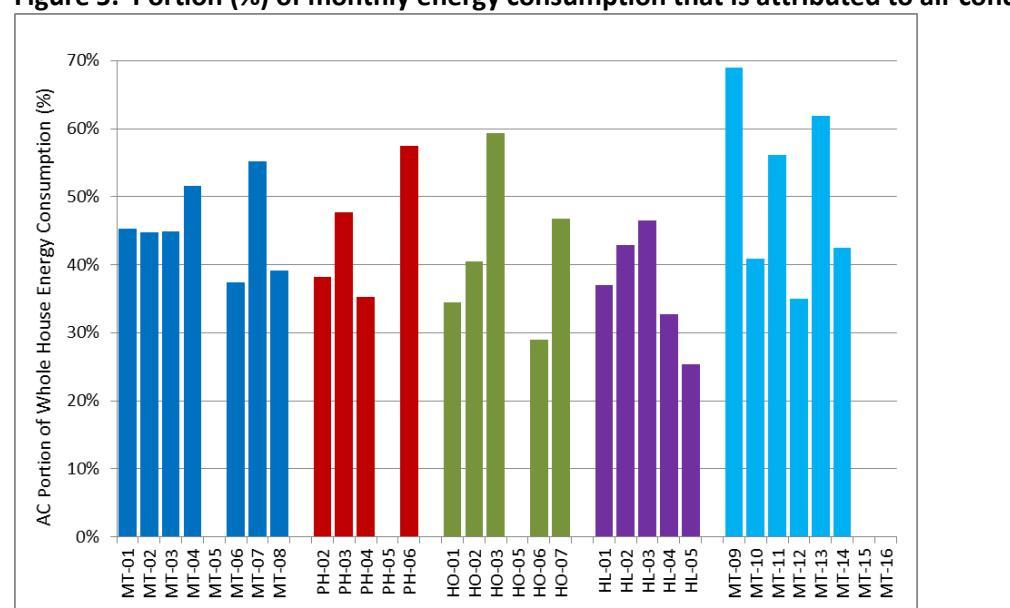
Figure 5. Portion (%) of monthly energy consumption that is attributed to air conditioning.

Air conditioning data was collected for 28 homes with 949 to 1431 ft² of living area. AC energy consumption is highly variable, ranging from 0.15 to 1.2 kWh/ft²/month (Fig. 4; equivalent to 150 to 1,200 kWh/month for a 1,000-ft² house). Air conditioning accounts for 25 to 69% of the total monthly energy use, with an average of 44% (Fig. 5). Occupants use air conditioning all or most of the time in 90% of the homes and 61% prefer a temperature setting below 74°F (Table 3).

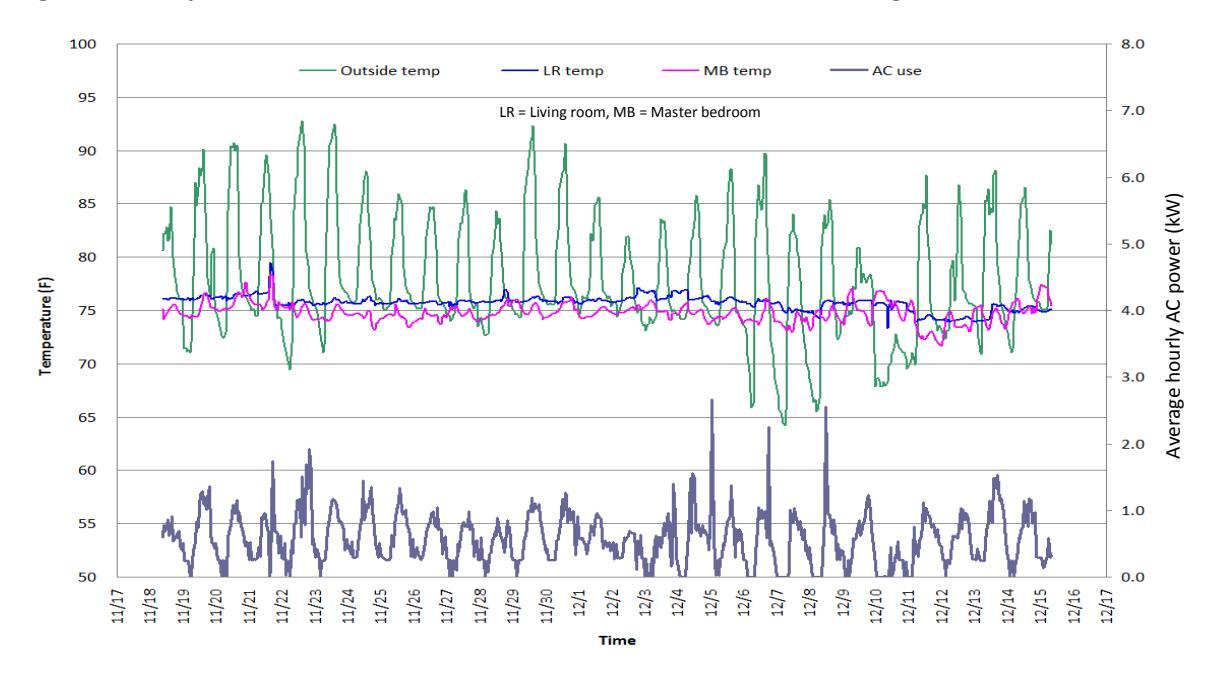
Figure 8. Temperatures in PH-02 which used 411 kWh/month for cooling.

Figure 8 shows stable indoor temperatures for PH-02 which has a programmable thermostat, a 2.5 ton 2009 Rheem compressor and used 411 kWh/month for cooling. In contrast, Figure 9 shows MT-03 which also has a programmable thermostat but it has more variable temperatures, reaching well into the 80's in the master bedroom in the afternoon, consumed 840 kWh/month for cooling, or twice that of PH-02. Without further information, it cannot be determined if the new AC compressor contributed significantly to the improved efficiency or if it's a difference in tightness of the envelope and duct work.

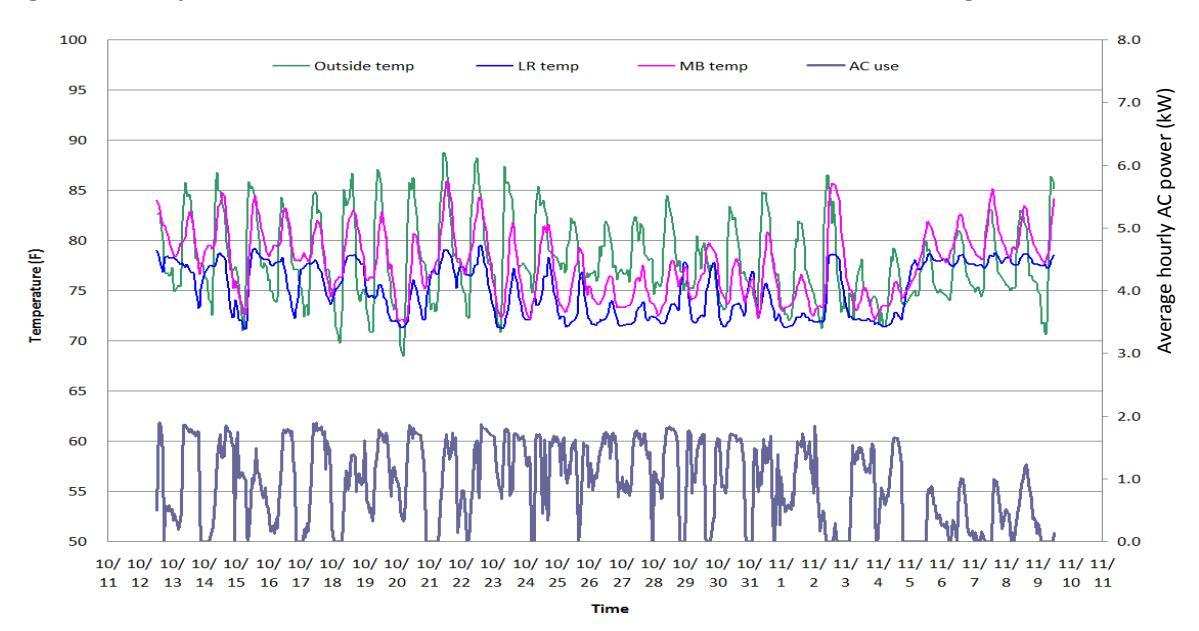
Figure 9. Temperatures in home MT-03 which used 840 kWh/month for cooling.

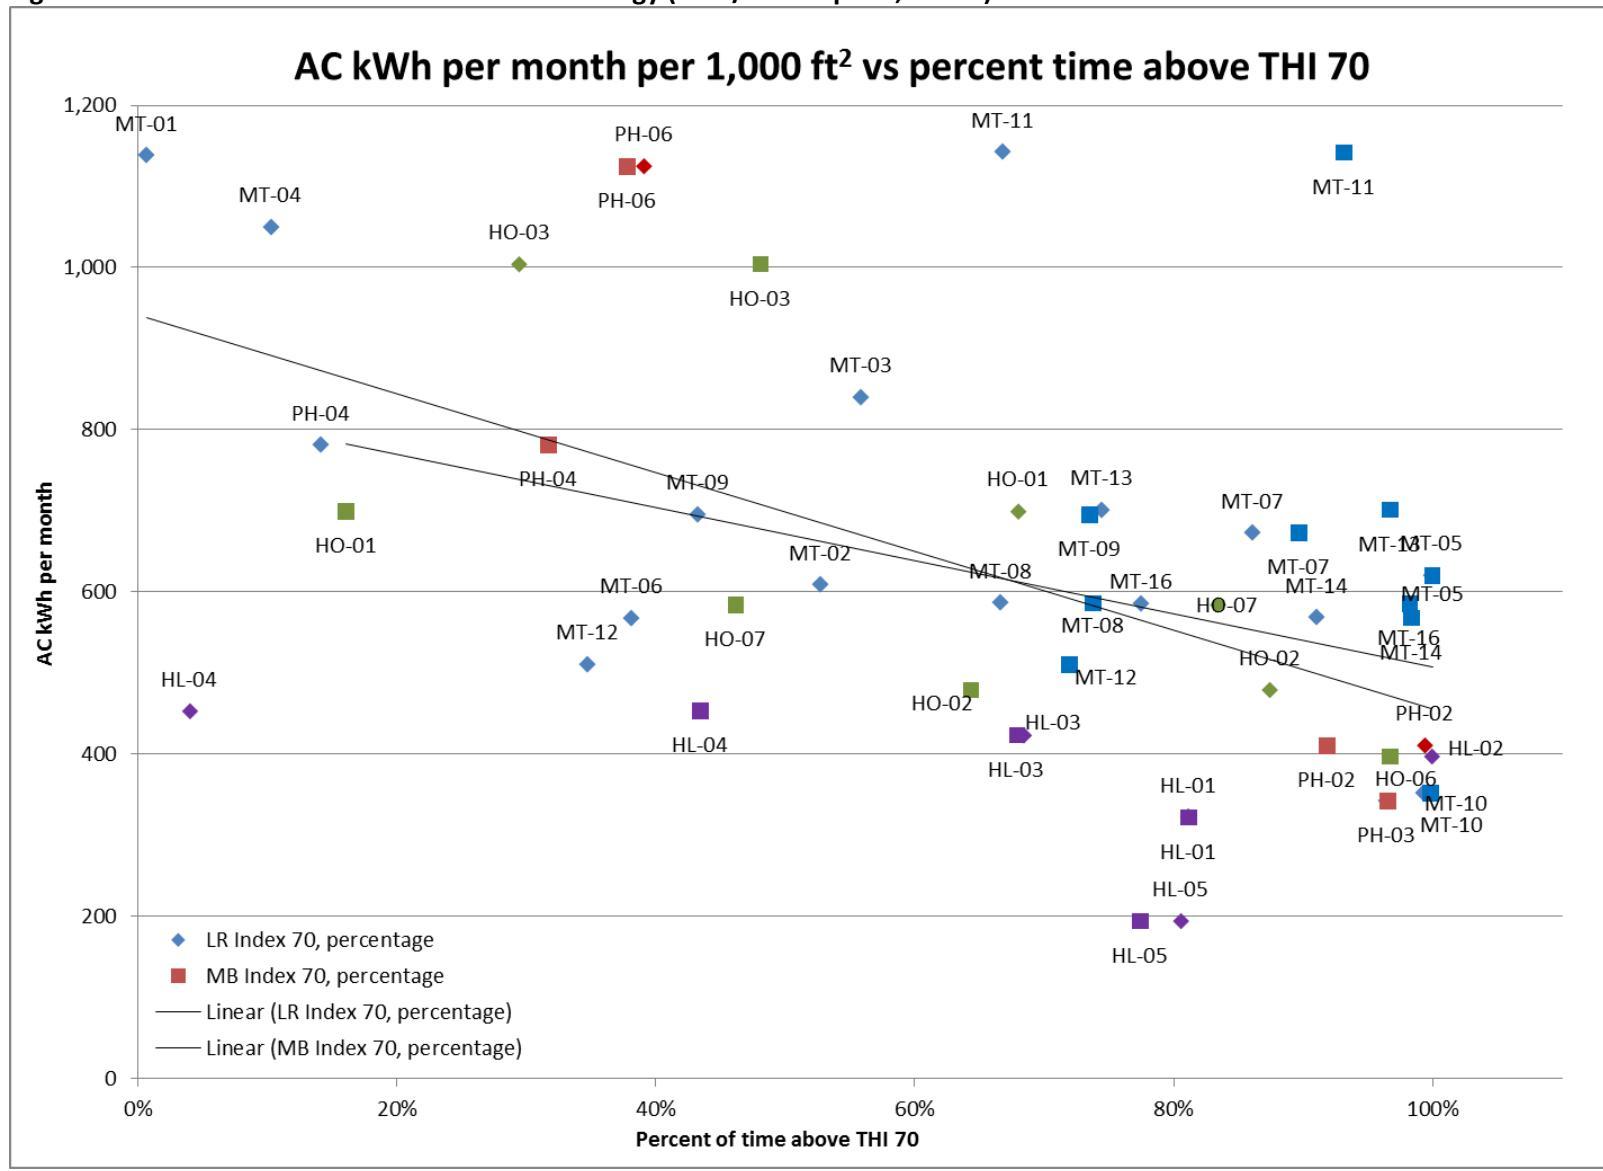
Figure 10. Percent time THI was over 70 vs AC energy (kWh/month per 1,000 ft²).

The most accurate way to estimate occupant comfort for this study is to look at their use of air conditioning. Even though the above issues can all affect the individual heating patterns of a home, they are all built in a similar manner and exist in a similar environment, therefore should follow a basic pattern of more air conditioning equals more comfort. Several homes do not follow this trend and show high internal temperatures despite extremely high air conditioning use. Figures 10 and 11 use a linear average to indicate the general trend these homes follow (i.e., the more air conditioning, the more comfortable). The ideal home would use little to no air conditioning yet be low in the percent of time above the indicated THI. Thus the lower left corner of the graph is ideal and gets worse towards the upper right hand corner.

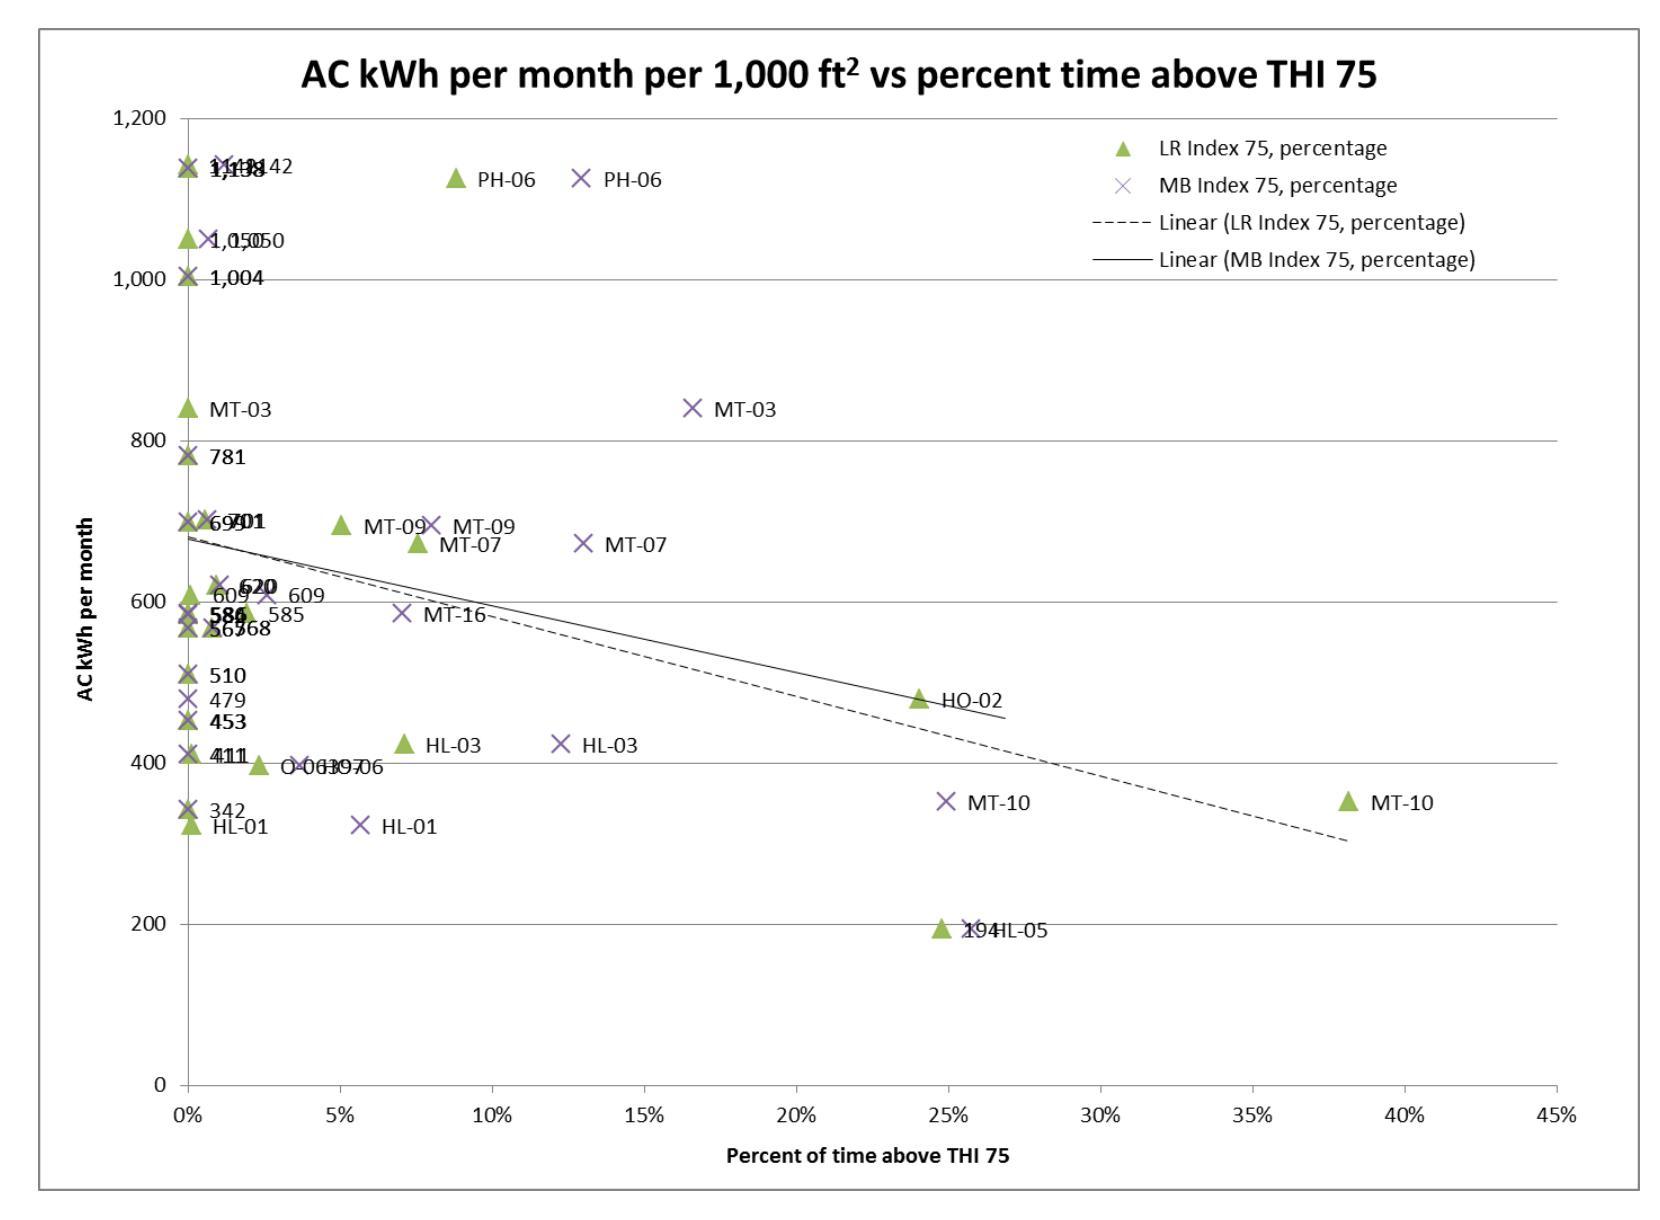
Figure 11. Percent time THI was over 75 vs AC energy (kWh/month per 1,000 ft²).

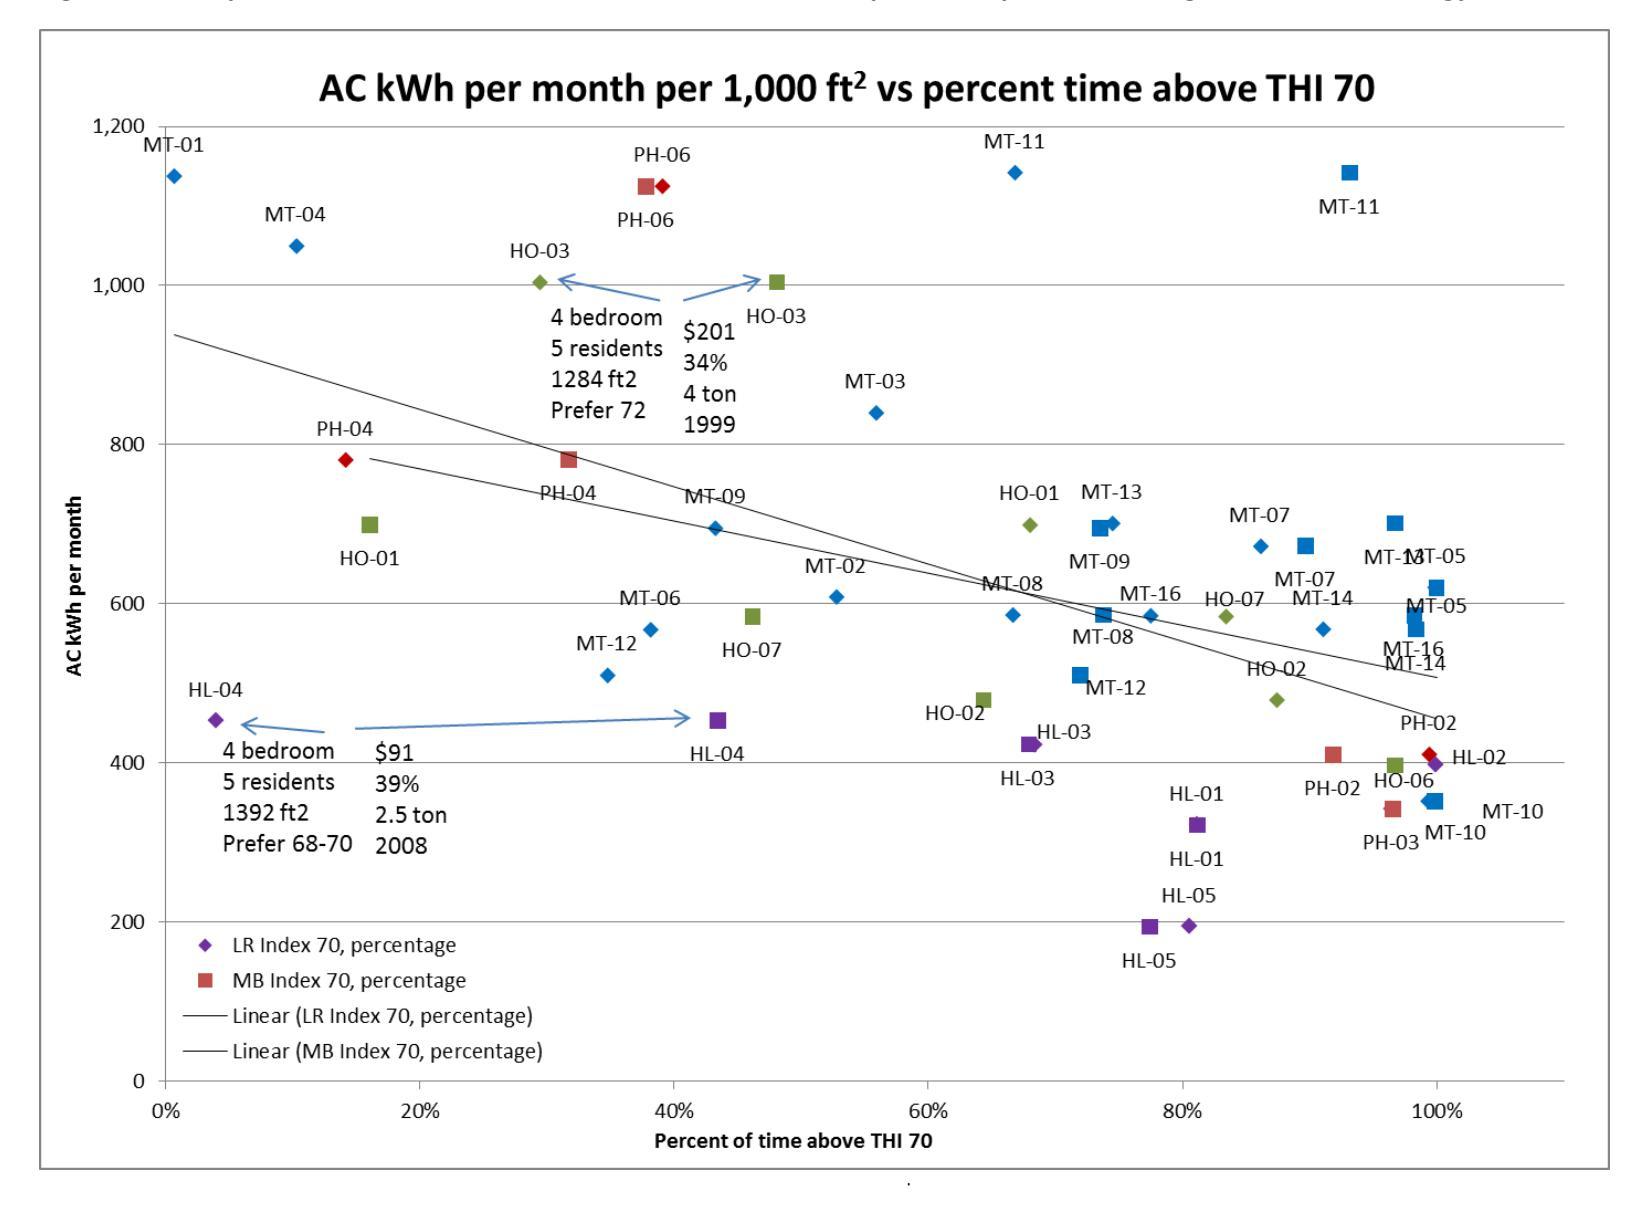
Figure 12. Comparison of two homes of similar size, number of occupants, temperature settings, but different energy use for AC.

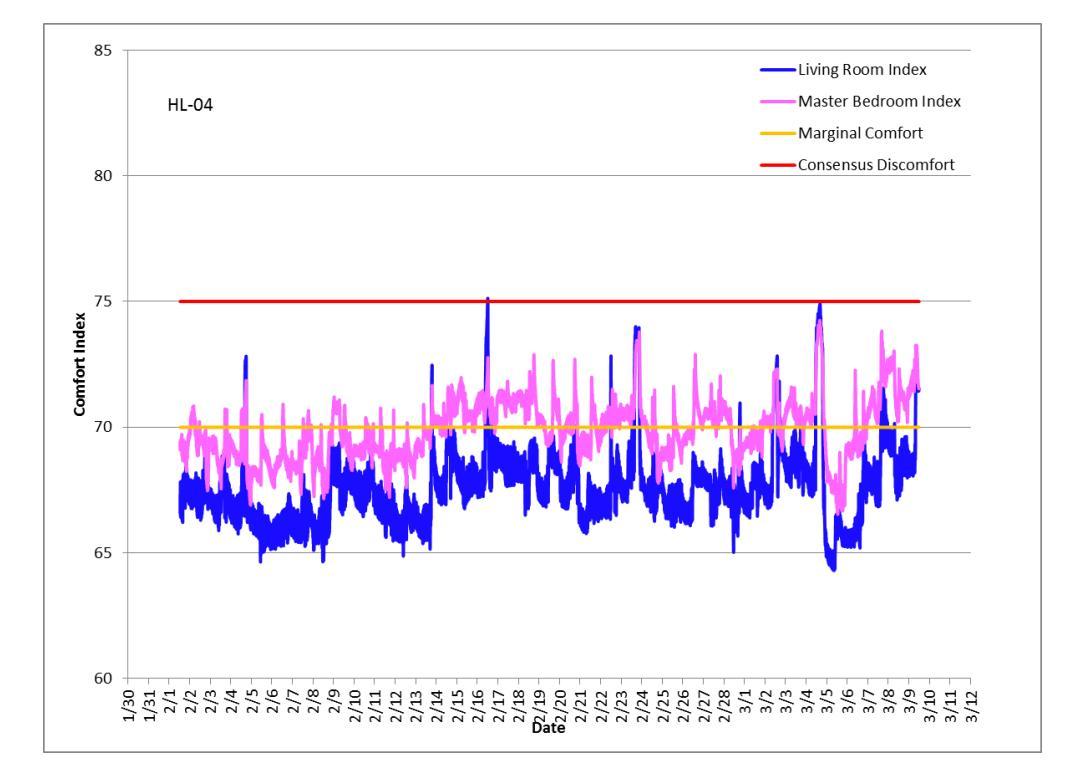
Figure 13. Comfort Index conditions within HL-04 were always below THI 75 and a considerable amount of time below THI 70.

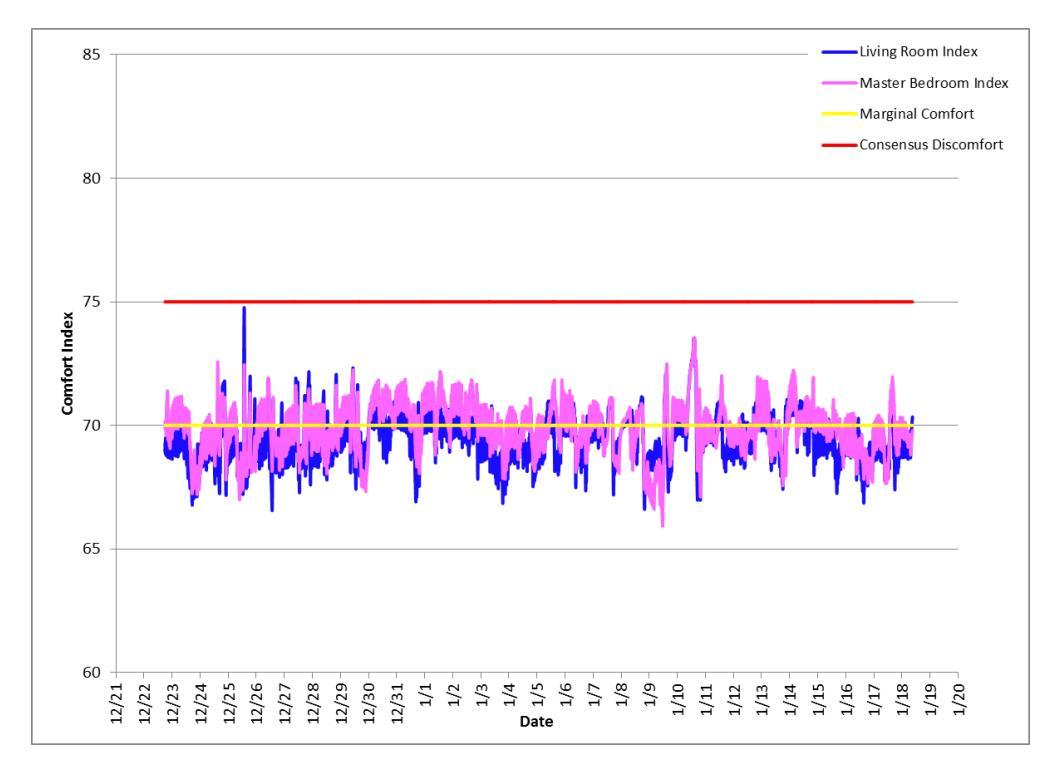
Figure 14. Comfort Index conditions within HO-03 were not better than HL-04 despite using more than twice as much energy for cooling.

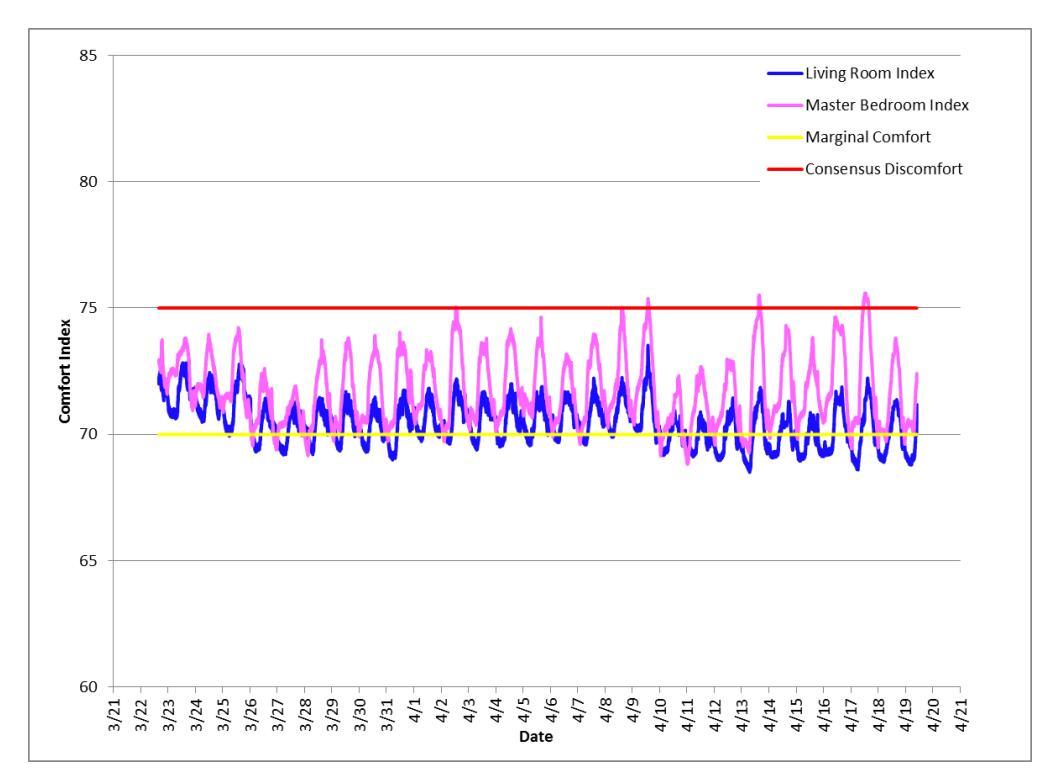
Figure 16. The worst case scenario for the highest energy use with the lowest comfort was MT-11.

While the exact reasons for the differences can vary widely, it is clear that some homes are working much more efficiently than others in relation to the THI. Solutions for this problem may be as simple as a better explanation to homeowners on how to set their programmable thermostats to fit their daily routine, assuring all the insulation is in place in the attic and repairing leaky ducts. Figures 12, 13, and 14 illustrate the performance of two homes, HO-03 and HL-04, which are of similar size, have the same number of occupants and temperature preferences, but the energy use for AC in HO-03 is more than twice that of HL-04. This may be due to the younger AC in HL-04, or it might be caused by leaky ducts in HO-03. The worst case scenario for comfort alone was MT-10 (Fig. 15). The overall worst case scenario for high energy consumption for cooling combined with low comfort was MT-11 (Fig. 16).

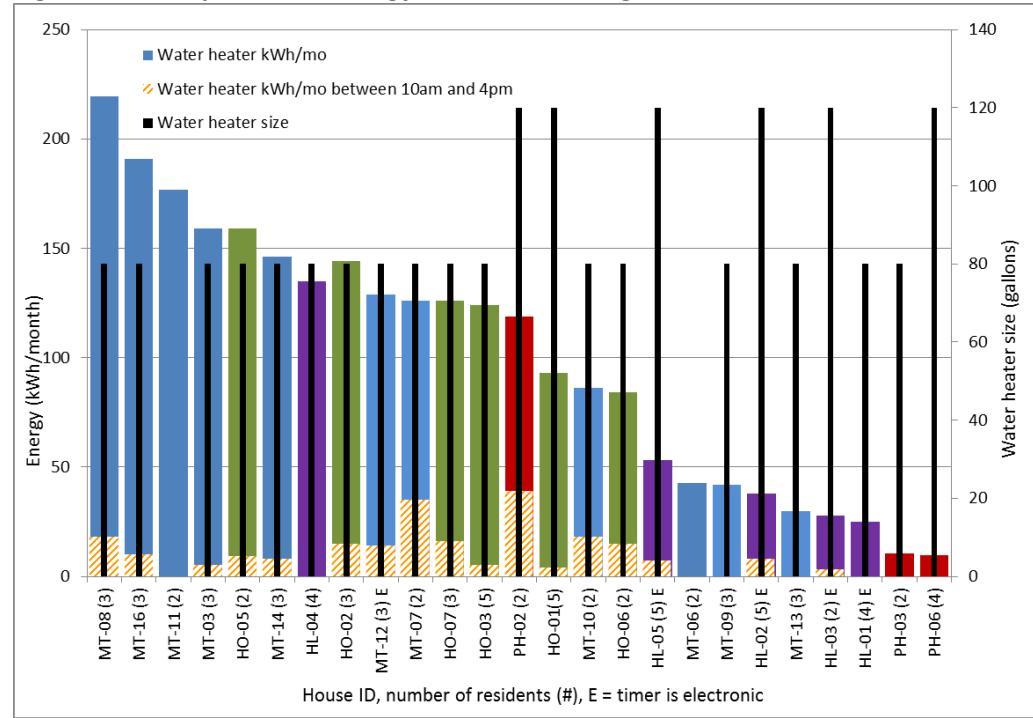
- Some solar water systems are not functioning. The system in MT-03 was turned off. Solar pumps in MT-09 and MT-10 ran all the time and in MT-12 it ran most of the time.
- Some water heater timers are not working (MT-03, MT-12).
- Some families might use a lot of hot water during the evening and early morning hours.
- Low or no energy use between 10am and 4pm but high energy use overall is indicative of a system with a functioning timer but a non-functioning solar heating system. Some data showed heaters often came on right at 4pm when the timer allowed it, indicating the solar system did not heat the water in the afternoon.
- Families with 4 or 5 people are not the highest users.
- Homes with 120 gallon tanks are not the highest users.

Figure 17. Comparison of energy for water heating, water heater size, number of residents in home.

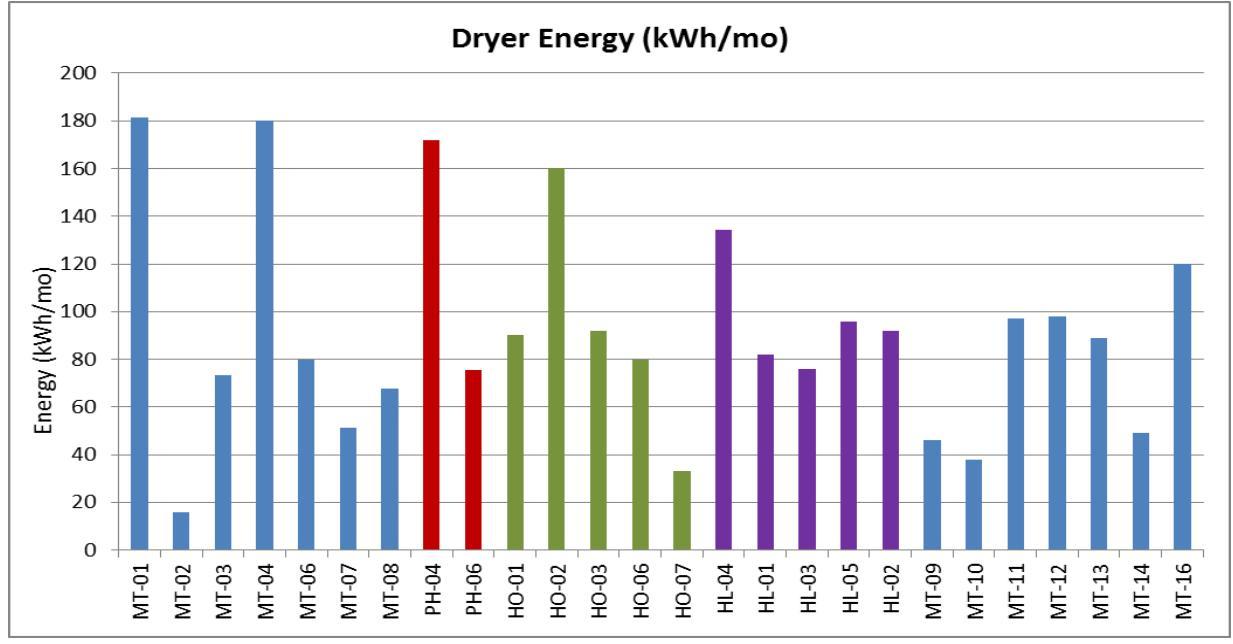
Energy used monthly for drying clothes varied from 16 to 181 kWh (Fig. 18). Monthly hours of operation ranged from 7 to 95 hrs. This is mainly due to variations in lifestyles, but dryer efficiency could play a role. Some of the ventilation ducts were long and not venting the hot, humid air properly - adding to the heat and humidity ("latent heat") load of the home. A typical 12-pound load of dry laundry can hold 8 pounds of water when taken out of the washer.

Figure 18. Comparison of energy used for clothes drying (kWh/mo).

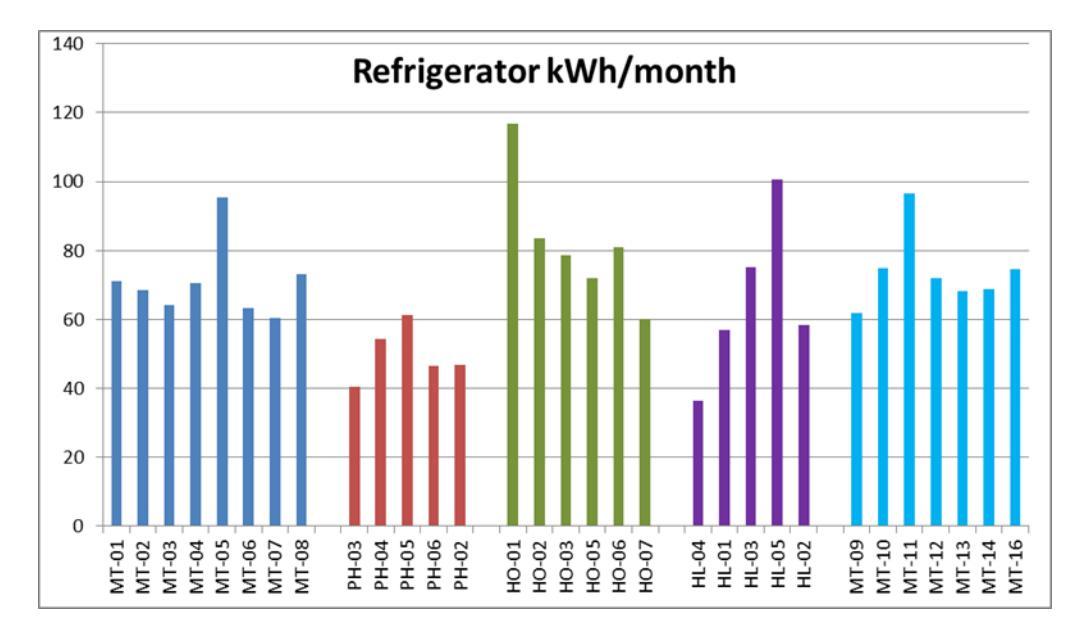
The variation in energy consumption (Fig. 20) of refrigerators is mainly a factor of size (Table 9) and age (Table 10). The average age of refrigerators in the MT and HO neighborhoods is 1997, but the average age of the appliance in PH and HL is 2001-2002. Refrigerators supplied by Forest City are all 18 to 22 ft³ in size and are standard top-mount freezer design (the most efficient configuration; Table 11). The refrigerator in HL-05 was a 21 ft³ Hotpoint instead of the standard Whirlpool found in Forest City homes and consumed 101 kWh/mo. This was considered an outlier and omitted from further analyses along with the resident-supplied 26-ft³ side-mount freezer Frigidaire model in HO-01.

Figure 20. Comparison of monthly energy consumption of refrigerators at Forest City.

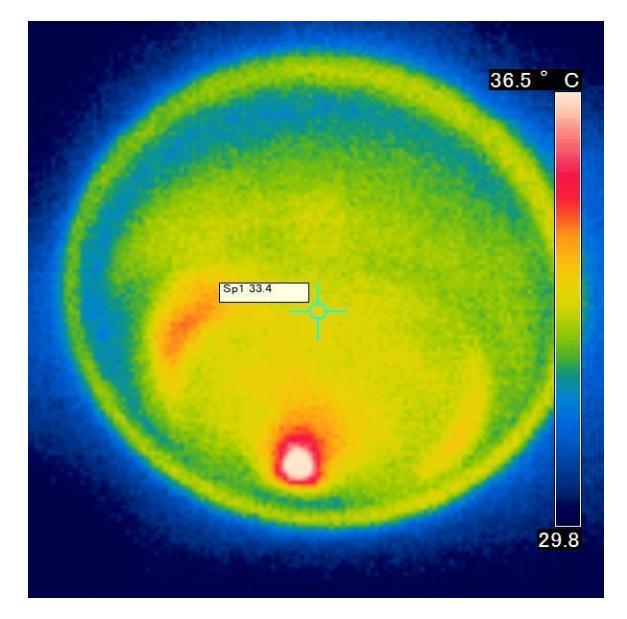
- 5. More ceiling fans increased air speed means that a higher temperature/humidity condition can still be comfortable.
- 6. We observed in a home that the recessed lighting upstairs (master bedroom) is conducting a lot of heat they are equipped with CFLs but a sticker on the light housing states "Warning Risk of Fire, do not install insulation within 3 inches of any part of this luminaire, remove this label if installed in an IC application." The warning to not insulate may have been for when the fixture was equipped with incandescent bulbs.

Photo 6. Infrared image of recessed light upstairs of a 2-story house, allowing heat transfer from attic into master bathroom. The light is *not* turned on. Temperature range of the fixture is 85.6 to 97.9°F.

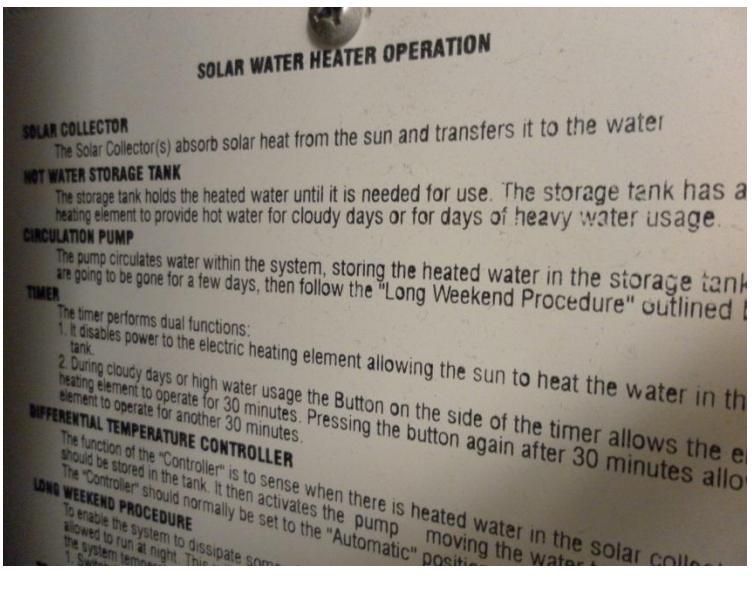
Photo 7. Solar water heater instructions posted in one home. Instructions should be posted in all houses.

- 1. Post clear instructions for the occupant.
- 2. Four pins set on manual timer sometimes these are missing and the occupant never touched it, so FC did not check it on turnover.

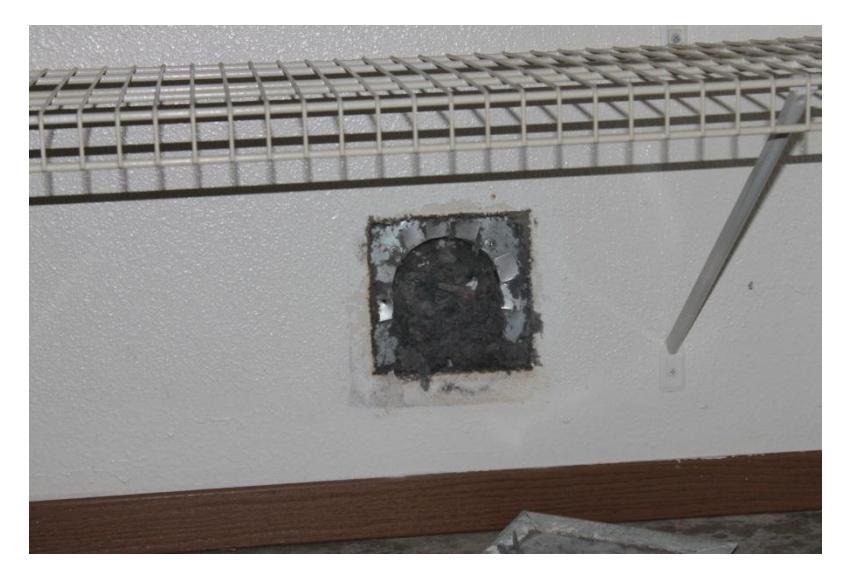
Photo 8. Clogged dryer duct in an empty home.

- Dryer duct lengths are often too long with a couple of 90° elbows. Avoid this in new builds and retrofit existing houses with long duct runs by installing a clean-out access. In one 2-story house we inspected, the dryer duct ran from the first floor up to the attic.
- 2. Dryer duct needs regular inspection/clean out.
- 3. Dryer located in the garage is a good idea it is isolated and will keep heat and humidity out of house.

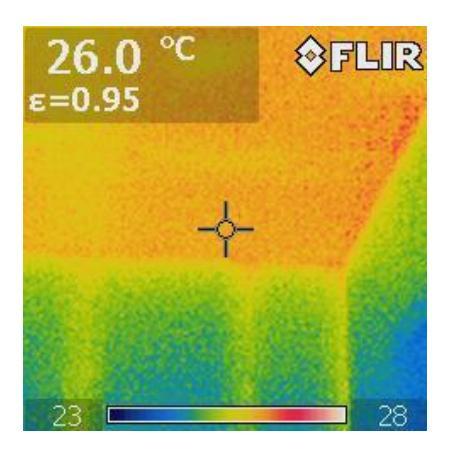
Photo 8. Thermography images from houses in PH neighborhood.

a) wall studs; ceiling

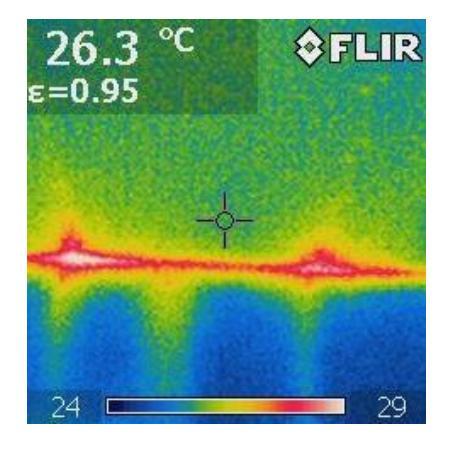
b) ceiling plate; soffit areas not insulated

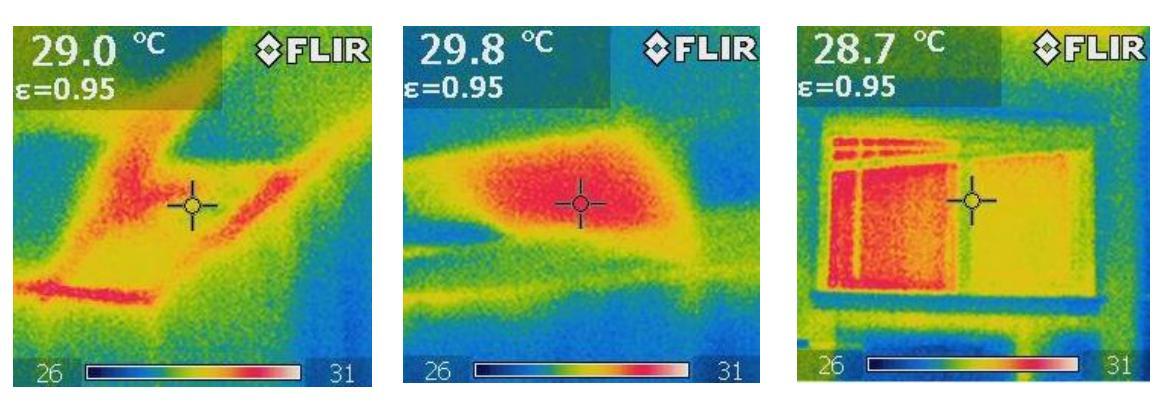
c) ceiling joists

d) ceiling; attic insulation missing

e) window
