Hawaii National Marine Renewable Energy Center (HINMREC)

WETS Deepwater Mooring Inspection

Prepared by:
Sea Engineering, Inc.

March 2017

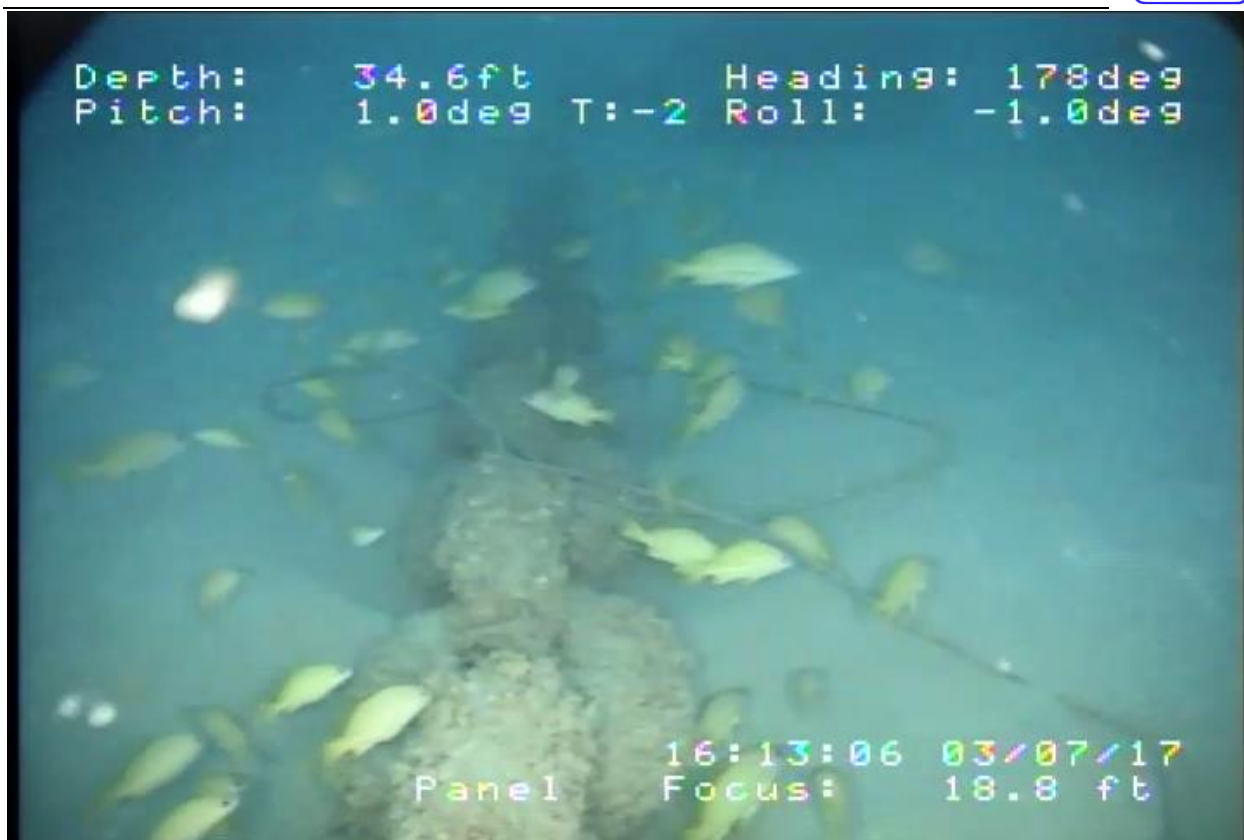
The failed B2 mooring chain, sinker weights, and anchor (see 11/5/2016 Inspection report) were observed on the seafloor. The surface float was removed by Healy Tibbits. The B3 mooring leg is intact and all sinker weight are still attached.

Figure 4-49 B2-ML-4 Cable

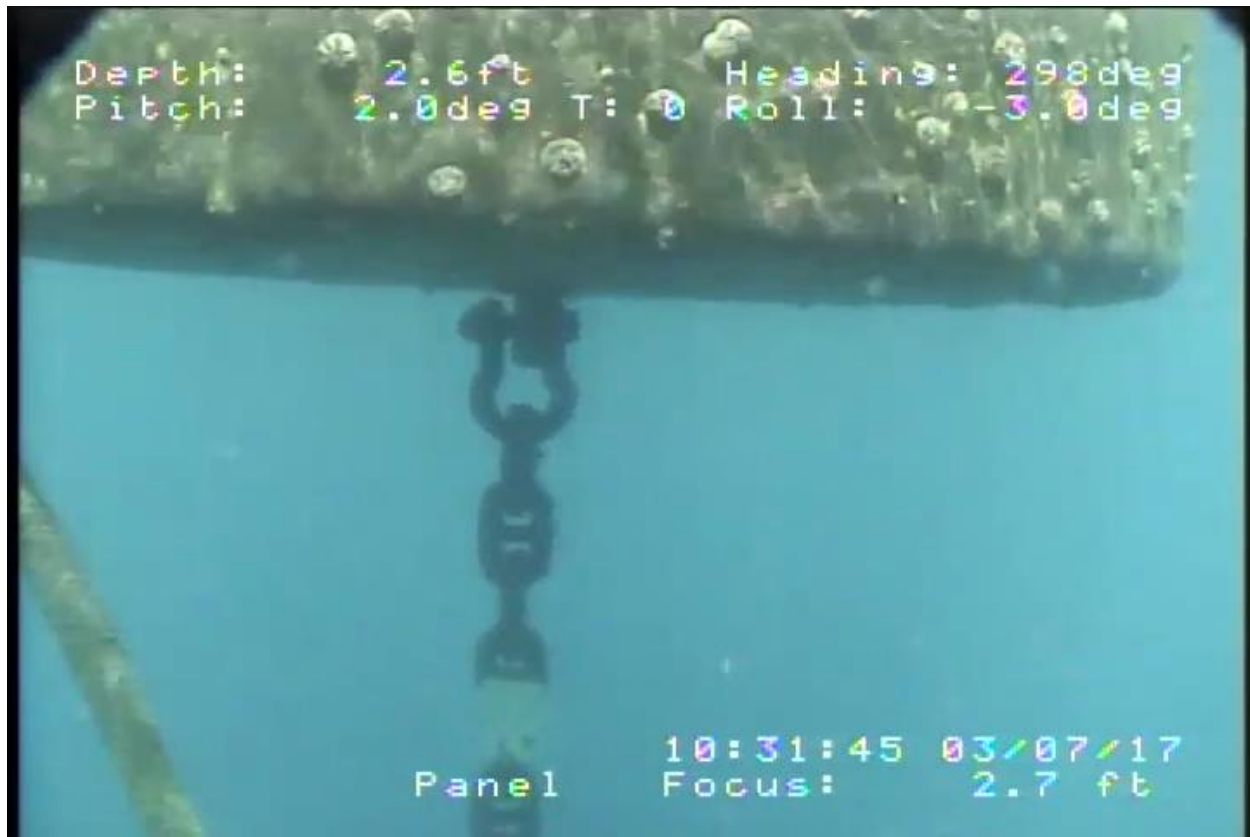
Figure 4-51 B3-ML-(11,12,13,14)

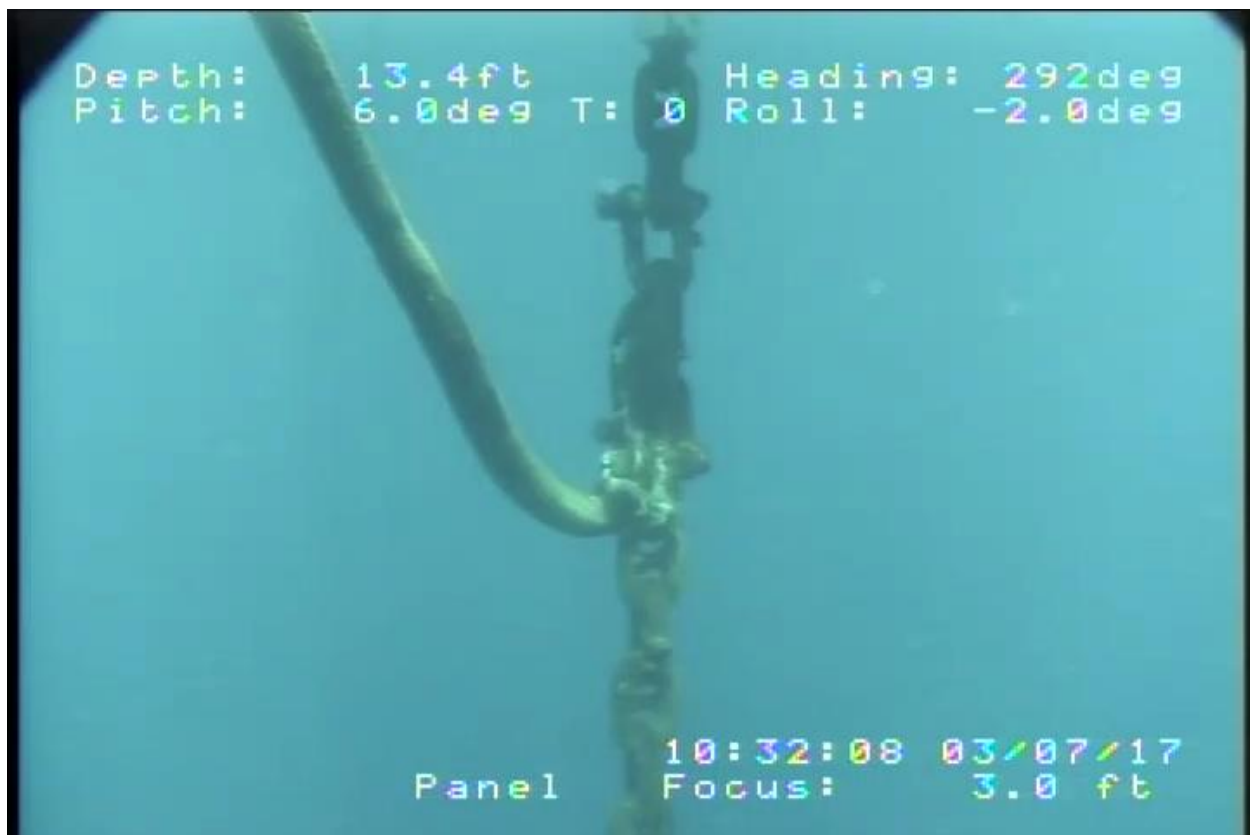
Figure 4-52 B3-ML-(4,5,6,7,8,9,10,11,15,16)

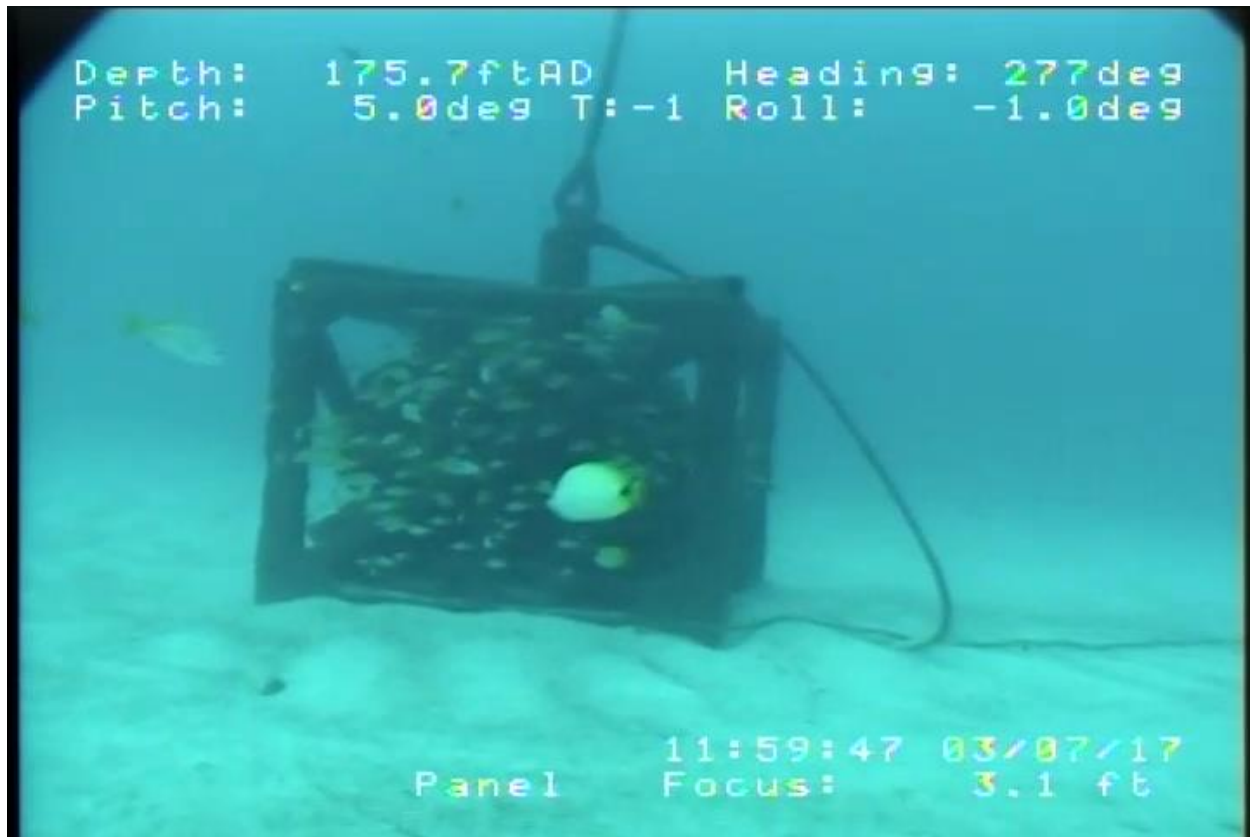
Figure 4-62 PTO1-1 Chain Box

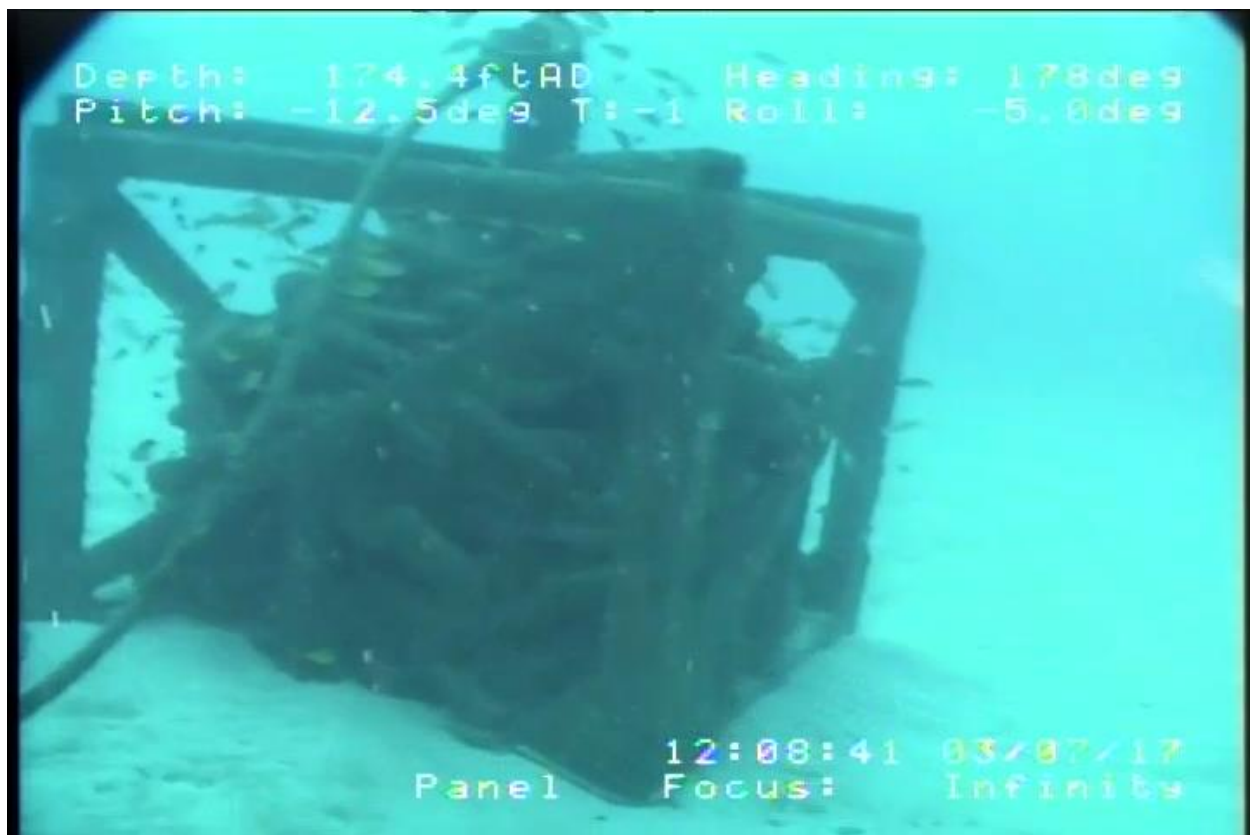
The configuration of the power take off (PTO) chain baskets and bands at the A mooring site is shown in Figure 3-3 and Table 3-3. PTO 1 and PTO 2 were operational during the inspection. The intact components of the PTO 1 and PTO 2 systems are shown in Figure 4-63 through Figure 4-65 and Figure 4-66 through Figure 4-69, respectively. The link of chain attached to the underside of the PTO3 subsurface float failed (see previous Task 6K Report). The two remaining pieces of chain are piled together on the sea floor with the thimble and part of the riser line shown in Figure 4-73. There is a loop in the riser line that is an entanglement hazard to ROV operations shown in Figure 4-74.

Figure 4-63 PTO1 Recovery Wire

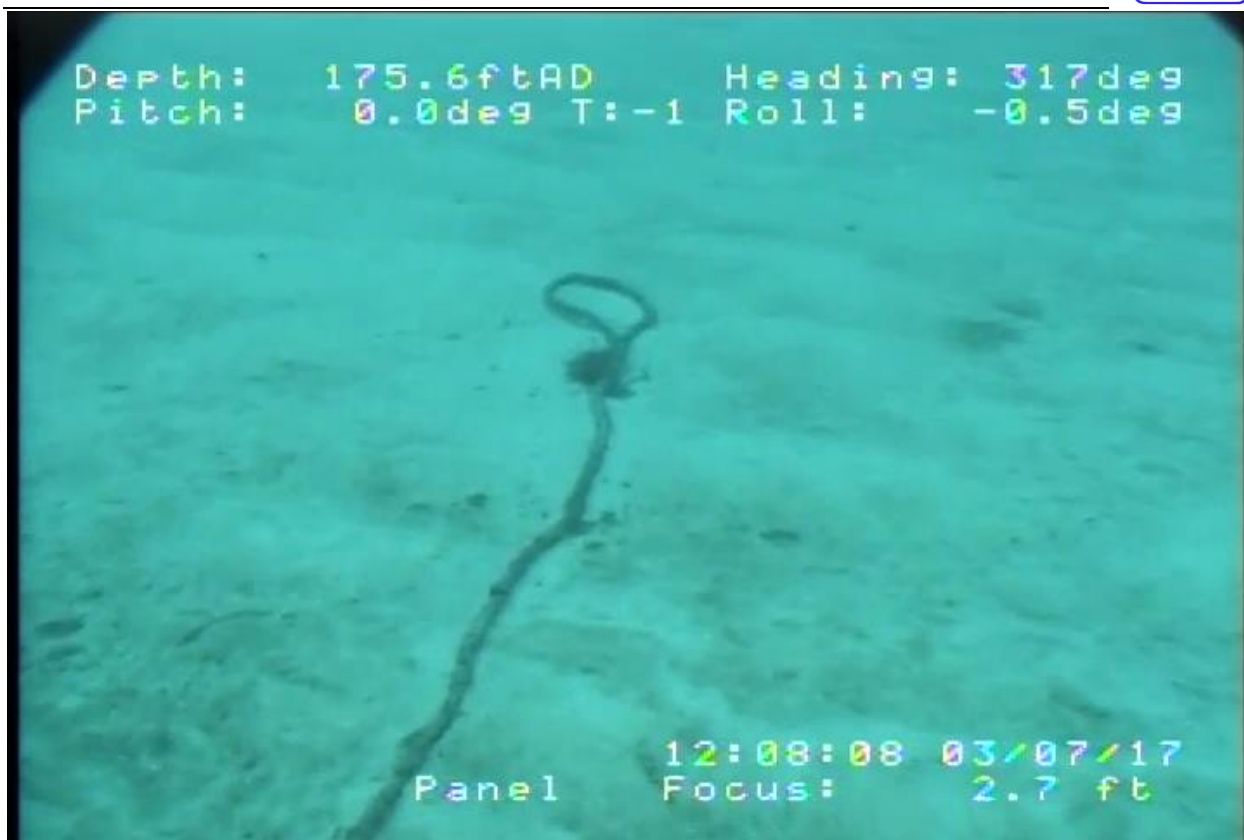
Figure 4-64 PTO1 Poly Recovery Line

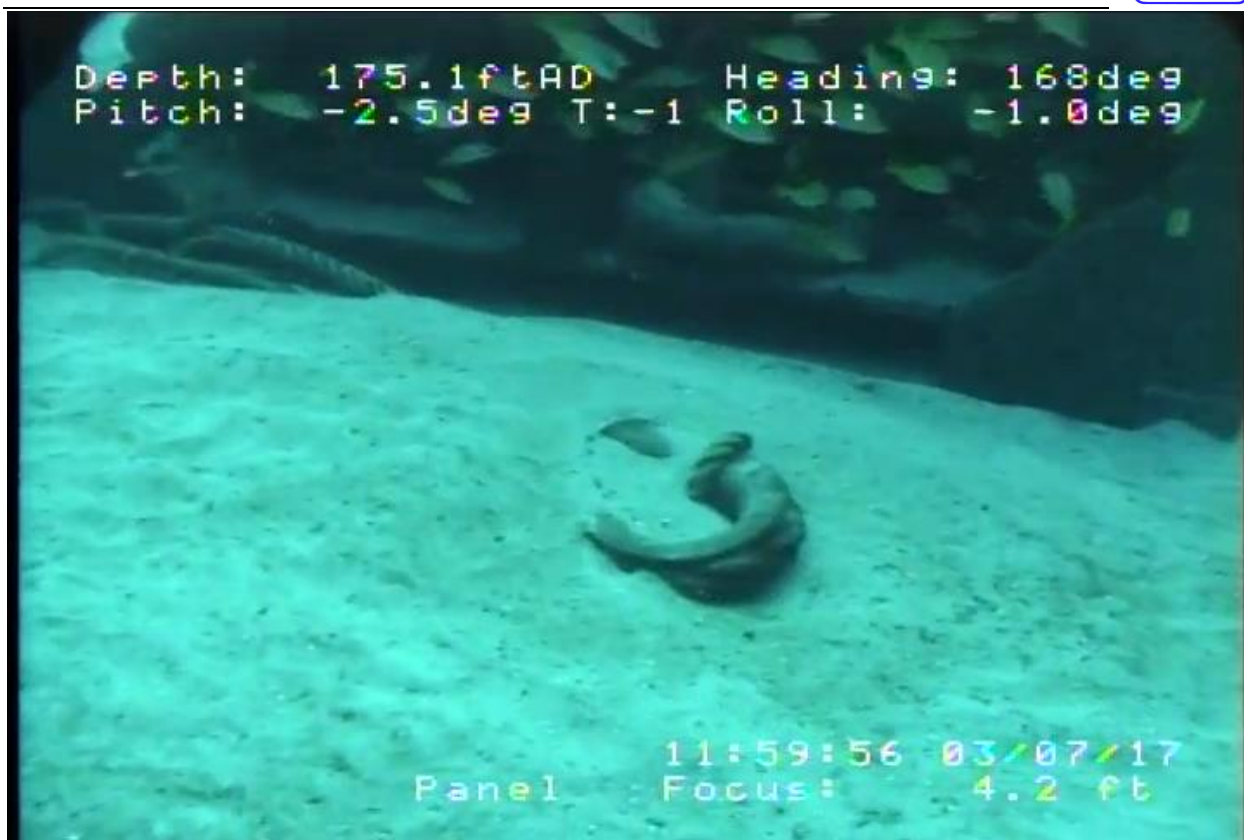
Figure 4-68 PTO2 Thimble on Recovery Wire

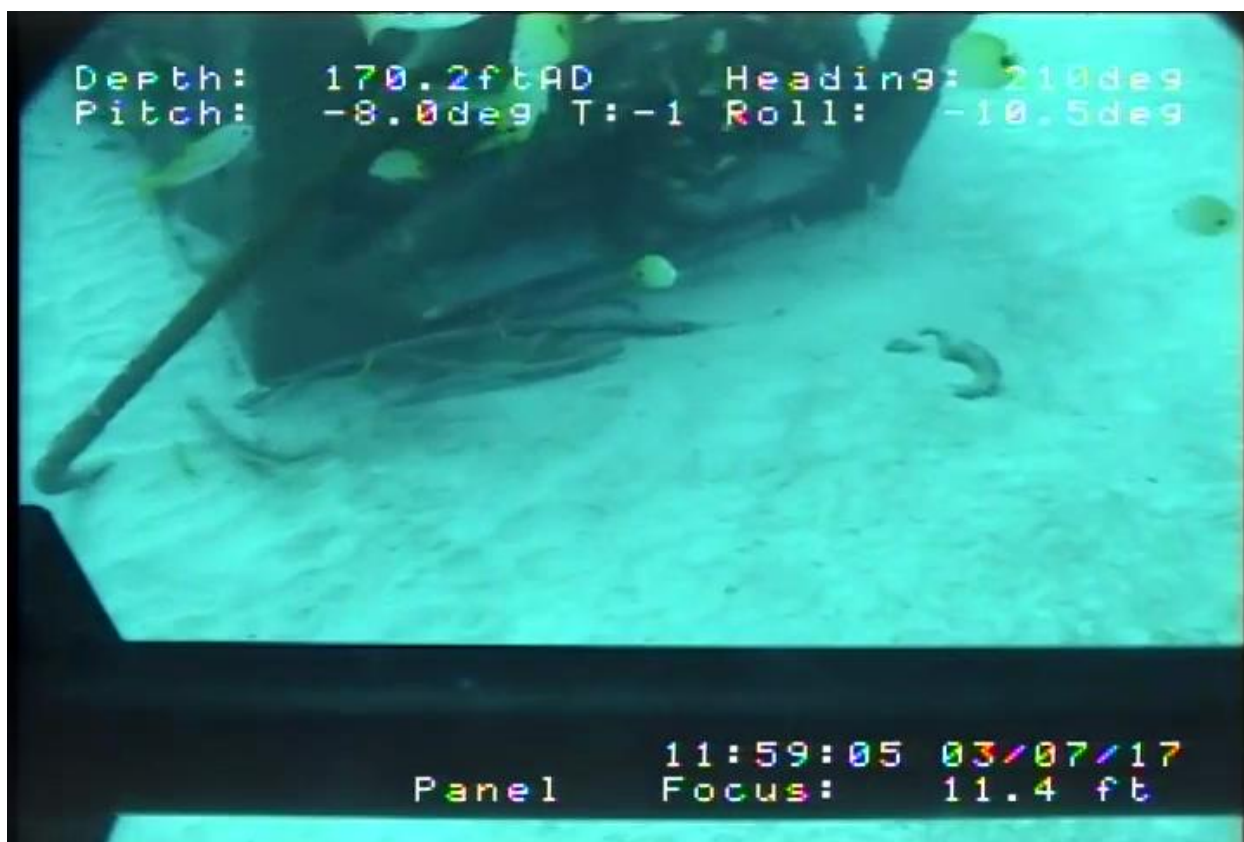
Figure 4-69 PTO2 Recovery Wire
